Report: PRELIM

Function: Test, Adjust, & Balance

06-09-25 CULVERS LEXINGTON (MEIJER WAY), KY

Project: 06-09-25 CULVERS LEXINGTON (MEIJER WAY), KY

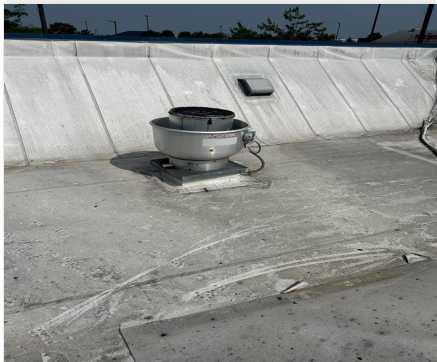
Issue Name : EF-1
Description : EF-1 connects to the mop sink and the diffuser above the ice maker. Its producing 780 CFM currently, which isn't necessary as it is pushing the store negative and out of the threshold for BP. Recommend installing a speed controller, a smaller fan, or turning it off completely
Created By : National TAB **Assigned To :** National TAB - Dan Hertenstein
Status : Open
Priority : Urgent **Asset Tag :**
Originated Date : 06/11/2025 - Aaron Cosby - National TAB

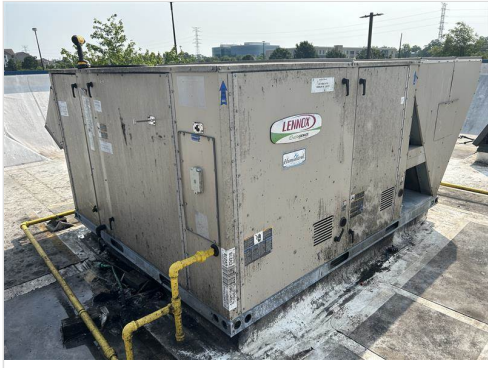
Unit Data - PHOTO LOG

Issue Name : RTU-1 Pulley Frozen
Description : RTU-1 is below CFM per tonnage. If the unit produced more air, OA could be turned up which would make building pressure more positive. Even if key is unstuck, it would likely need a pulley change to get more air from the unit
Created By : National TAB **Assigned To :** National TAB - Dan Hertenstein
Status : Open
Priority : High **Asset Tag :**
Originated Date : 06/11/2025 - Aaron Cosby - National TAB

Asset: RTU1

Test Data		
	Design	Actual
SF CFM	7000	5140
SF RPM	-	1777
RA CFM	-	3496
OA CFM	1000	1644
RL Voltage	-	209
RL Amperage	-	9.3
SF Rotation	-	GOOD
Min OA Damper Position	-	27%

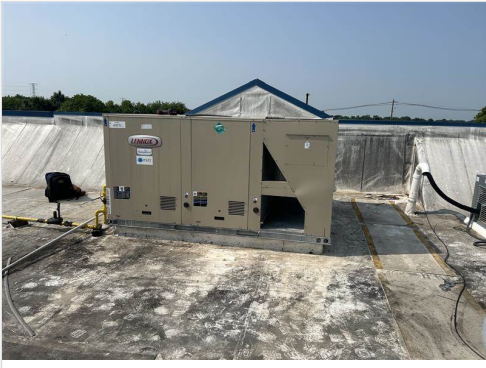
Unit Data - PHOTO LOG

Asset: RTU2

Test Data		
	Design	Actual
SF CFM	7000	7112
SF RPM	-	882
RA CFM	5100	5057
OA CFM	1900	2055
RL Voltage	-	NOT SAFELY ACCESSIBLE
RL Amperage	-	11.8 VFD
SF Rotation	-	CCW
SF System SetPt	-	54HZ
RA Damper Position	-	MECHANICALLY LINKED
Min OA Damper Position	-	4.7 DCV
Min OA Damper Type	-	ECONOMIZER

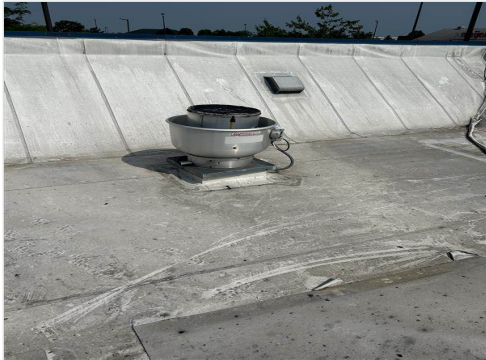
Unit Data - PHOTO LOG

Asset: EF1

Test Data		
	Design	Actual
CFM	-	780
RL Amperage	-	UNDER FLA

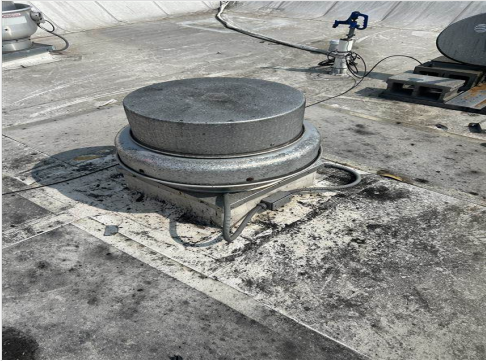
Unit Data - PHOTO LOG

Asset: EF4

Test Data		
	Design	Actual
CFM	-	780
Fan Rotation	-	GOOD
RL Amperage	-	UNDER FLA

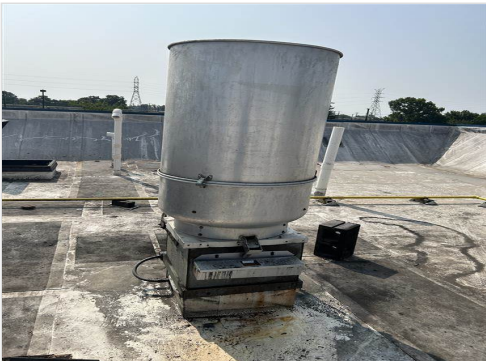
Unit Data - PHOTO LOG

Asset: PRV2

Test Data		
	Design	Actual
CFM	-	1561
Fan Rotation	-	GOOD
RL Voltage	-	208
RL Amperage	-	UNDER FLA

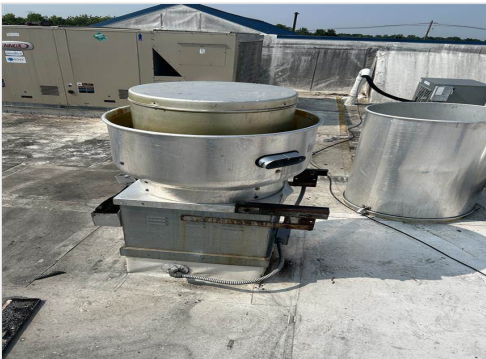
Unit Data - PHOTO LOG

Asset: PRV3

Test Data		
	Design	Actual
CFM	-	1432
Fan Rotation	-	GOOD
RL Voltage	-	209
RL Amperage	-	UNDER FLA
