# PlanGrid Task Report - Aug 8, 2024

10 tasks in this report.

**L04954\_Chapel Hill University Place FSU (NC)**

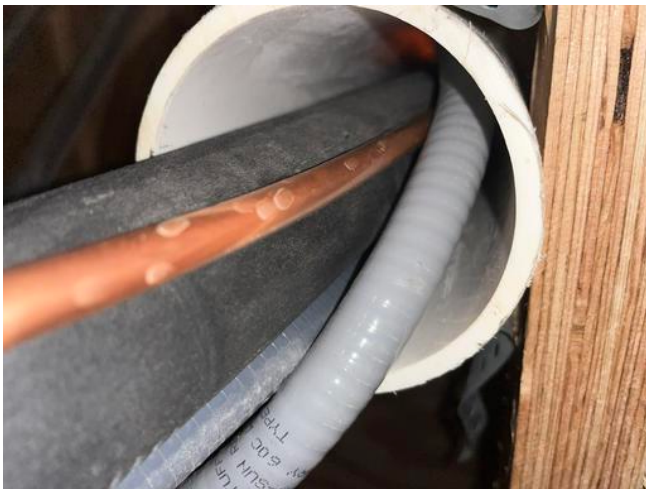
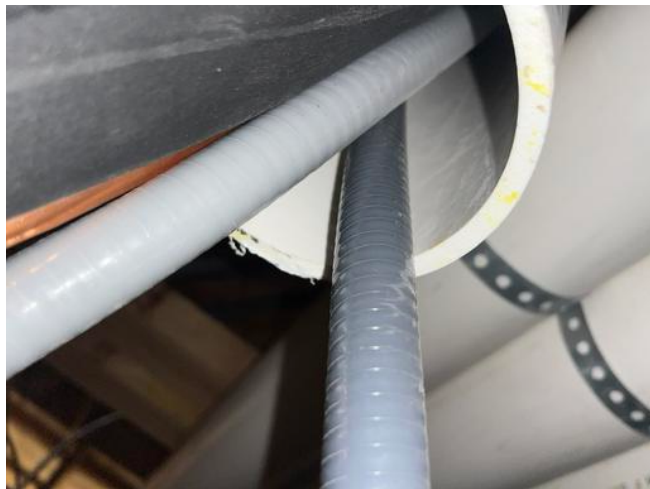
## #61 [REFG 511] [NEW] PVC pipe chase (gooseneck) installation.

WIC & WIF gooseneck penetrations need to be sealed with spray foam.

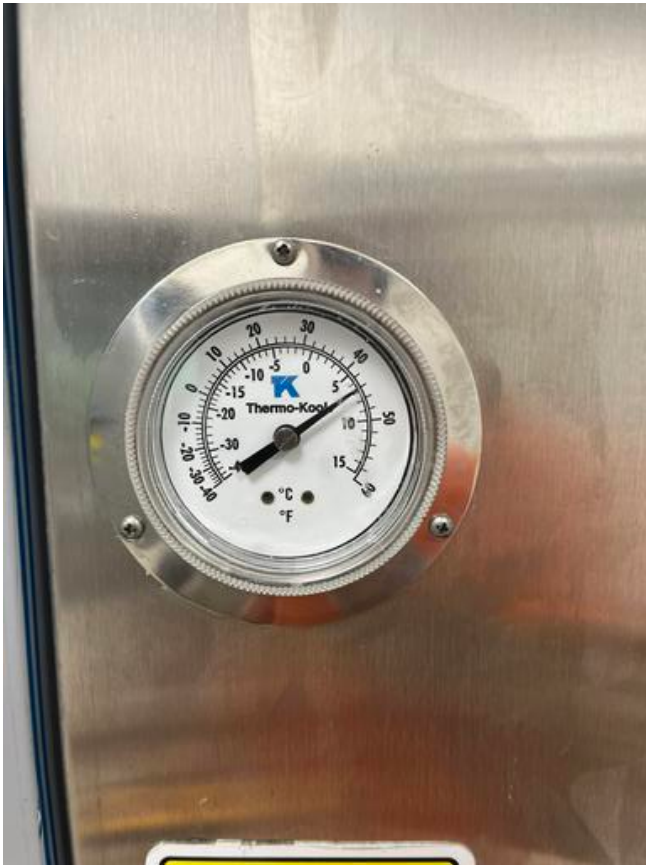
IMG\_5096

**#60 [REFG 500] [NEW] WIC/WIF temperatures.**

WIC is at 45F should be at 35F.

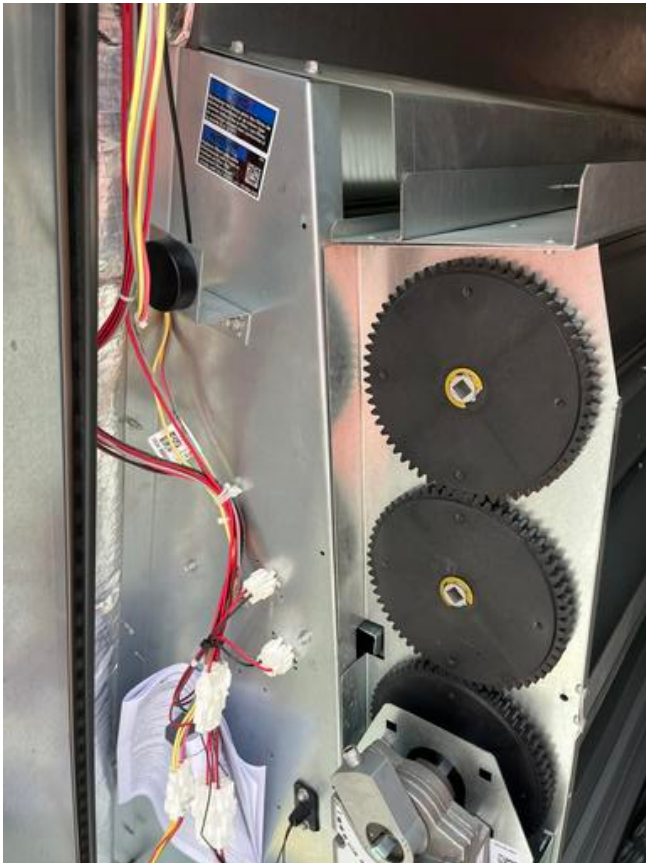
IMG\_5087

## #59 [UNIT 999] [NEW] (MISC) [FACTORY OA PANEL]

AC1 econ is missing a factory installed block off plate to seal outside air canopy.

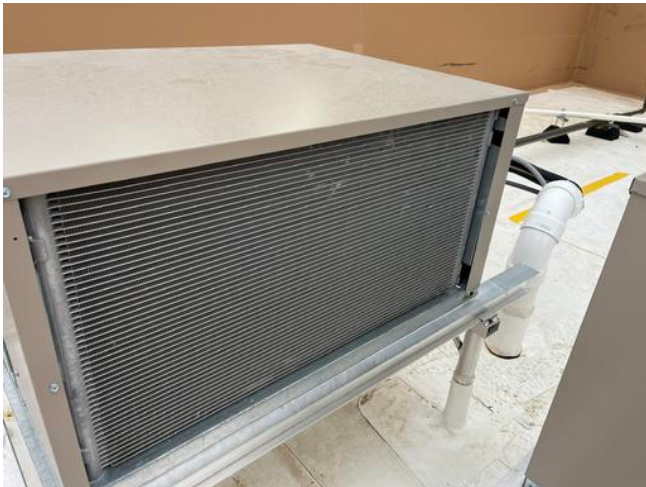
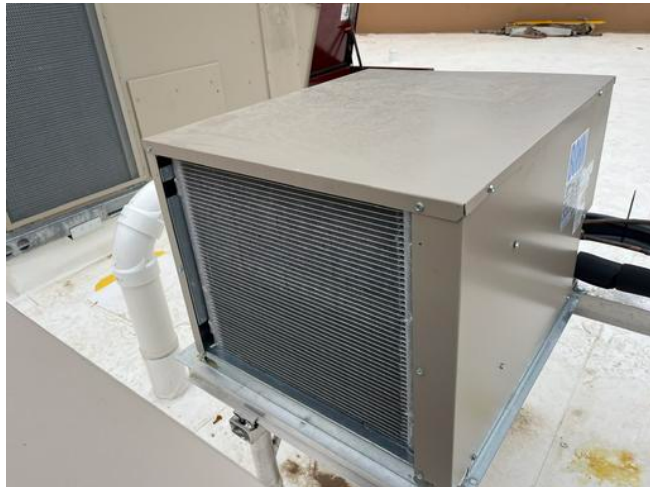
**#58 [REFG 517] [NEW] Hail guards.**

WIC & WIF hail guards are missing from condensers.

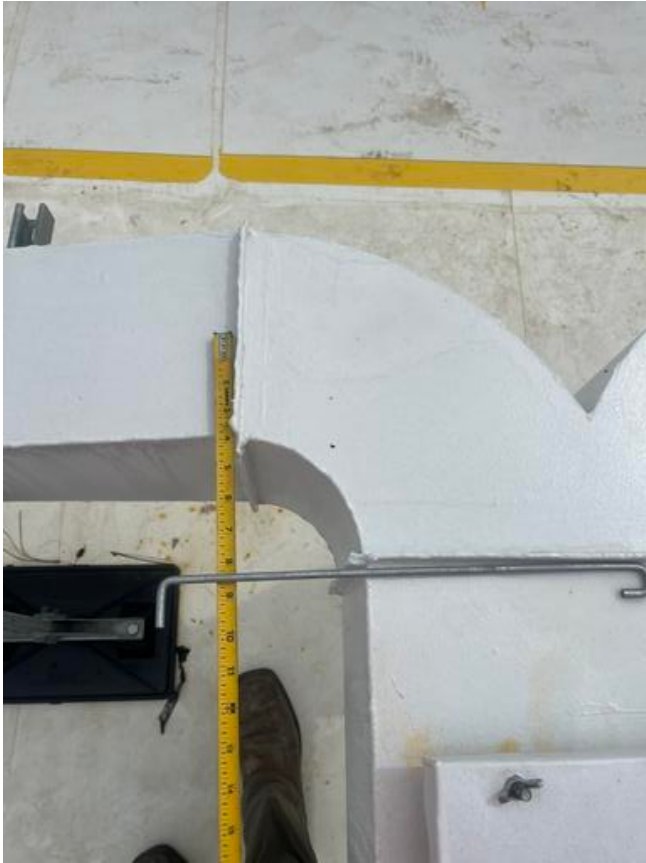
IMG\_5070

**#57 [EXHA 003] [NEW] CRITICAL – Incorrect grease exhaust duct ells.**

EF2 has two short radius turns installed. Plans call for long radius centerline R=3W/2 fittings per specification. Short radius, mitered ells, and offsets greater than 45 degrees are not allowed.

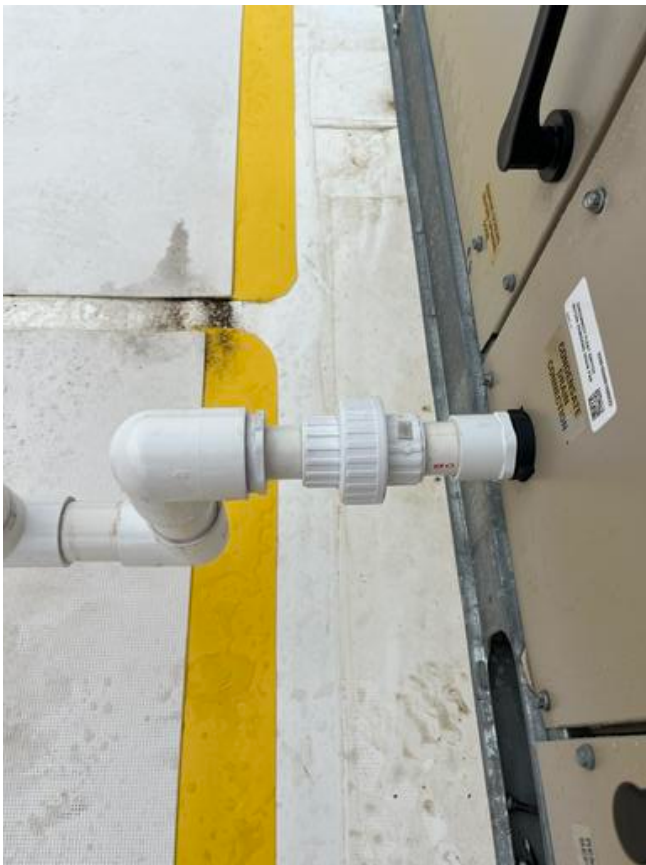
IMG\_5059

## #56 [UNIT 517] [NEW] Condensate piping construction.

AC1, AC2, AC3, AC4 union between p-trap and unit should be the same size as condensate line called for in prints.

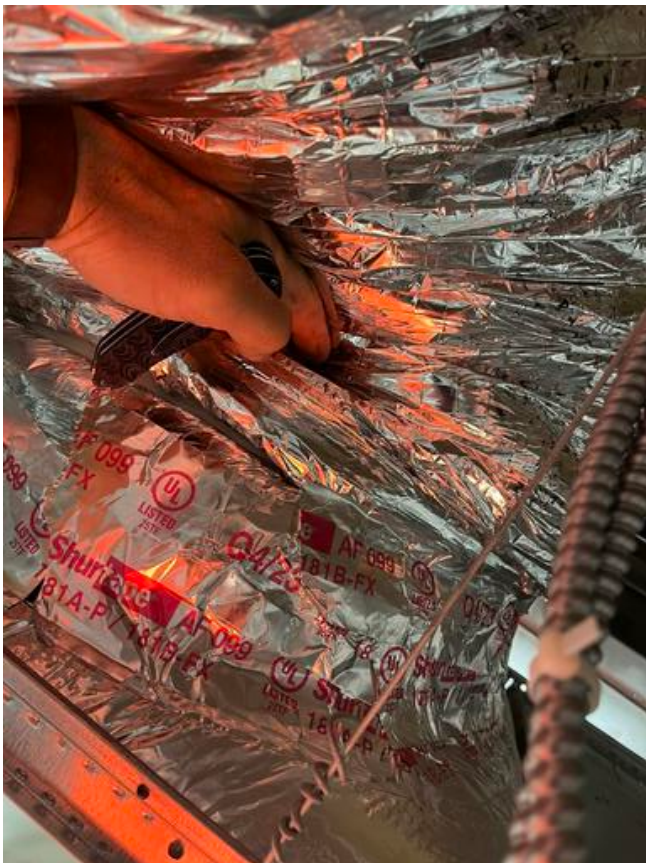
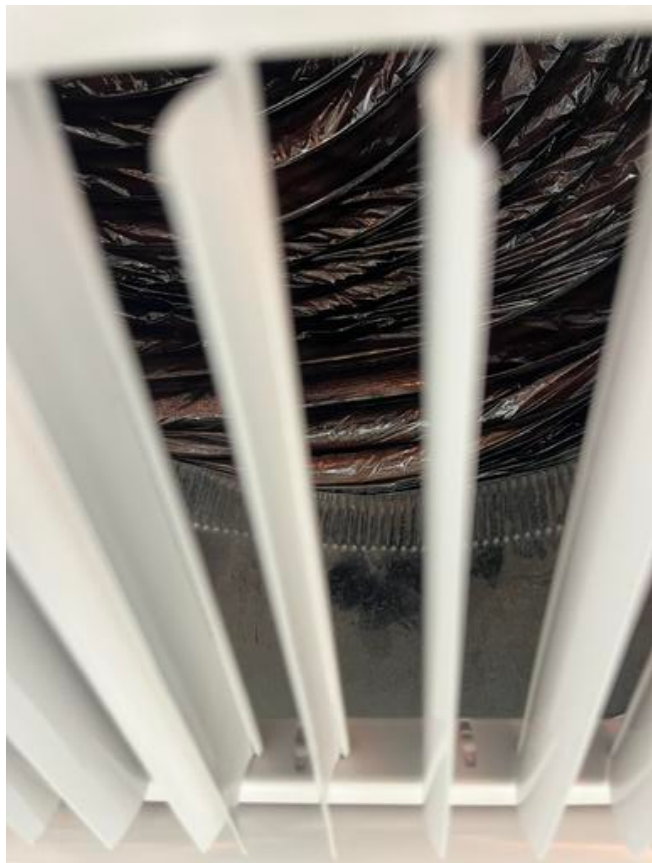
## #55 [DUCT 007] [NEW] CRITICAL – Diffuser rigid 90's.

AC1 SGRD9 is missing the hard rigid hard 90 at the diffuser.

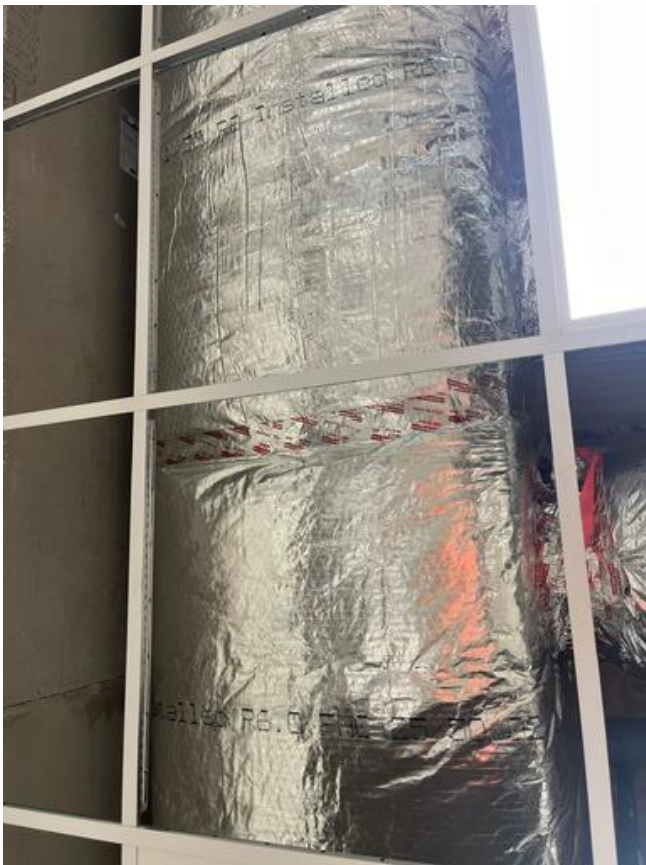
IMG\_5046

**#54 [DUCT 501] [NEW] Insulation stick pins.**

AC2 supply trunk line needs stick pins installed. Duct is over 24" in width.

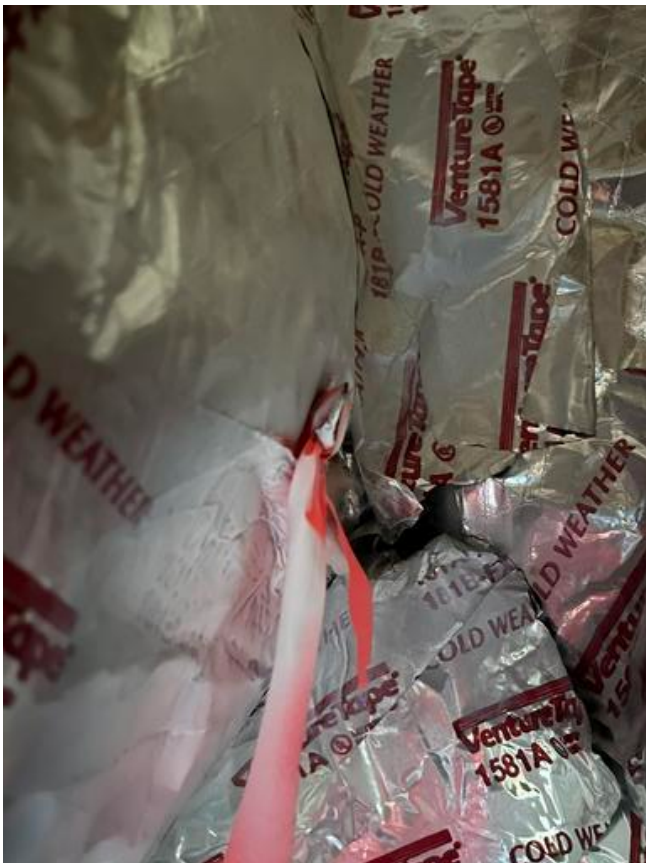
IMG\_5103

## #53 [DUCT 009] [NEW] CRITICAL – Damper incorrect type.

AC4 SGRD4 has the incorrect damper type installed.

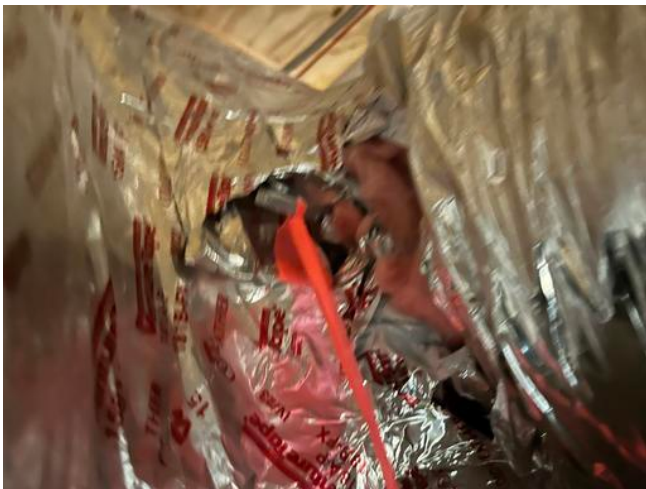
IMG\_5053

**#52 [DUCT 010] [NEW] CRITICAL – Damper(s) missing hardware.**

AC4 SGRD3 is missing the damper handle. SGRD3 is at design CFM.
