Report: TAB REPORT
Function: Test, Adjust, & Balance
Date: 11/07/2024
Completed By: National TAB

PROJECT
Daybreak Market Wesley Chapel, FL

Scope for the Daybreak Market in Wesley Chapel is to balance (1) RTU, (1) EF, and all associated air devices. Reason for the visit is to address concerns of negative building pressure and to ensure the equipment is properly balanced.

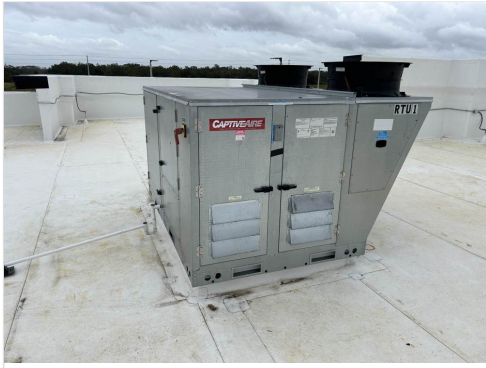
IMG_1587_1840751780_7..

Asset: RTU1

Unit Data		
	Design	Actual
MFG	CARRIER	CAPTIVEAIRE
Serial Num	-	6547192
Model Num	50HC**17	CAS-HVAC3-E.604-24-15T
Type	RTU	DOAS
Configuration	VERTICAL	VERTICAL
Num OA Filters 1	-	4
OA Filter Size 1	-	16x25x2
Num Final Filter 1	-	8
Final Filter Size 1	-	20x25x2

Test Data		
	Design	Actual
SF CFM	6000	5353
SF RPM	-	1667
RA CFM	5200	4536
OA CFM	800	817
RL Voltage	-	485 VFD
RL Amperage	-	9.2 VFD
SF Rotation	-	CCW
SF System SetPt	-	57 HZ
RA Damper Position	-	5.9 V
Min OA Damper Position	-	4.1 V
Min OA Damper Type	-	ECONOMIZER

Initially the RTU was found running 50HZ and the airflow was measured as 4735 CFM (73% of design). The mechanical contractor indicated that there had been an issue in the past where the RTU had tripped off. The supply fan VFD had been set to 60 Hz which caused it to overamp and trip off. To keep the unit running they had set to 50Hz.

Fan speed was increased to 57Hz and at this speed the airflow was 89% of design. This airflow was validated with both flow hood and traverse readings. At 58Hz, the airflow was at and sometimes exceeding the full load rating of the motor. Left at 57 Hz to prevent the unit from tripping off again.

The outside air damper was initially found set to a 3V setpoint which was nearly closed so it was bringing almost 0 CFM of outside air. The damper was opened to a setting of 4.1 V to achieve design airflow of 817 CFM.

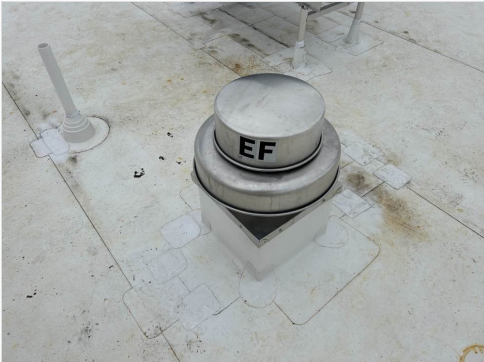
IMG_1588_862475501_19..

Asset: EF1

Unit Data		
	Design	Actual
MFG	GREENHECK	GREENHECK
Model Num	G-090-VG	G-090-VG-1-17-X
Serial Num	-	24462777
Type	-	DOWNBLAST
Configuration	VERTICAL	VERTICAL

Test Data		
	Design	Actual
CFM	450	444
Fan RPM	1542	1052
Fan Rotation	-	CW
Motor RPM	-	1052
System SetPt	-	5.0 POTENTIOMETER
RL Voltage	-	121
RL Amperage	-	0.3
Total ESP	0.50"	0.04"
Fan Inlet SP	-	-0.04"
Fan Discharge SP	-	ATM

The exhaust fan was initially found operating at 660 CFM (146% of design). This was reduced and balanced to 444 CFM (98% of design).
