Report: TAB REPORT
Function: Test, Adjust, & Balance
Date: 10/10/2023

PROJECT
10-09-23 NIKE UNITE - ANTIOCH, TN

Project: 10-09-23 NIKE UNITE - ANTIOCH, TN

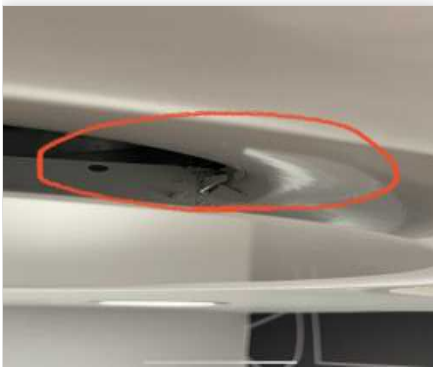
IMG_1820
10/11/2023

Issue Name : Unable to balance fitting room diffusers
Description : Several fitting room diffusers unable to be balanced due to screws protruding from inside diffuser. Prevents face plate from being removed to access balancing damper.
Created By : National TAB **Assigned To :** National TAB - Jordan Best
Status : Open
Originated Date : 10/11/2023 - Jordan Best - National TAB
