PlanGrid Task Report - Jan 29, 2025

L05075_Cedarbrook Plaza (Wyncote, PA) FSU

3001 West Cheltenham Avenue, Wyncote, Pennsylvania

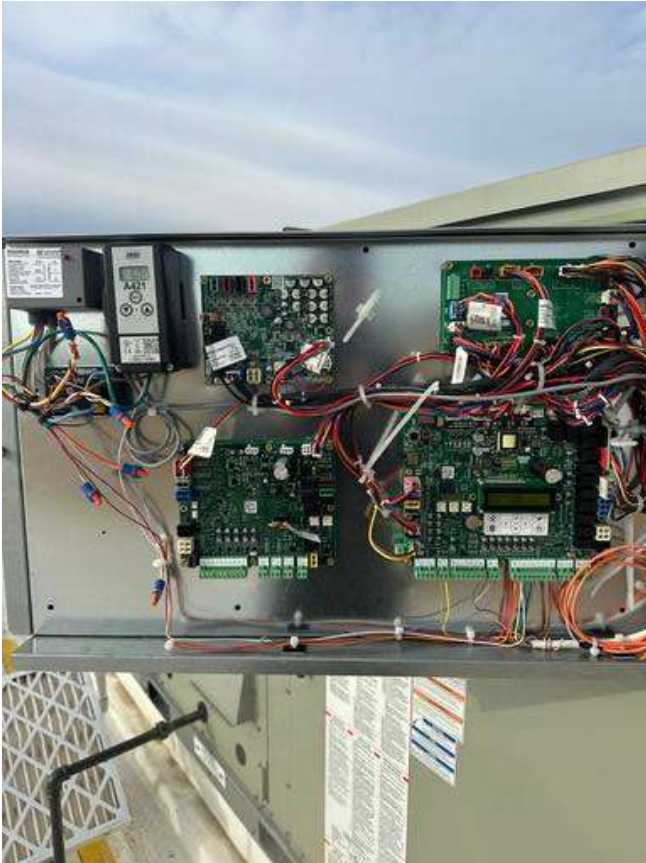
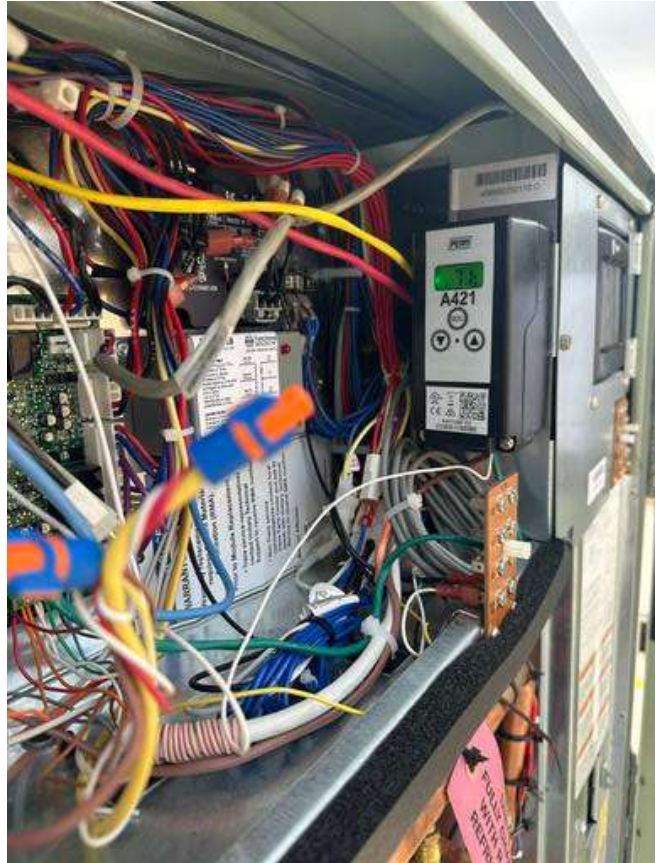
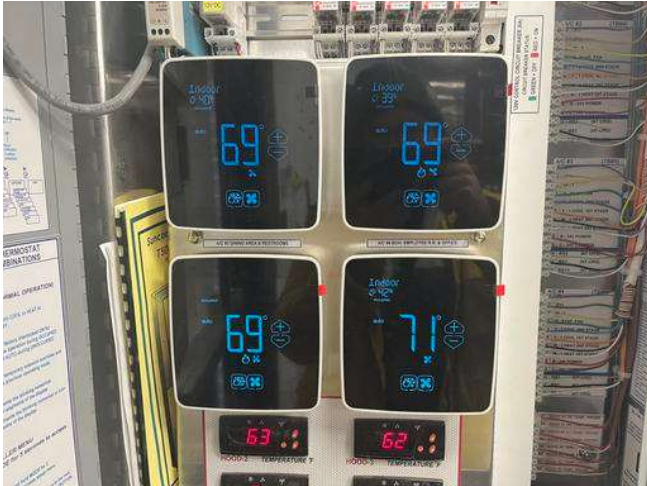
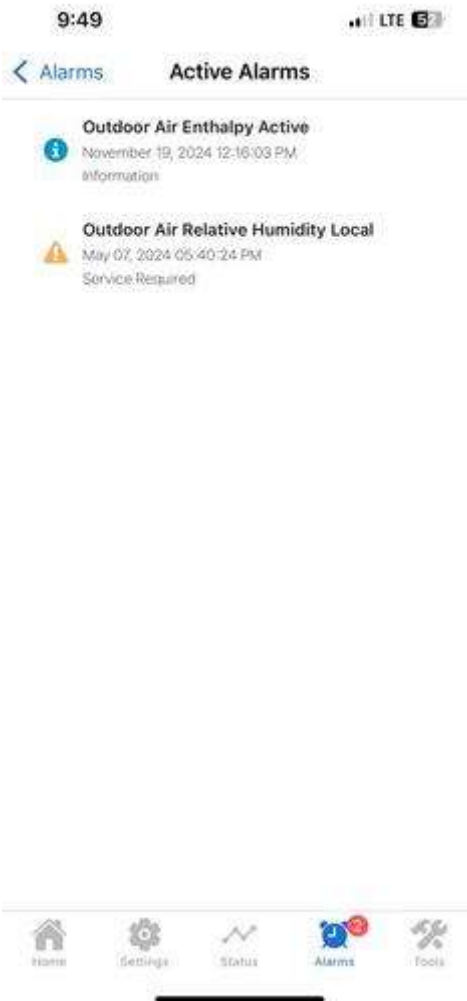
AC3 has two active alarms for "OUTDOOR AIR ENTHALPY ACTIVE" and "OUTDOOR AIR RELATIVE HUMIDITY LOCAL" and it appears to be interfering with humidity readings on the thermostat.

Provide screenshot of Symbio app showing no alarms to close.

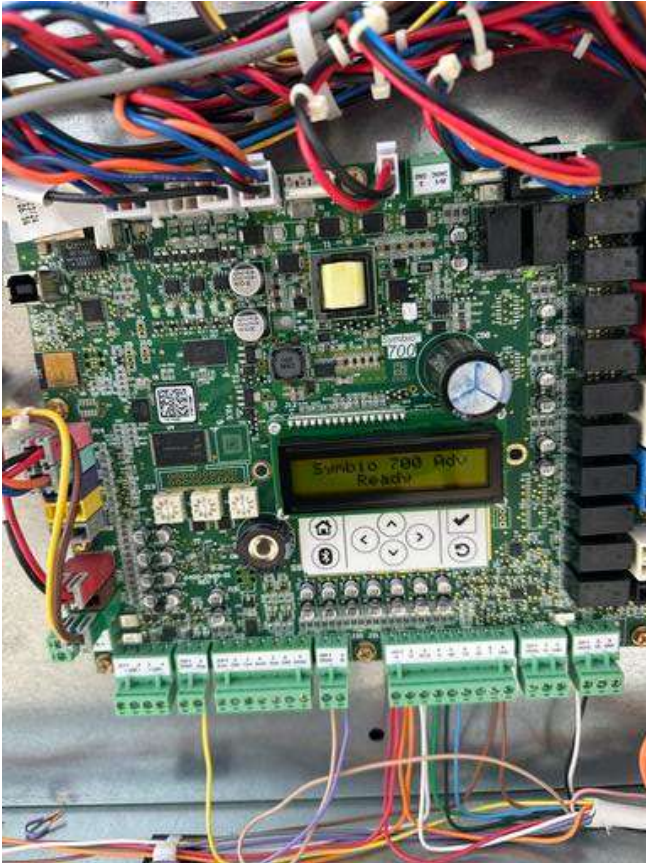
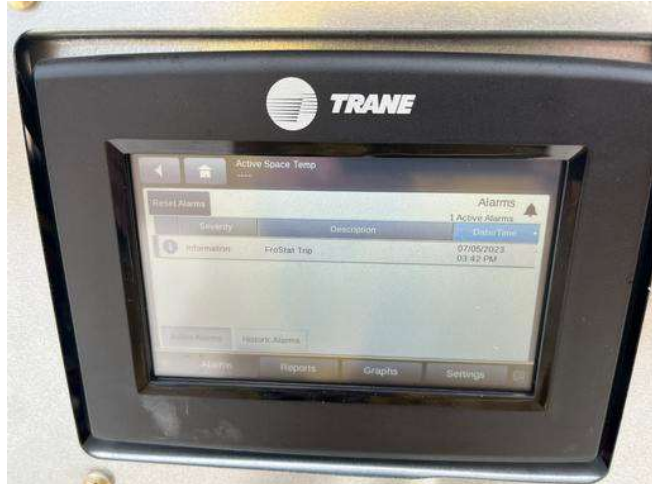
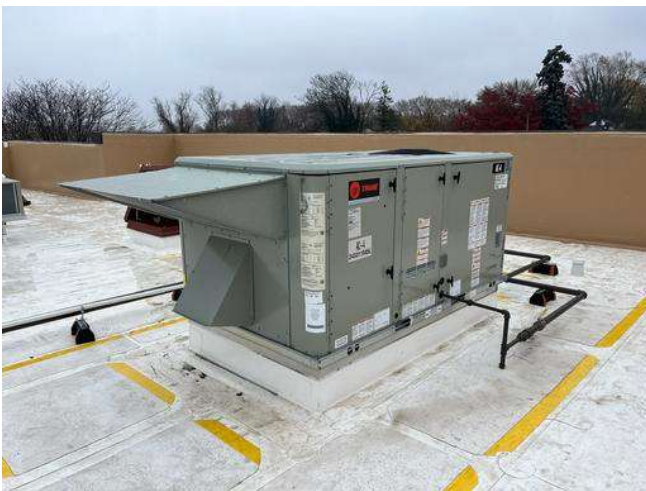
AC4 has an active alarm "FROSTAT TRIP" and it is preventing the condensers from turning on during cooling. Tech tried to put unit into test cooling and while fan speed increase, the condensers did not turn on.

Provide picture of TRANE display screen with no alarms to close. Attached picture is of incorrect display/unit.

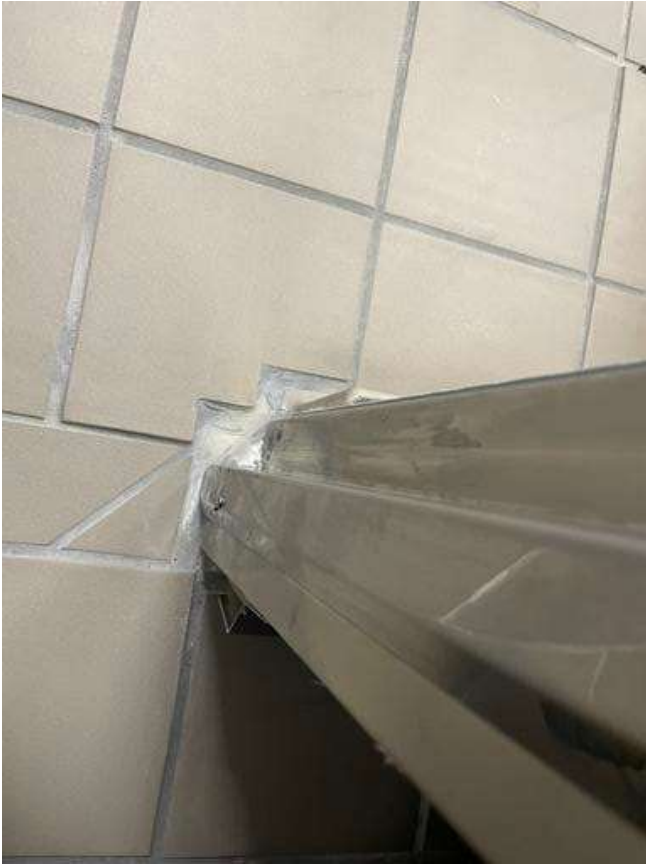
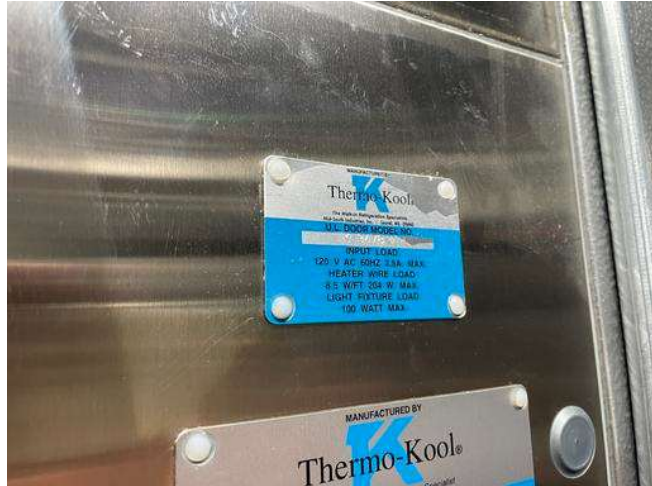
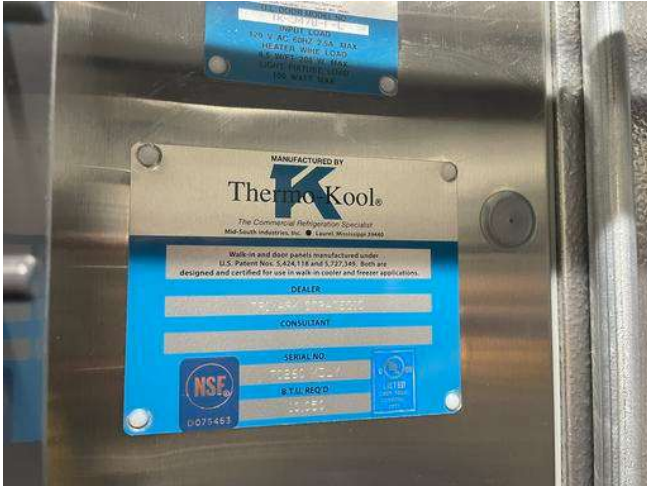
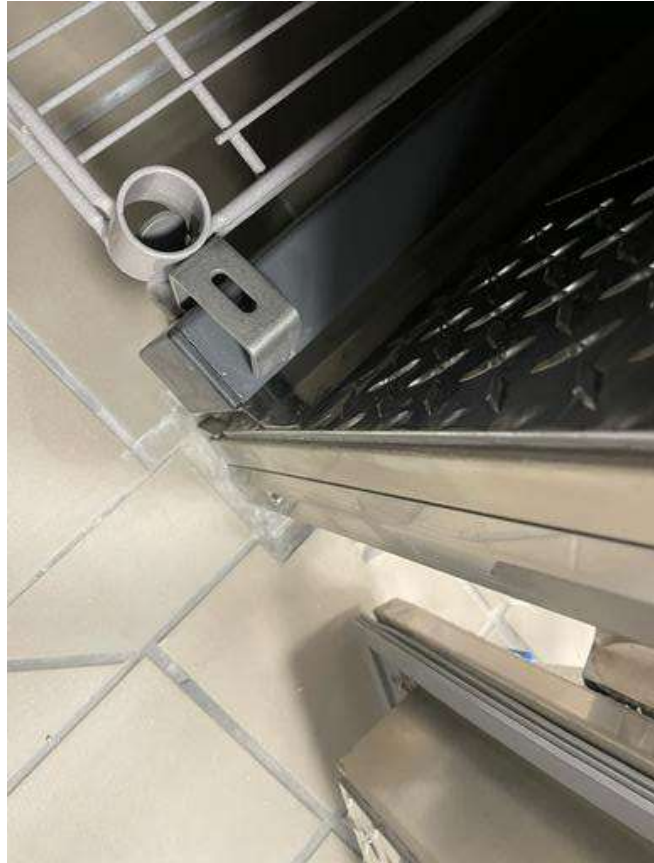
WIC door sweep is not sealed tightly with threshold when door is closed. Only translucent light should be present inspecting from the inside out with box lights off.

Cooler tech lowered the door down as far as it will go but there are gaps in the tile where light can still be seen. To alleviate this, a threshold will need to be added.

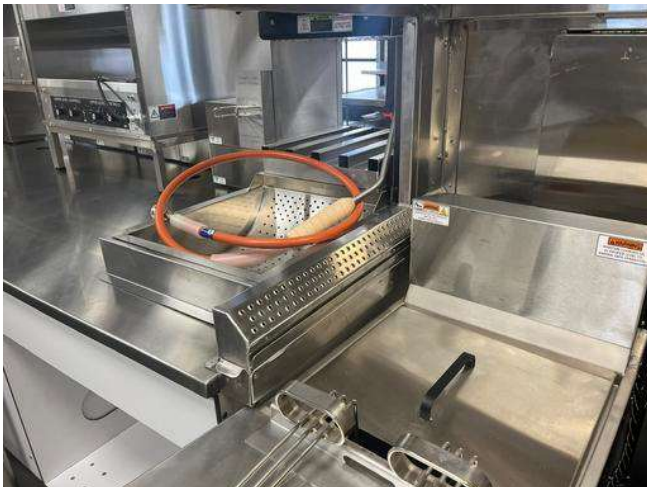
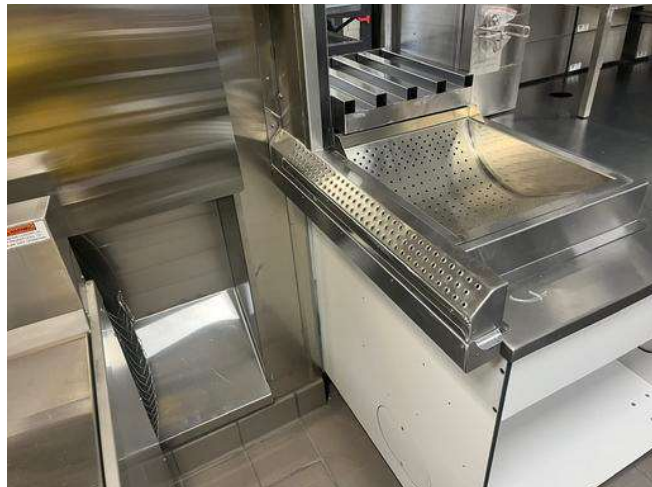
HD2 and HD3 are missing its fry chute.

Provide documentation to close task.

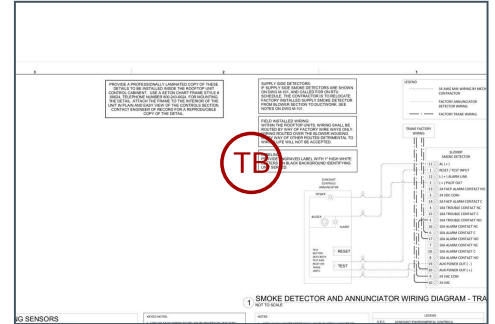
M-701

Label all sensors, humidistats, thermostats, smoke annunciators and remote space mounted OADs, MODs, VFD's for which piece of equipment they serve. Most are labeled but some are not.

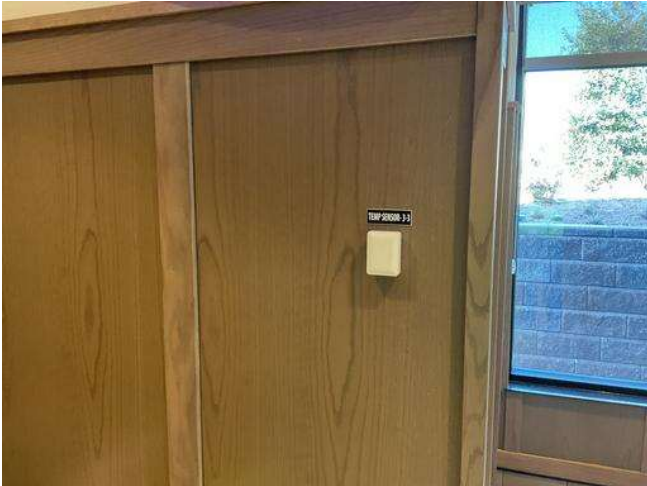
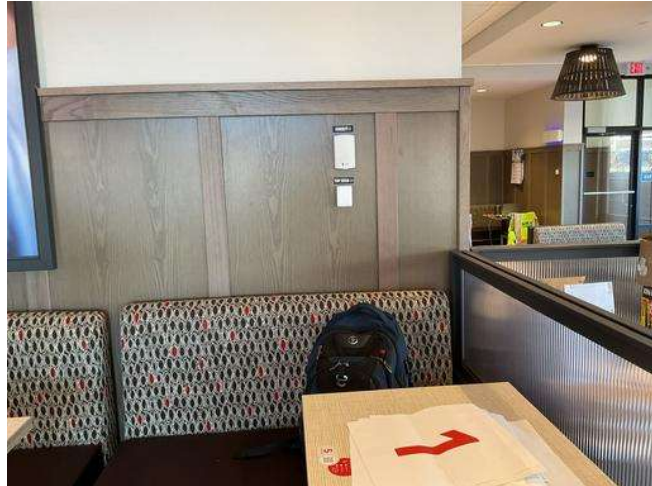
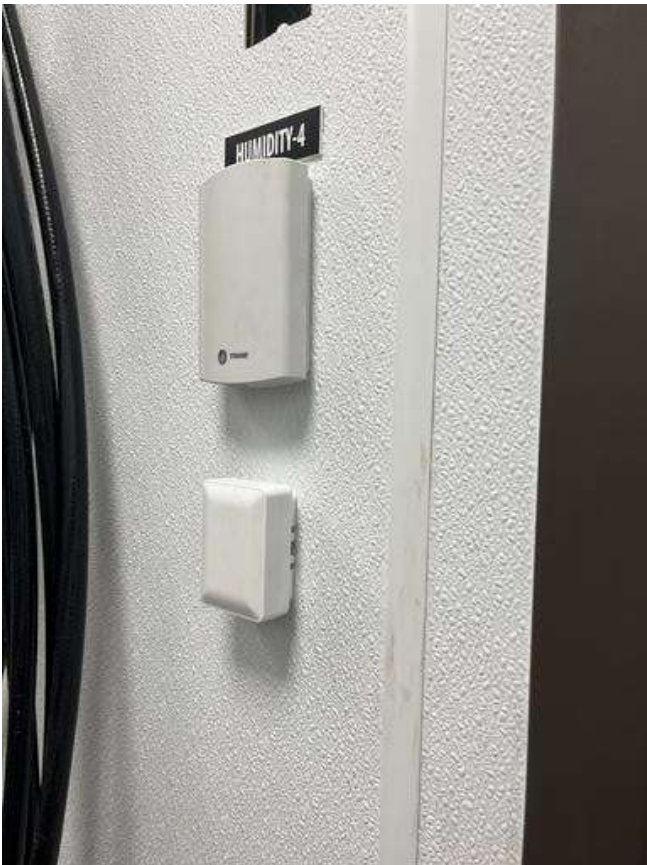
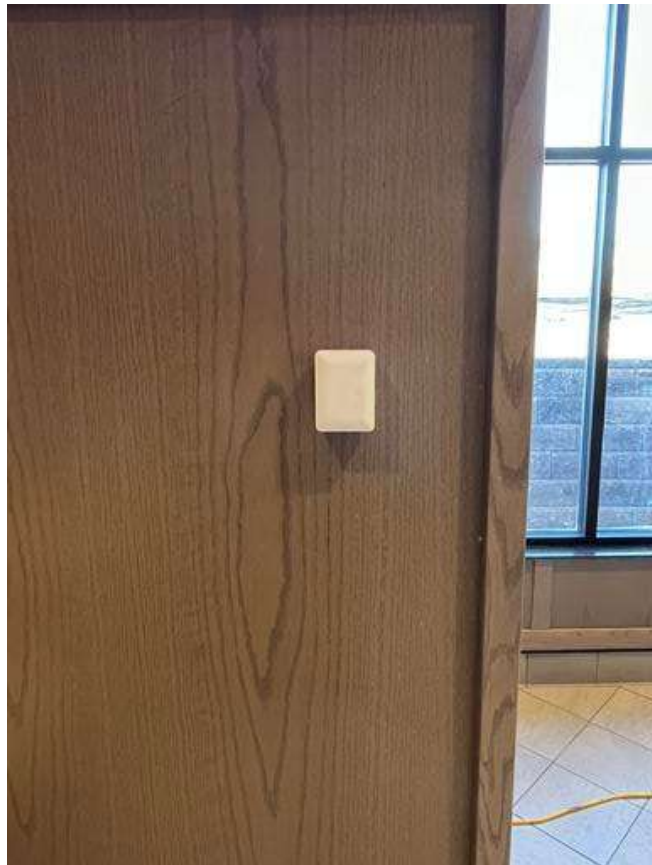
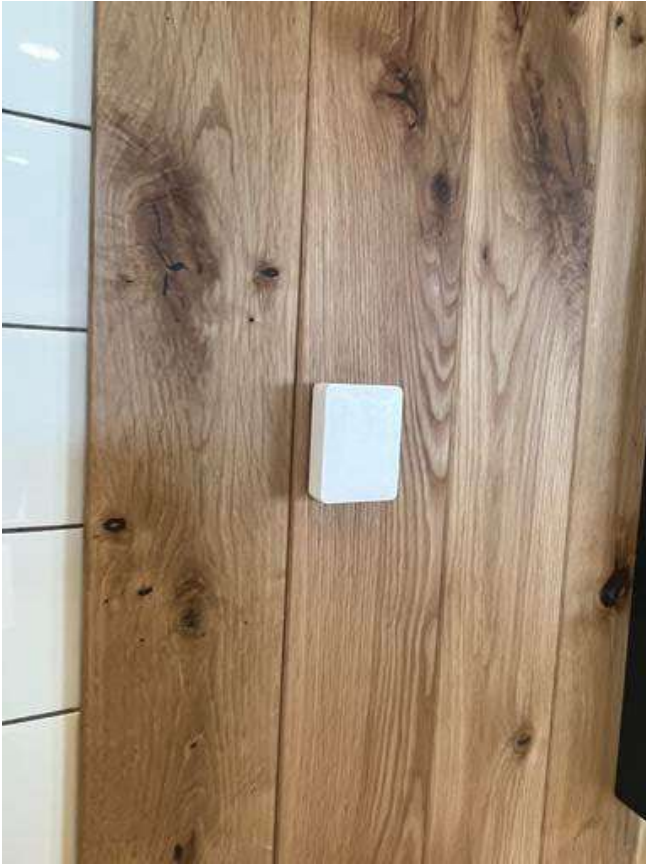
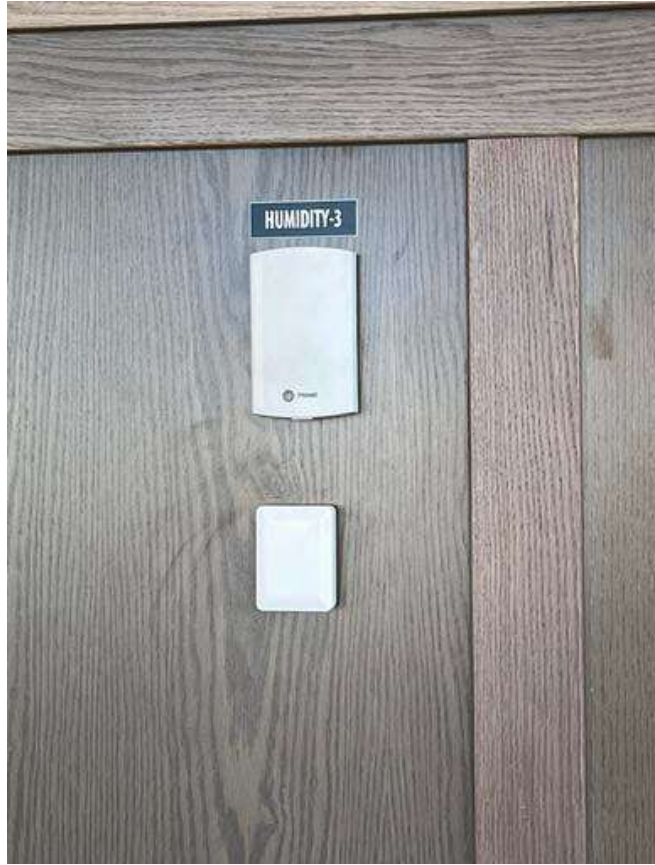
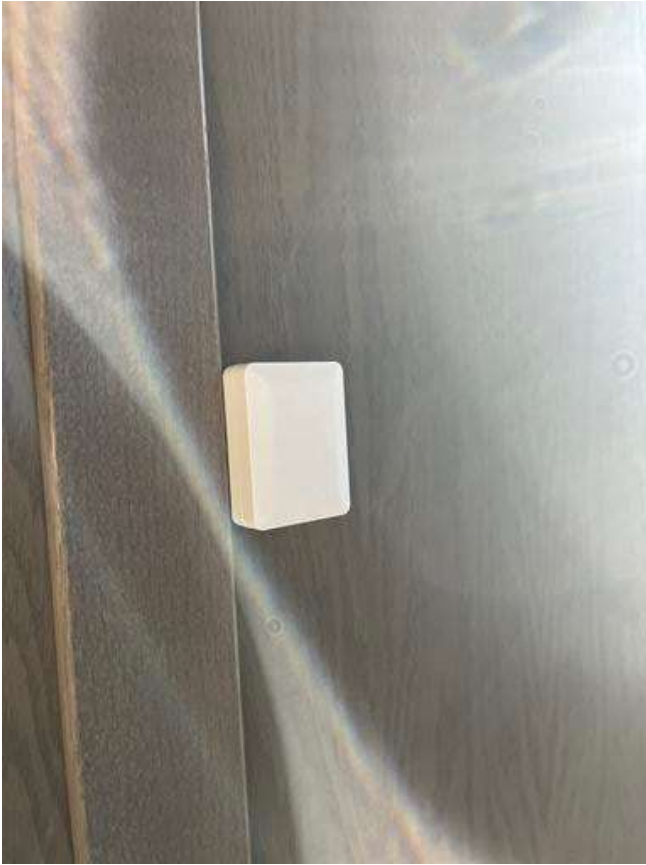
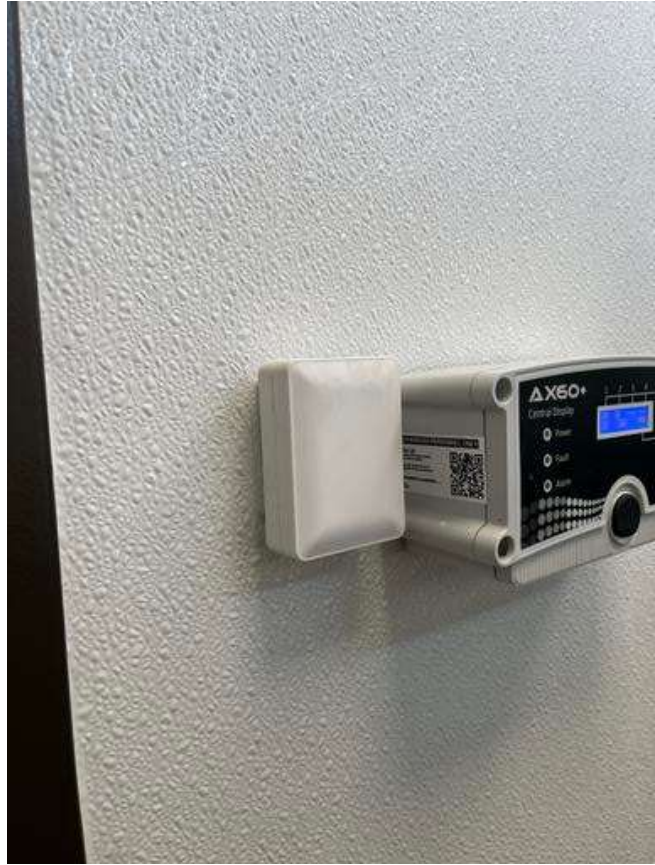
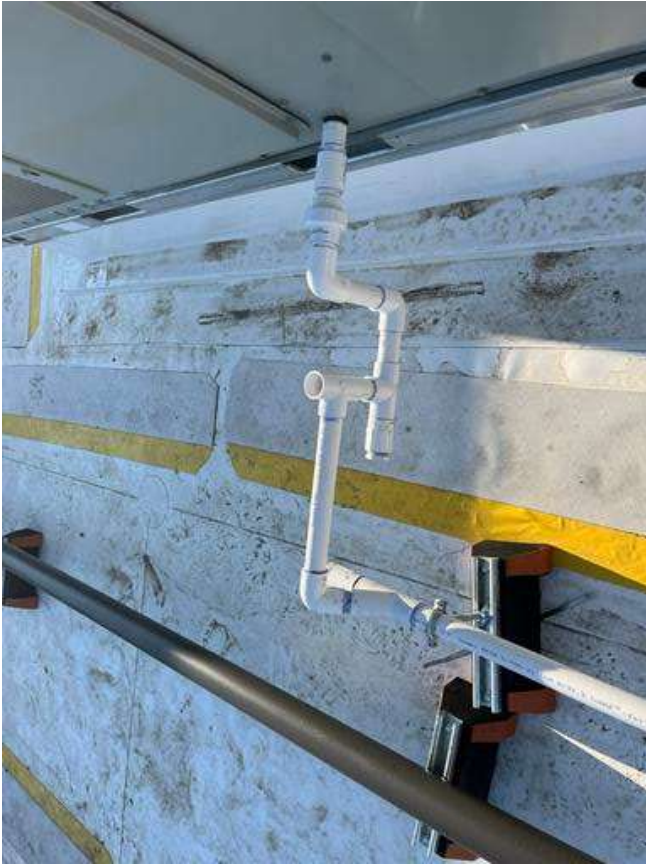
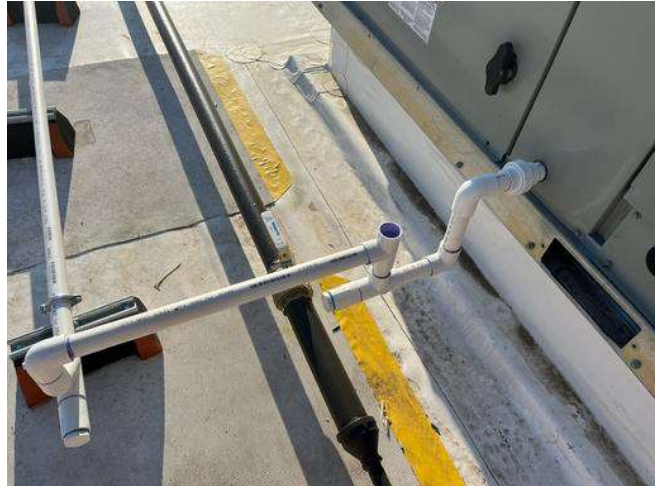
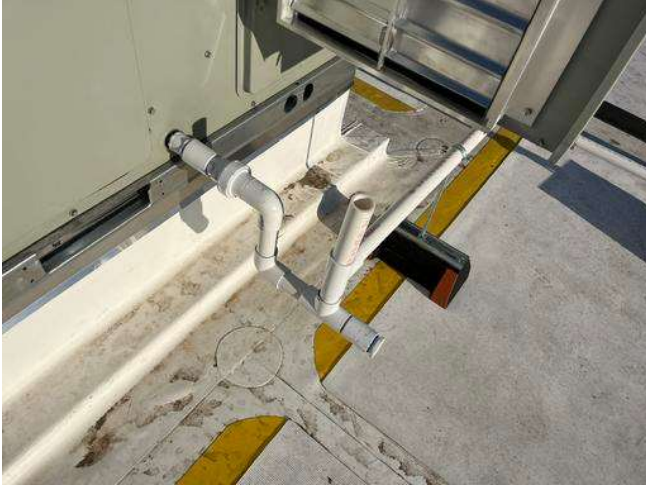
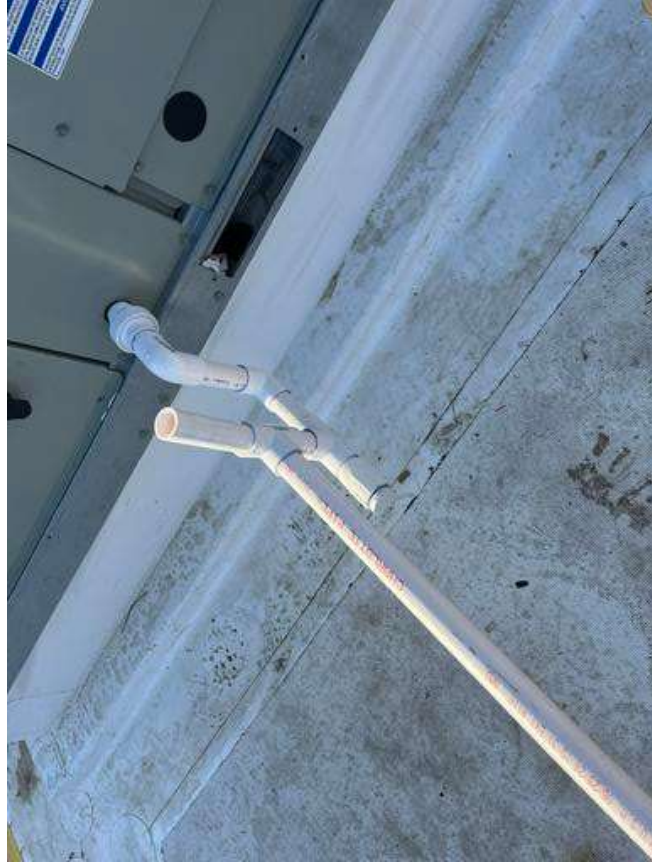
Labels not worded per plan. Recommend replacing or seeking approval as-is from CFA CM.
