**National TAB
1329 E. KEMPER ROAD
SUITE 4210
CINCINNATI, OH 45246**

**Report: TAB Report
Function: Test, Adjust, & Balance
Date: 8/26/2022**

08-08 MCDILL ELEMENTARY - WAUSAU, WI

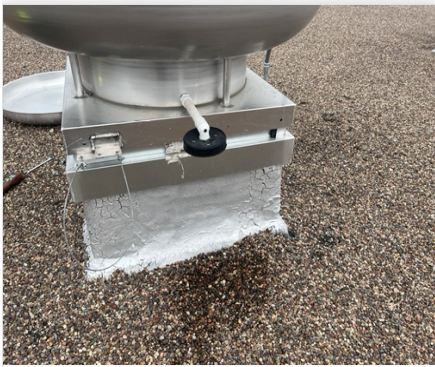
FuseITd26c9341f20e4d019d3c9b
5dbc4e5dd8.jpeg

Issue Name : EF-1 grease trap not yet installed.

Description : Grease trap not yet installed.

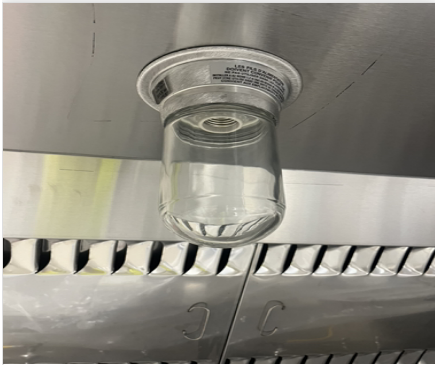
FuseITd05db5b3fde8452c89f257
904198316b.jpeg

Issue Name : Hood lights not yet installed

Description : Hood lights are not yet installed.
