**Report: TAB Report**  
**Function: Test, Adjust, & Balance**  
**Date: 10/16/2024**  
**Completed By: National TAB**

**PROJECT**  
**10-14-24 WAWA #5805 MOBILE, AL**

664 SCHILLINGER RD

MOBILE, AL 36695

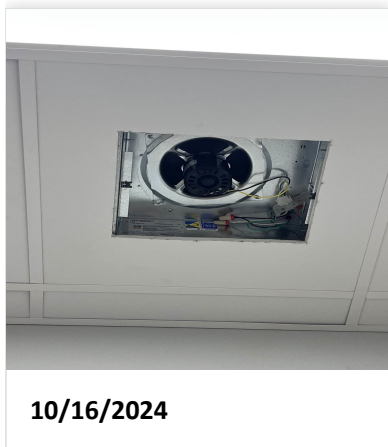
**Issue Name :** EF-3 is missing grille  
**Description :** Unable to locate grille for EF-3. Recommended to install grille once found.  
**Created By :** National TAB                      **Assigned To :** National TAB - Ian Fuller  
**Status :** Open  
**Priority :** High                                      **Asset Tag :**  
**Originated Date :** 10/16/2024 - Ian Fuller - National TAB
