Report: FINAL TAB REPORT
Function: Test, Adjust, & Balance
Date: 10/10/2022

PROJECT
10-03 FAMILY DOLLAR - LEWISPORT, KY

Project: 10-03 FAMILY DOLLAR - LEWISPORT, KY

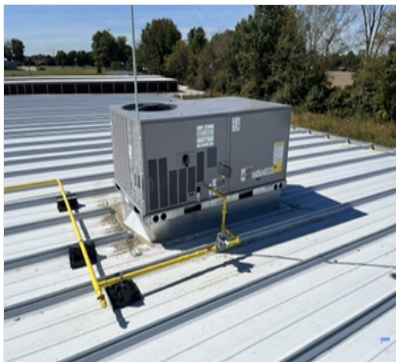
RTU-1

Unit Data		
	Design	Actual
MFG	CARRIER	CARRIER
Serial Num	-	2222C09381
Model Num	HC	48GCEM05A2M5A6W1F0
Type	RTU	RTU
Configuration	VERTICAL	VERTICAL
Num OA Filters 1	-	1
OA Filter Size 1	-	30X16
Num Final Filter 1	-	2
Final Filter Size 1	-	16X24X2

Test Data		
	Design	Actual
SF CFM	1400	1443
SF RPM	-	7.89V
RA CFM	1250	1286
OA CFM	150	157
RL Voltage	-	216.2
RL Amperage	-	5.46
SF Rotation	-	CORRECT
RA Damper Position	-	MECHANICAL LINKAGE
Min OA Damper Position	-	3.15V
Min OA Damper Type	-	ECONOMIZER
OA Enthalpy Setpt	-	ES5

General		
	Design	Actual
Fan Rotation Correct	-	YES
Unit Filters Clean	-	YES/CONSTRUCTION
Condensate Drain Installed	-	YES

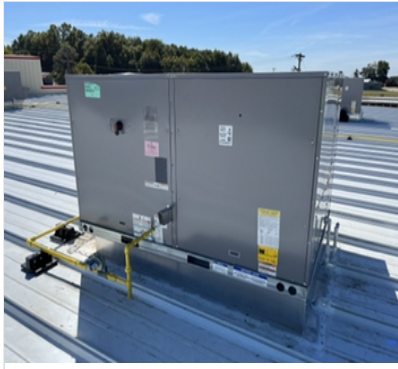
RTU-2

Unit Data		
	Design	Actual
MFG	CARRIER	CARRIER
Serial Num	-	3422P61754
Model Num	HC	48HCED08B2M5A6F1J0
Type	RTU	RTU
Configuration	VERTICAL	VERTICAL
Num OA Filters 1	-	1
OA Filter Size 1	-	36X20
Num Final Filter 1	-	4
Final Filter Size 1	-	20X20X2

Test Data		
	Design	Actual
SF CFM	2800	2953
SF RPM	-	765
RA CFM	2150	2312
OA CFM	650	641
RL Voltage	-	214/214.9/214.1
RL Amperage	-	3.65/4.32/4.16
SF Rotation	-	CCW
RA Damper Position	-	MECHANICAL LINKAGE
Min OA Damper Position	-	4.45V
Min OA Damper Type	-	ECONOMIZER
OA Enthalpy Setpt	-	ES5

General		
	Design	Actual
Fan Rotation Correct	-	YES
Unit Filters Clean	-	YES/CONSTRUCTION
Condensate Drain Installed	-	YES

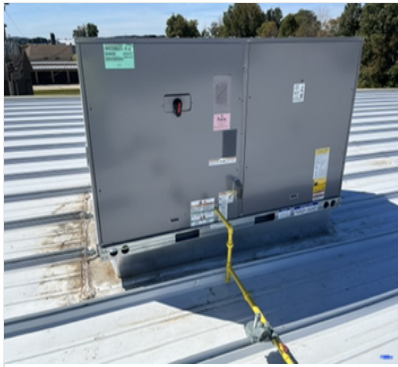
RTU-3

Unit Data		
	Design	Actual
MFG	CARRIER	CARRIER
Serial Num	-	3422P61753
Model Num	HC	48HCED08B2M5A6F1J0
Type	RTU	RTU
Configuration	VERTICAL	VERTICAL
Num OA Filters 1	-	1
OA Filter Size 1	-	36X20
Num Final Filter 1	-	4
Final Filter Size 1	-	20X20X2

Test Data		
	Design	Actual
SF CFM	2800	2987
SF RPM	-	764
RA CFM	2150	2326
OA CFM	650	661
RL Voltage	-	216/216.8/215.7
RL Amperage	-	3.99/3.47/4.49
SF Rotation	-	CCW
RA Damper Position	-	MECHANICAL LINKAGE
Min OA Damper Position	-	4.45V
Min OA Damper Type	-	ECONOMIZER
OA Enthalpy Setpt	-	ES5

General		
	Design	Actual
Fan Rotation Correct	-	YES
Unit Filters Clean	-	YES/CONSTRUCTION
Condensate Drain Installed	-	YES

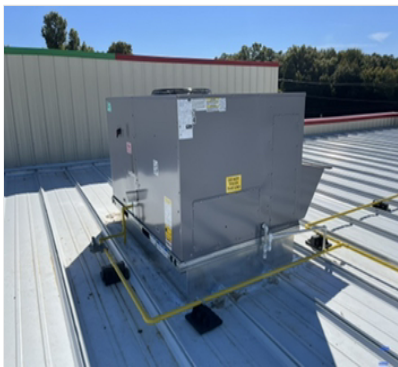
RTU-4

Unit Data		
	Design	Actual
MFG	CARRIER	CARRIER
Serial Num	-	2222P76406
Model Num	HC	48HCED11B2M5A6F1J0
Type	RTU	RTU
Configuration	VERTICAL	VERTICAL
Num OA Filters 1	-	1
OA Filter Size 1	-	36X20
Num Final Filter 1	-	4
Final Filter Size 1	-	20X20X2

Test Data		
	Design	Actual
SF CFM	3500	3728
SF RPM	-	868
RA CFM	2735	2964
OA CFM	775	764
RL Voltage	-	215.4/216.3/215.0
RL Amperage	-	4.99/5.62/6.09
SF Rotation	-	CCW
RA Damper Position	-	MECHANICAL LINKAGW
Min OA Damper Position	-	4.35V
Min OA Damper Type	-	ECONOMIZER
OA Enthalpy Setpt	-	ES5

General		
	Design	Actual
Fan Rotation Correct	-	YES
Unit Filters Clean	-	YES/CONSTRUCTION FILTERS
Condensate Drain Installed	-	YES

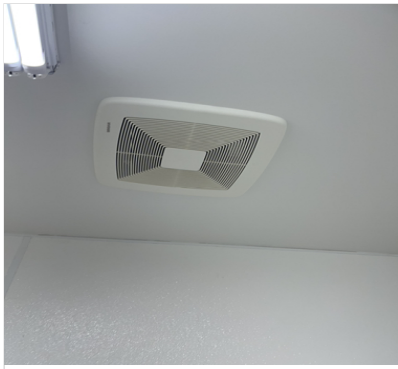
EF-1

Unit Data		
	Design	Actual
MFG	GREENHECK	BROAN
Model Num	SP-B110	LP-80B
Serial Num	-	12H05C1
Type	CEILING	CEILING
Configuration	VERTICAL	HORIZONTAL

Test Data		
	Design	Actual
CFM	75	78
Fan RPM	-	735
Fan Rotation	-	CW
Motor RPM	-	735
System SetPt	-	FULL SPEED
RL Voltage	-	122.1
RL Amperage	-	0.17
Total ESP	0.25"	NA
Fan Inlet SP	-	NA
Fan Discharge SP	-	NA

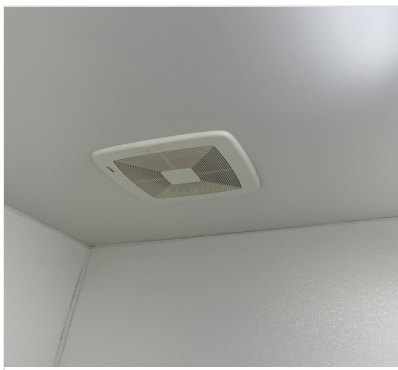
EF-2

Unit Data		
	Design	Actual
MFG	GREENHECK	GREENHECK
Model Num	SP-B110	SP-B110
Serial Num	-	12HO2C1
Type	CEILING	CEILING
Configuration	VERTICAL	HORIZONTAL

Test Data		
	Design	Actual
CFM	75	77
Fan RPM	-	735
Fan Rotation	-	CW
Motor RPM	-	735
System SetPt	-	FULL SPEED
RL Voltage	-	121.4
RL Amperage	-	0.17
Total ESP	0.25"	NA
Fan Inlet SP	-	NA
Fan Discharge SP	-	NA
