Report: Deficiency Report
Function: Test, Adjust, & Balance
Date: 07/08/2024

07-08-24 WAWA #05803 ROBERTSDALE, AL

Issue List

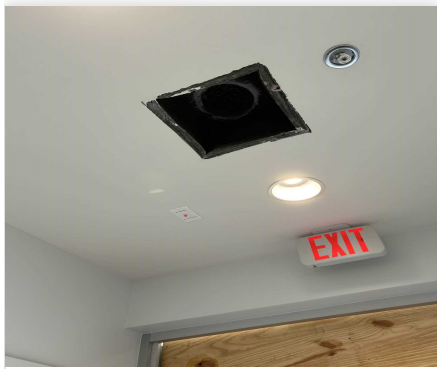
IMG_0614
07/08/2024

Issue Name : Diffuser 1-13 Missing Grille
Description : Diffuser 1-13 (rear vestibule) is missing a grille. Recommend installing per mechanical plans.
Created By : National TAB **Assigned To :** National TAB - Will Turnbough
Status : Open
Priority : Medium **Asset Tag :**
Originated Date : 07/08/2024 - Mark Johnson - National TAB
