Report: Deficiency Report
Function: Test, Adjust, & Balance
Date: 07/08/2024

07-08-24 WAWA #05803 ROBERTSDALE, AL

Issue List

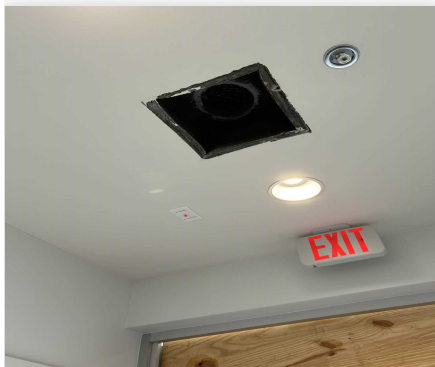
IMG_0614
07/08/2024

Issue Name : Diffuser 1-13 Missing Grille
Description : Diffuser 1-13 (rear vestibule) is missing the grille. Recommend installing per mechanical plans.
Created By : National TAB **Assigned To :** National TAB - Will Turnbough
Status : Open
Priority : Medium **Asset Tag :**
Originated Date : 07/08/2024 - Mark Johnson - National TAB

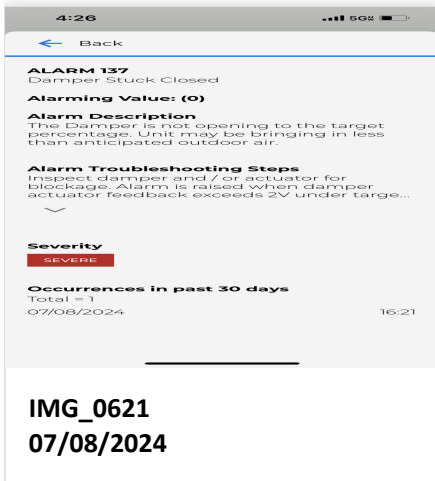
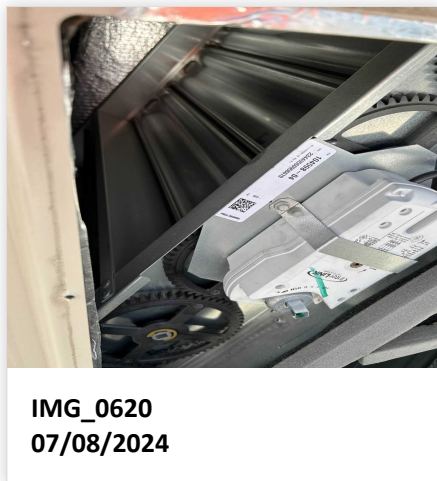
Issue Name : RTU 3 - Economizer Not Functional
Description : The economizer for RTU 3 is not responding to setting changes through CORE. Alarm 137 - "Damper Stuck Closed" appears and the damper will not open. Must be corrected for proper balancing.
Created By : National TAB **Assigned To :** National TAB - Will Turnbough
Status : Open
Priority : **Urgent** **Asset Tag :**
Originated Date : 07/08/2024 - Mark Johnson - National TAB
