**Report: TAB REPORT**  
**Function: Test, Adjust, & Balance**  
**Date: 7/22/2022**

**PROJECT**  
**SWEETGREEN #MIA - MIAMI, FL (THE**  
**FALLS) TAB, IAQ**

8870 SW 136TH ST

Project: SWEETGREEN #MIA - MIAMI, FL (THE FALLS) TAB, IAQ

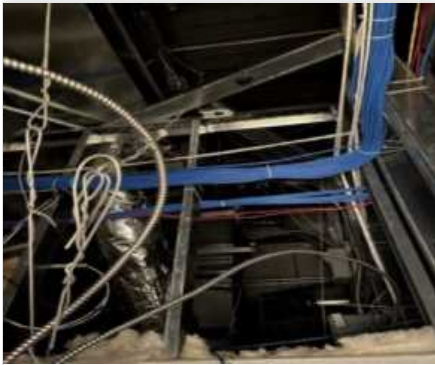
Screenshot\_2022\_07\_22\_13403  
5.png

**Issue Name :** AC Units are Inaccessible

**Description :** AC units are 5 feet above ceiling and are inaccessible for access. Unable to gather all data off the equipment or troubleshoot units with low flow. May also present issues for maintenance.

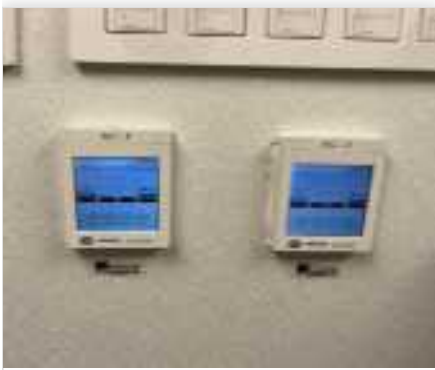
Screenshot\_2022\_07\_22\_13412  
4.png

**Issue Name :** AC-2 and 3 are low on flow

**Description :** AC-2 airflow is 71% of design and AC-3 is 64% of design. Spoke with Trane technician and they said that the unit fan speed is balanced via the thermostat and currently set for the highest speed. Unable to access equipment to troubleshoot further. Recommend verifying that the filters are clean and speaking with Trane for further guidance.

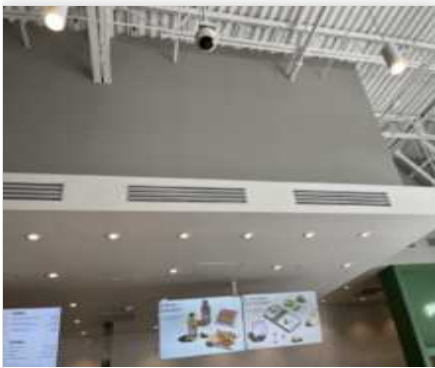
Screenshot\_2022\_07\_22\_13392  
3.png

**Issue Name :** AC5 dampers are not accessible.  
**Description :** Balanced the equipment to total flow but unable to balance the individual air devices.  
**Created By :** National TAB **Assigned To :** National TAB - Will Turnbough  
**Status :** Open  
**Originated Date :** 07/22/2022 - Will Turnbough - National TAB

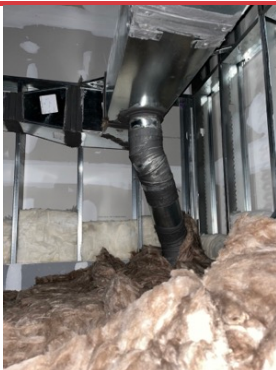
## RESTROOM EXHAUST DAMPERS NOT PRESENT

Fan total balanced.
