Report: Inspection Report
Function: Test, Adjust, & Balance
Date: 02/09/2026
Completed By: National TAB

PROJECT
02-09-26 QT #1425 PEORIA, AZ

Project: 02-09-26 QT #1425 PEORIA, AZ

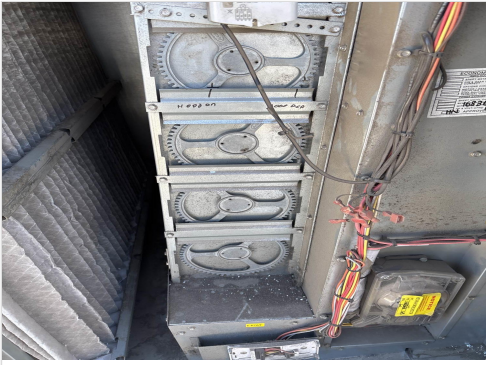
Unit Data - PHOTO LOG

Asset: RT-1

Test Data		
	Design	Actual
SF CFM	4200	4115
SF RPM	-	1337
OA CFM (Hoods On)	800	799
OA CFM (Hoods Off)	350	347
RL Voltage	-	155@VFD
RL Amperage	-	7.4@VFD
VFD Max SetPt	-	45.6HZ
VFD Min SetPt	-	24HZ
OA Damper Position (Hoods On)	-	46%
OA Damper Position (Hoods Off)	-	19%

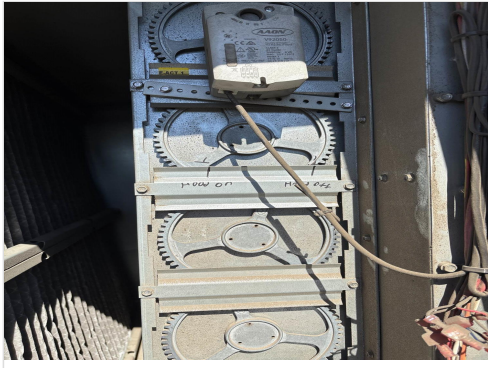
Unit Data - PHOTO LOG

Asset: RT-2

Test Data		
	Design	Actual
SF CFM	4200	4314
SF RPM	-	1320
OA CFM (Hoods On)	800	806
OA CFM (Hoods Off)	350	375
RL Voltage	-	151@VFD
RL Amperage	-	7.7@VFD
VFD Max SetPt	-	45HZ
VFD Min SetPt	-	24HZ
OA Damper Position (Hoods On)	-	46%
OA Damper Position (Hoods Off)	-	21%

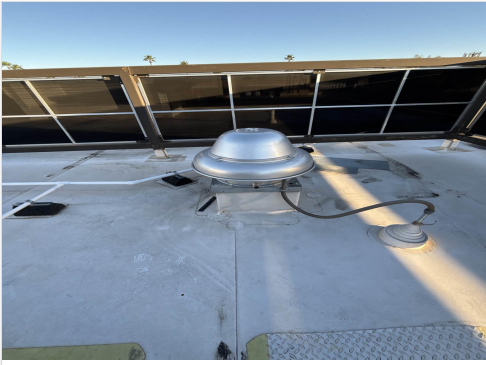
Unit Data - PHOTO LOG

Asset: EF1

Test Data		
	Design	Actual
CFM	750	779
Fan RPM	-	NA
Fan Rotation	-	CCW
Motor RPM	-	NA
System SetPt	-	LOW
RL Voltage	-	NA
RL Amperage	-	4.3
Total ESP	-	0.31"
Fan Inlet SP	-	-0.31"
Fan Discharge SP	-	ATMS

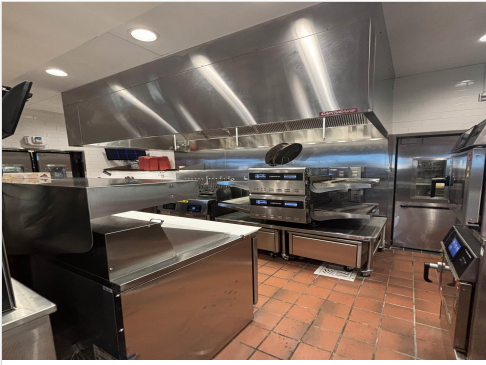
Unit Data - PHOTO LOG

Asset: HD1

Test Data Exhaust		
	Design	Actual
Filter Type	-	BAFFLE
Filter Size 1	-	20X16
Filter Qty 1	-	6
Filter AK factor size 1	-	2.08
Filter Total AK Area	-	12.48
Filter1 FPM	-	105
Filter2 FPM	-	119
Filter3 FPM	-	113
Filter4 FPM	-	117
Filter5 FPM	-	114
Filter6 FPM	-	96
Filter Ave FPM(corr)	-	110
CFM	1350	1372
