**Report: Remarks**  
**Function: Test, Adjust, & Balance**  
**Date: 10/16/2024**  
**Completed By: National TAB**

**10-14-24 KURA SUSHI K041 PHILADELPHIA,  
PA REVIVE**

Project: 10-14-24 KURA SUSHI K041 PHILADELPHIA, PA REVIVE

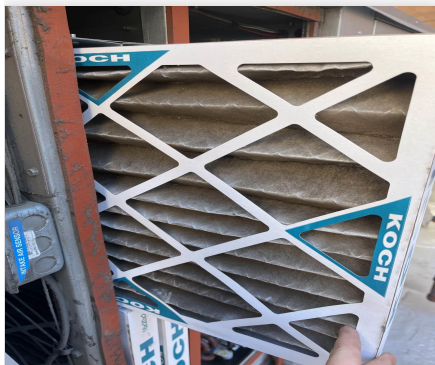
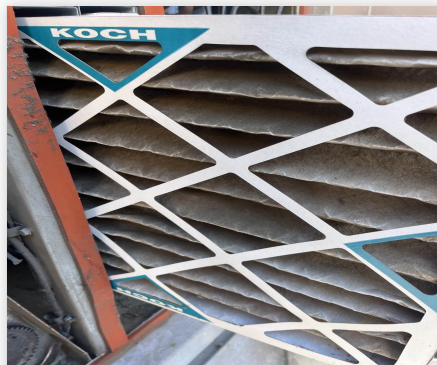
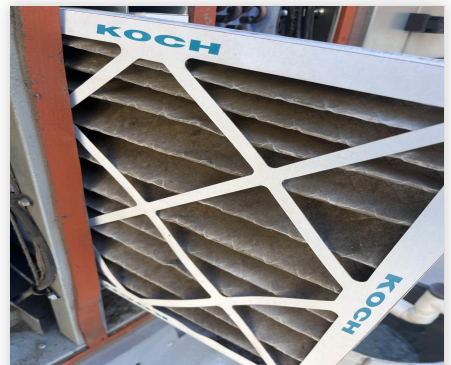
**Issue Name :** DOAS- Final Filters  
**Description :** Doas disposable final filters are not clogged but they are dirty and are near end of life. Recommend replacement soon.  
**Created By :** National TAB                      **Assigned To :** National TAB - Dan Hertenstein  
**Status :** Open  
**Priority :** Low                                      **Asset Tag :**  
**Originated Date :** 10/16/2024 - Tyler Youells - National TAB

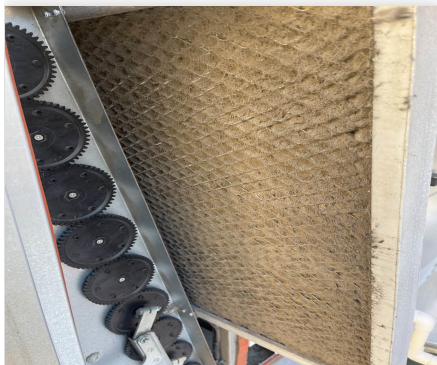
**Issue Name :** DOAS- Intake filters  
**Description :** Doas-1/2 Intake filters are fully clogged. Recommend cleaning or replacement. Filters removed for TAB and replaced when completed.  
**Created By :** National TAB                      **Assigned To :** National TAB - Dan Hertenstein  
**Status :** Open  
**Priority :** Urgent                                      **Asset Tag :**  
**Originated Date :** 10/16/2024 - Tyler Youells - National TAB

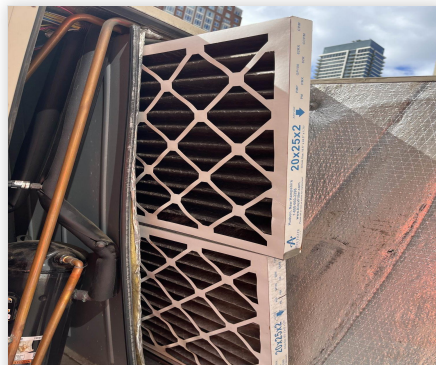
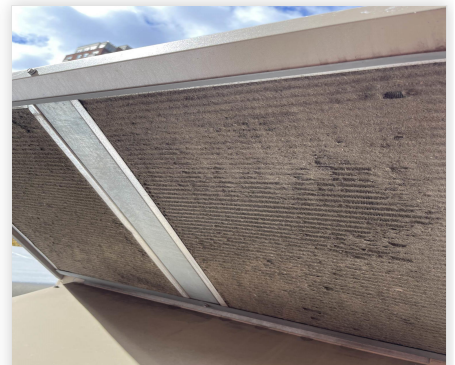
**Issue Name :** RTU-1 Filters  
**Description :** RTU-1 OA intake filters are dirty/clogged recommend cleaning/replacing. Also disposable final filters are clogged and recommend replacing.  
**Created By :** National TAB                      **Assigned To :** National TAB - Dan Hertenstein  
**Status :** Open  
**Priority :** High                                      **Asset Tag :**  
**Originated Date :** 10/16/2024 - Tyler Youells - National TAB

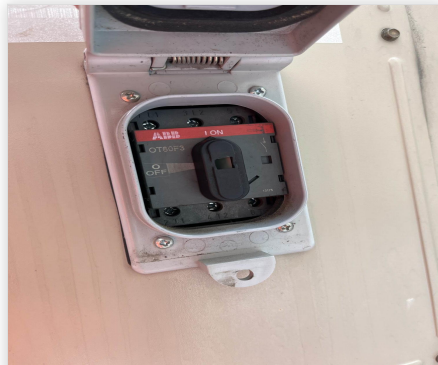
**Issue Name :** RTU-1 Power  
**Description :** RTU-1 Does. It have any power to the disconnect and unit is not running. NTi will try to find the breaker panel to see if unit is tripped. Recommend having HVAC diagnose  
**Created By :** National TAB                      **Assigned To :** National TAB - Dan Hertenstein  
**Status :** Open  
**Priority :** Urgent                                      **Asset Tag :**  
**Originated Date :** 10/16/2024 - Tyler Youells - National TAB

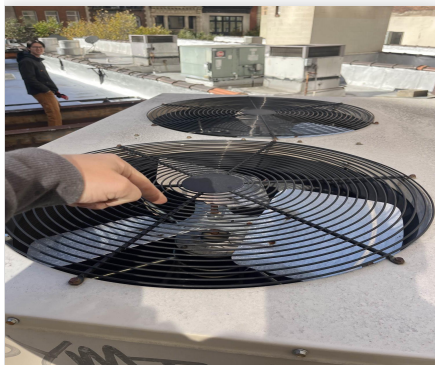
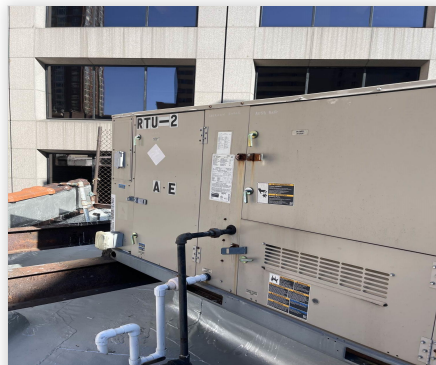
**Issue Name :** RTU-2 Condensor Fan motor  
**Description :** Right side Outdoor fan motor/condenser motor is not operational and is allowing air to bypass condenser coil. Recommend hvac service repair.  
**Created By :** National TAB                      **Assigned To :** National TAB - Dan Hertenstein  
**Status :** Open  
**Priority :** High                                      **Asset Tag :**  
**Originated Date :** 10/16/2024 - Tyler Youells - National TAB
