Report: TAB Report
Function: Test, Adjust, & Balance
Date: 10/10/2025
Completed By: National TAB

PROJECT
09-15-25 QT #1727 EMERSON, GA

Project: 09-15-25 QT #1727 EMERSON, GA

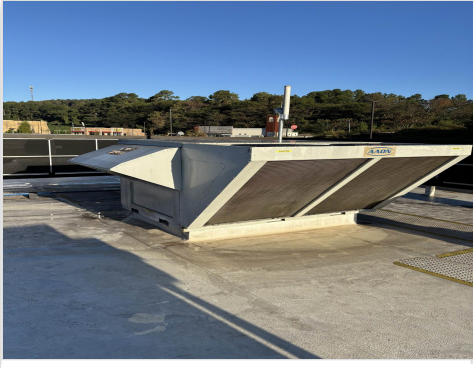
Unit Data - PHOTO LOG

Asset: RT-3

Unit Data		
	Design	Actual
MFG	NA	AAON
Serial Num	-	202009-ANEK21079
Model Num	NA	RN-013-8-0-EA0A-152
Type	-	RTU
Num OA Filters 1	-	1
OA Filter Size 1	-	45X22"

Test Data		
	Design	Actual
SF CFM	4200	4039
SF RPM	-	1291
RA CFM	3400	3296
OA CFM	800	743
RL Voltage	-	145 VFD
RL Amperage	-	7.45 VFD
SF Rotation	-	CCW
SF System SetPt	-	44.0 Hz
RA Damper Position	-	90%
Min OA Damper Position	-	10%
Min OA Damper Type	-	ECONOMIZER
