Report: TAB Report
Function: Test, Adjust, & Balance
Date: 10/10/2025
Completed By: National TAB

PROJECT
09-15-25 QT #1727 EMERSON, GA

QUIKTRIP
4705 SOUTH 129TH EAST AVENUE
TULSA, OK 74134

Project: 09-15-25 QT #1727 EMERSON, GA

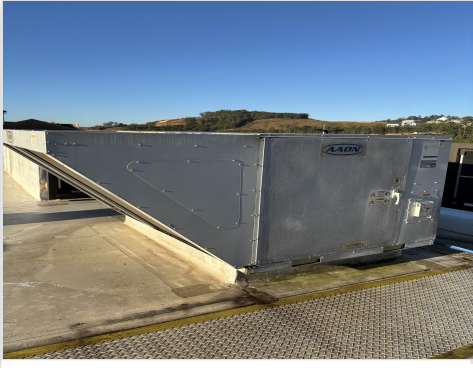
Unit Data - PHOTO LOG

Asset: RT-1

Unit Data		
	Design	Actual
MFG	NA	AAON
Serial Num	-	202009-ANEK21078
Model Num	NA	RN-013-8-0-EA0A-152
Type	-	RTU
Num OA Filters 1	-	1
OA Filter Size 1	-	45X22"

Test Data		
	Design	Actual
SF CFM	4200	4128
SF RPM	-	1238
RA CFM	3400	3316
OA CFM	800	812
RL Voltage	-	131 VFD
RL Amperage	-	6.19 VFD
SF Rotation	-	CCW
SF System SetPt	-	42.2 Hz
RA Damper Position	-	90%
Min OA Damper Position	-	10%
Min OA Damper Type	-	ECONOMIZER

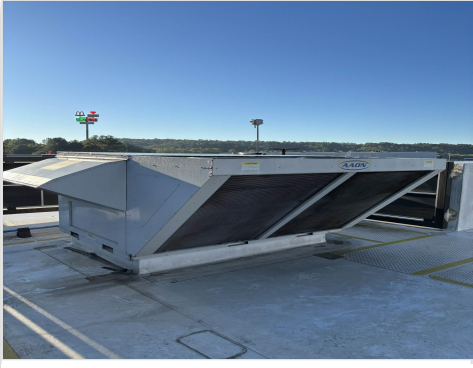
Unit Data - PHOTO LOG

Asset: RT-2

Unit Data		
	Design	Actual
MFG	NA	AAON
Serial Num	-	202009-ANEK2180
Model Num	NA	RN-013-8-0-EA0A-152
Type	-	RTU
Num OA Filters 1	-	1
OA Filter Size 1	-	45X22"

Test Data		
	Design	Actual
SF CFM	4200	4197
SF RPM	-	1270
RA CFM	3400	3461
OA CFM	800	736
RL Voltage	-	141 VFD
RL Amperage	-	7.24 VFD
SF Rotation	-	CCW
SF System SetPt	-	43.3 Hz
RA Damper Position	-	90%
Min OA Damper Position	-	10%
Min OA Damper Type	-	ECONOMIZER

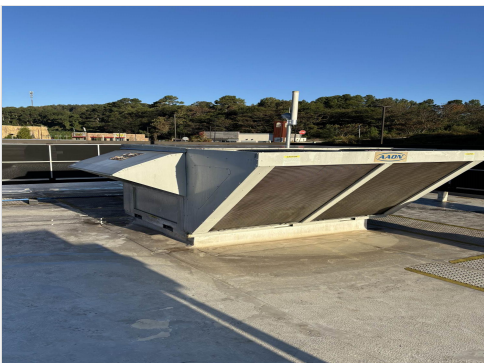
Unit Data - PHOTO LOG

Asset: RT-3

Unit Data		
	Design	Actual
MFG	NA	AAON
Serial Num	-	202009-ANEK21079
Model Num	NA	RN-013-8-0-EA0A-152
Type	-	RTU
Num OA Filters 1	-	1
OA Filter Size 1	-	45X22"

Test Data		
	Design	Actual
SF CFM	4200	4039
SF RPM	-	1291
RA CFM	3400	3296
OA CFM	800	743
RL Voltage	-	145 VFD
RL Amperage	-	7.45 VFD
SF Rotation	-	CCW
SF System SetPt	-	44.0 Hz
RA Damper Position	-	90%
Min OA Damper Position	-	10%
Min OA Damper Type	-	ECONOMIZER

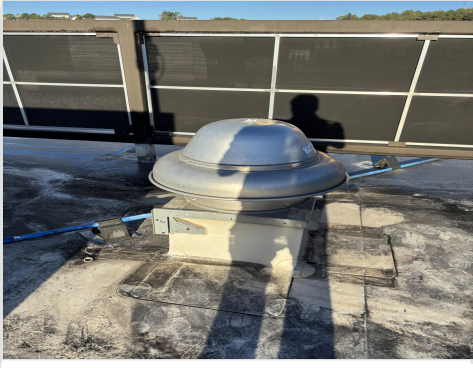
Unit Data - PHOTO LOG

Asset: EF1

Unit Data		
	Design	Actual
MFG	NA	CAPTIVEAIRE
Model Num	NA	DR50HFA
Serial Num	-	4639275
Type	-	DOWNBLAST
Configuration	-	VERTICAL

Test Data		
	Design	Actual
CFM	750	803
Fan Rotation	-	CCW
System SetPt	-	LOW
RL Voltage	-	[1]
RL Amperage	-	[1]
Total ESP	-	-0.16"
Fan Inlet SP	-	-0.16"
Fan Discharge SP	-	1 ATM

[1] UNABLE TO READ VOLTS AND AMPS SAFELY

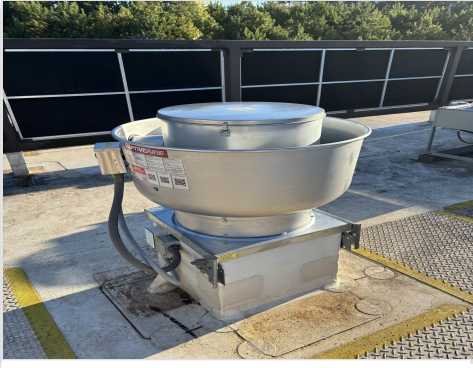
Unit Data - PHOTO LOG

Asset: EF3

Unit Data		
	Design	Actual
MFG	NA	CAPTIVEAIRE
Model Num	NA	DU50HFA
Serial Num	-	7632101
Type	UPBLAST	UPBLAST
Configuration	VERTICAL	VERTICAL

Test Data		
	Design	Actual
CFM	1350	1263
Fan RPM	-	1235
Fan Rotation	-	CCW
Motor RPM	-	1235
System SetPt	-	65.8 HZ (65% at MSC)
RL Voltage	-	209
RL Amperage	-	1.8
Total ESP	-	-0.58"
Fan Inlet SP	-	-0.58"
Fan Discharge SP	-	1 ATM

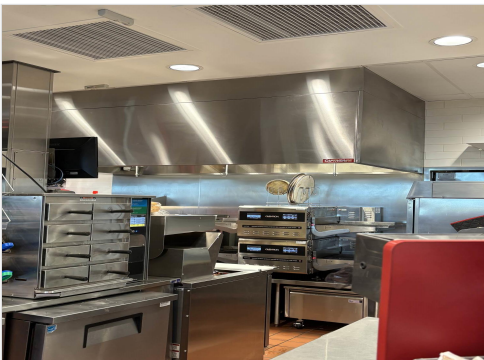
Unit Data - PHOTO LOG

Asset: HD1

Unit Data		
	Design	Actual
MFG	CAPTIVEAIRE	CAPTIVEAIRE
Model Num	6030 ND-2-F	6030 ND-2-F
Job / Serial Num	-	7632101
Type	TYPE I CANOPY	TYPE I CANOPY
Hood length	-	109"
Hood Width	-	60"

Test Data Exhaust		
	Design	Actual
Filter Type	-	CAPTRATE
Filter Size 1	-	16x20
Filter Qty 1	-	6
Filter AK factor size 1	-	2.08
Filter Total AK Area	-	12.48
Filter1 FPM	-	107
Filter2 FPM	-	104
Filter3 FPM	-	103
Filter4 FPM	-	106
Filter5 FPM	-	97
Filter6 FPM	-	90
Filter Ave FPM(corr)	-	101.16
CFM	1350	1263
