Report: TAB Report
Function: Test, Adjust, & Balance
Date: 03/28/2025
Completed By: National TAB

Springer School Addition (Cincinnati, OH)

Project: Springer School Addition (Cincinnati, OH)

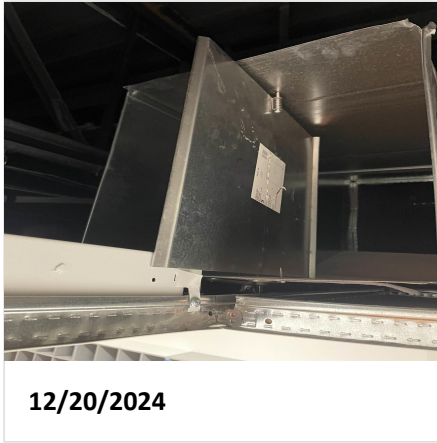
Issue Name : DOAS Return Unbalanced
Description : Returns for DOAS above ceiling were unable to be balanced evenly due to missing and jammed dampers. Return airflows air similar to supply air totals and should not disproportionately affect any of the three floors.
Created By : National TAB **Assigned To :** National TAB - Jordan Best
Status : Open
Priority : Low **Asset Tag :**
Originated Date : 12/20/2024 - Jordan Best - National TAB

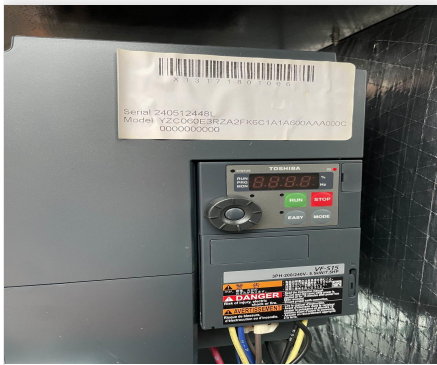
Issue Name : RTU-3 VFD Appears Non-Functional
Description : VFD for RTU-3 does not appear to be functional. When fan is running, VFD displays all 0's. Unit was read out in test mode. Suspect incomplete startup by Trane or malfunctioning VFD. Recommend contacting Trane to further investigate.
