08-08 FIVE GUYS - BROOKLYN, OH

Project Issue Information

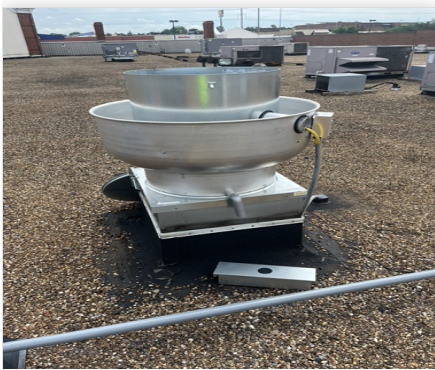
FuselT695f54990d994494a2a1f5
b0e0275edf.jpeg

Issue Name : EF#1 grease cup not installed

Description : Grease cup is on the roof next to fan just not installed

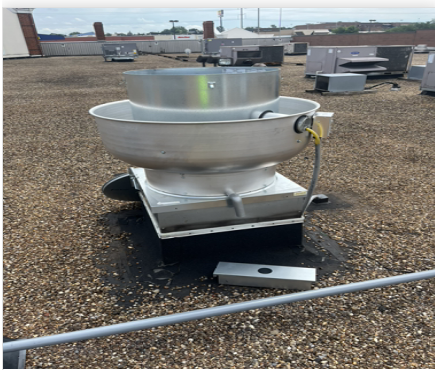
FuselT6af2ed6ac4ef4e9abd1482
820924ce52.jpeg

Issue Name : EF#1 not fully secured to curb

Description : There are no screws to prevent the fan from leaning back on its hinges.

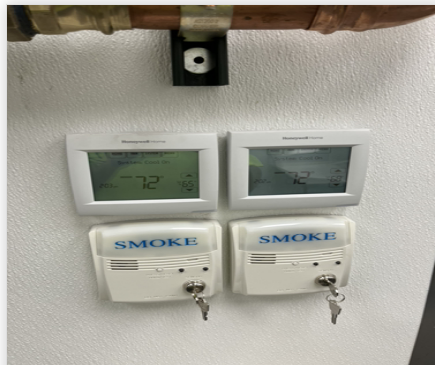
Issue Name : RTU#1 fan motor not starting after power disconnect

Description : RTU#1 was running, power was cut off at disconnect when turned back on motor will not start but the compressor still runs. Belimo board says unoccupied although thermostat says it's in occupied. When test button is pressed down motor is getting power. RTU is currently off.
