Report By:

National TAB  
1329 E. KEMPER ROAD  
SUITE 4210  
CINCINNATI, OH 45246

**Report: TAB REPORT**  
**Function: Test, Adjust, & Balance**  
**Date: 12/18/2023**

**09-25-23 CARMAX #7281 - BAKERSFIELD,  
CA**

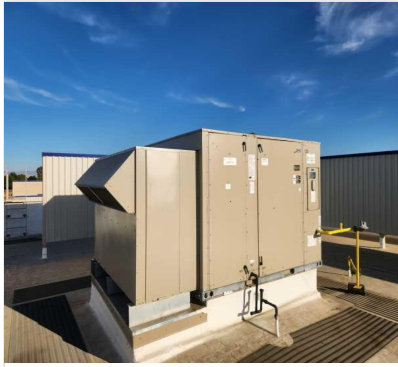
RTU-11

General		
	Design	Actual
Fan Rotation Correct	-	YES
Unit Filters Clean	-	100% LOADED
Condensate Drain Installed	-	YES

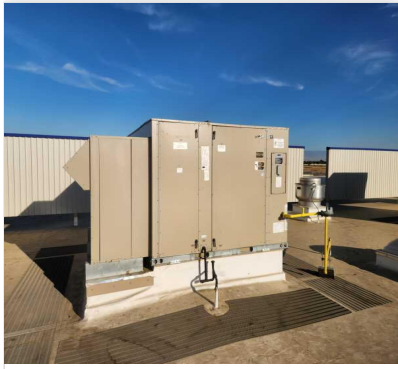
RTU-12

General		
	Design	Actual
Fan Rotation Correct	-	YES
Unit Filters Clean	-	100% LOADED
Condensate Drain Installed	-	YES

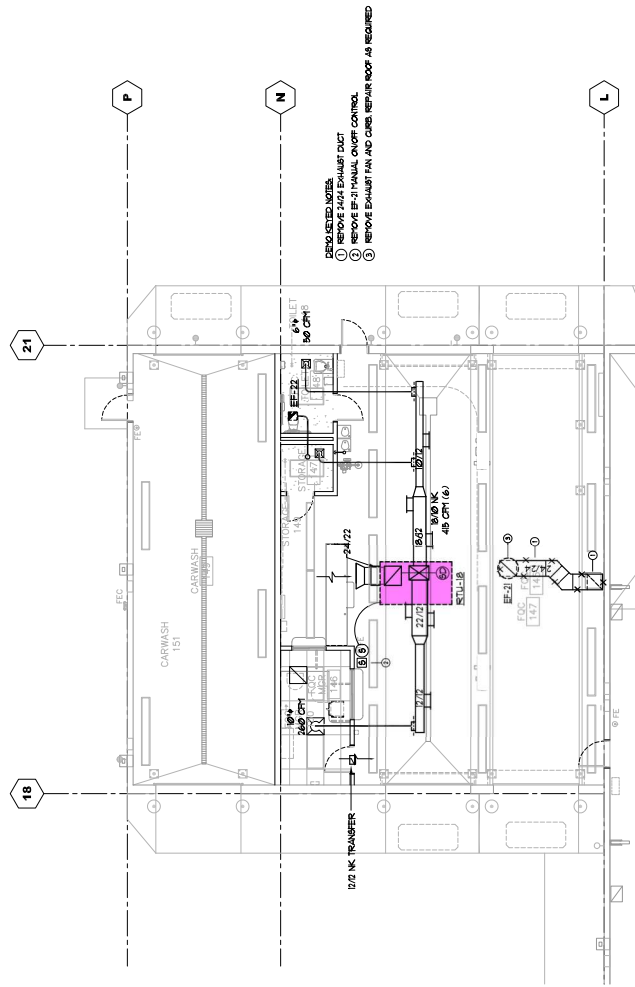
2 FQC DEMO PLAN - HVAC  
M1.2 SCALE: 1/8"=1'-0"

REMARKS:  
① REMOVE ABOVE EXHAUST DUCT  
② REMOVE EX-FURNACE ON/OFF CONTROL  
③ REMOVE EXHAUST FAN AND CABINET REPAIR HOOP AS REQUIRED
