PlanGrid Task Report - Feb 17, 2026

#247 [SITE 010] [NEW] CRITICAL – Return nvisit required.

L05597_Avalon Park FSU

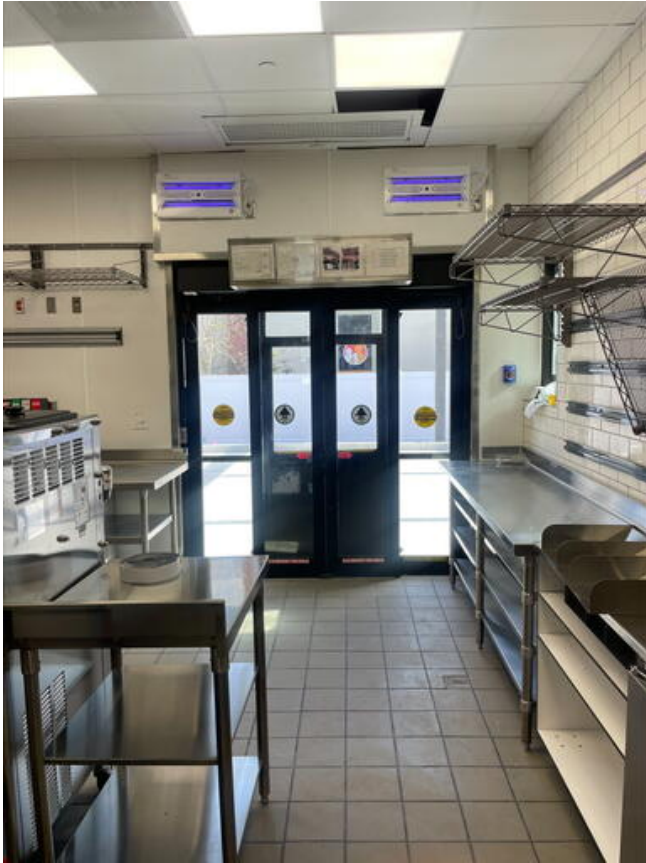
246

drive-thru door installed

NTi to verify building pressure and door function during return trip.

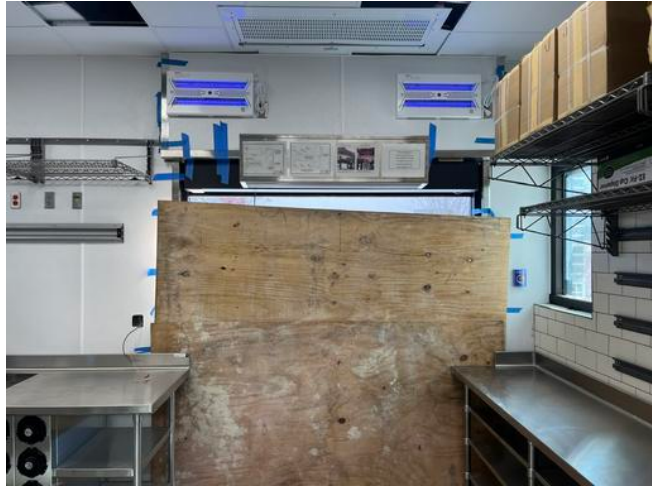
IMG_9106

Description
Drive-thru door installation incomplete or perimeter of door not sealed properly, unable to obtain accurate building pressure.

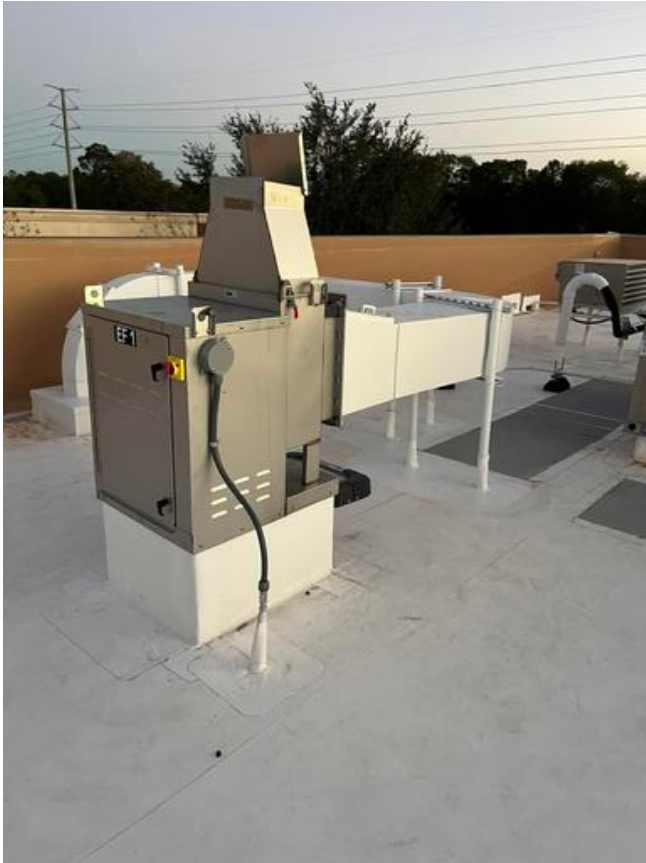
IMG_9159

EF-1 fan speed was reduced from the factory setpoint due to overramping. The maximum airflow that could be achieved without overramping is 87% of design.

Reverting to Open task. Last correspondence was that Halton is to ship a new motor to the site and install. NTi will need to rebalance EF and Hood once complete.

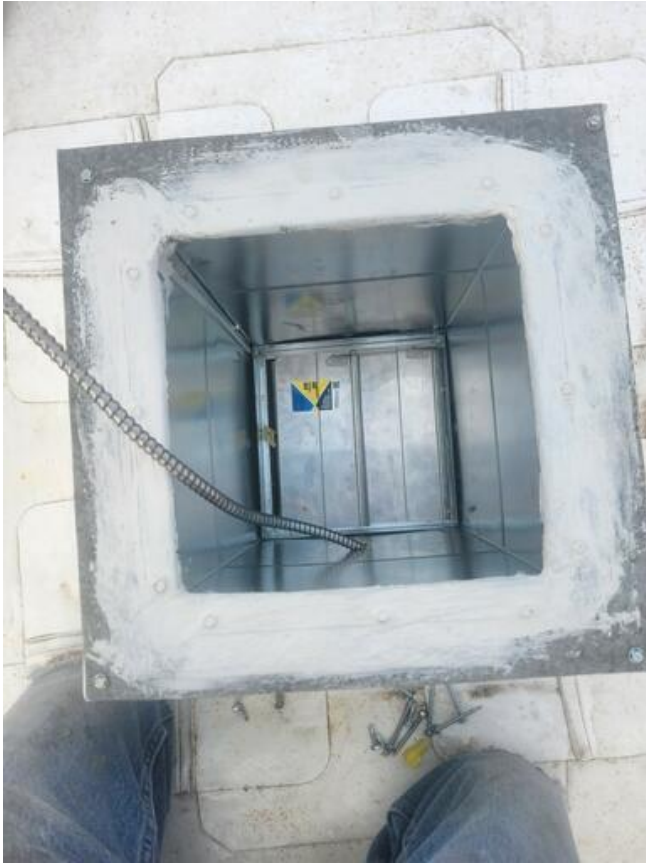
1
Jeff Golden
Jan 8, 2026 9:39 AM

exhaust duct is now changed (per plan) to all round below the BDD and does not get liner, only outside insulation.

NTi to rebalance during return trip

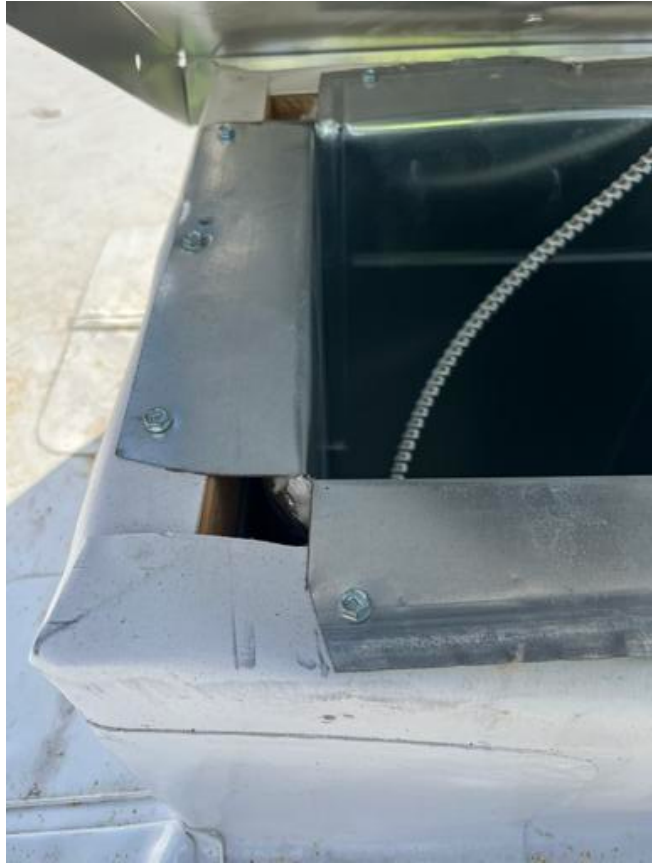
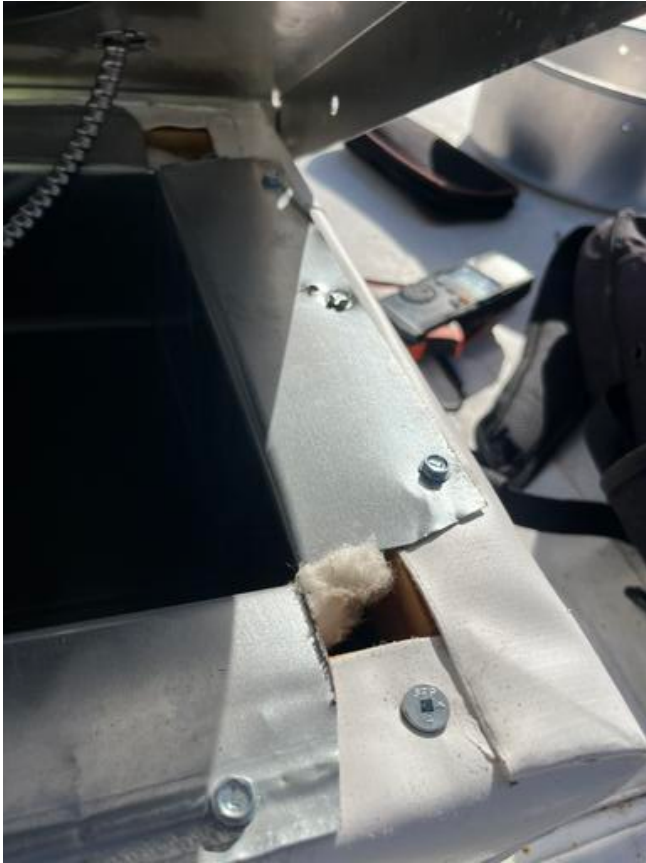
IMG_9136
Stephen Tassinaro
Dec 23, 2025 6:52 PM

Description
EF-3 is leaking at the
connection to the curb/fan.

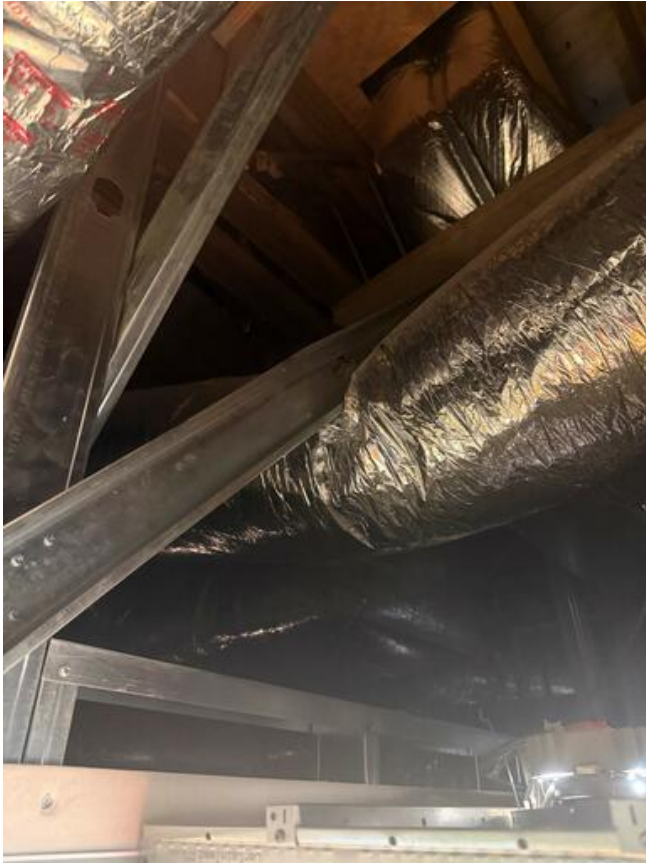
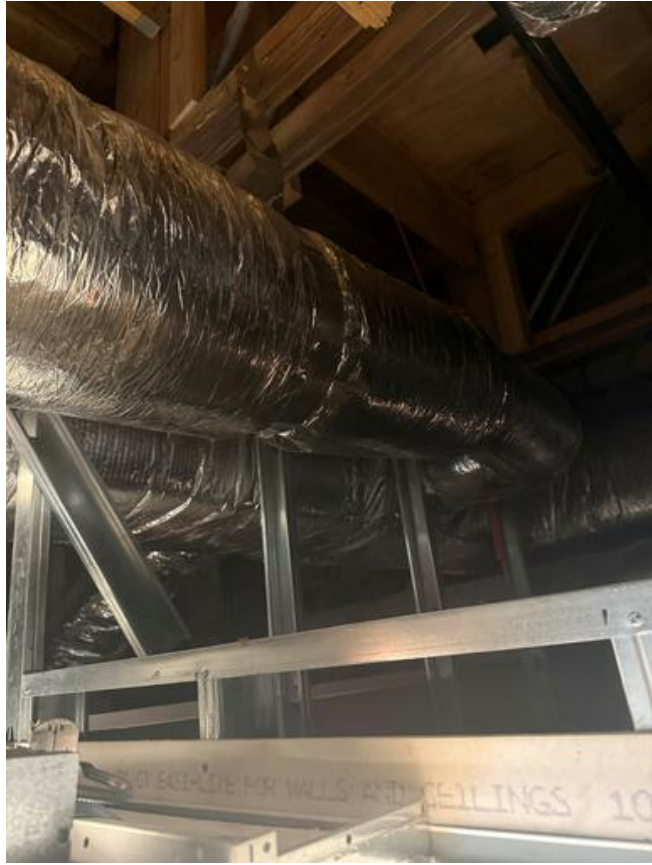
3

Rigid pipe added for SGRD4-4, flex no more than 4ft, metal brace pinching flex re-located, strapping added to support flex

NTi to inspect and rebalance unit during return trip.

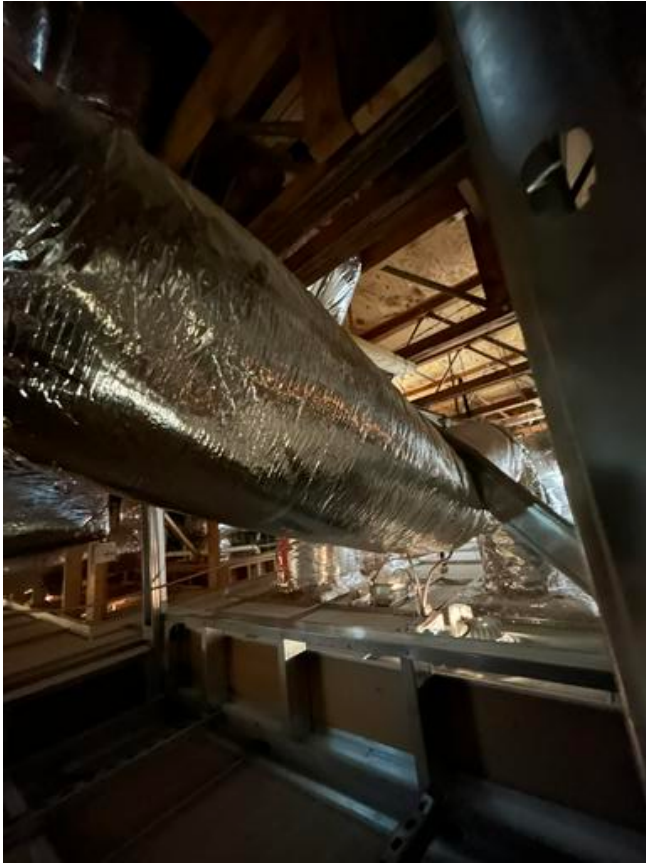
IMG_9164

Description
SGRD4-4 has more than 4ft of flex, which is causing some sag. Airflow to this diffuser is also 75% of design, additionally a scoop may need to be added to reach design flow.

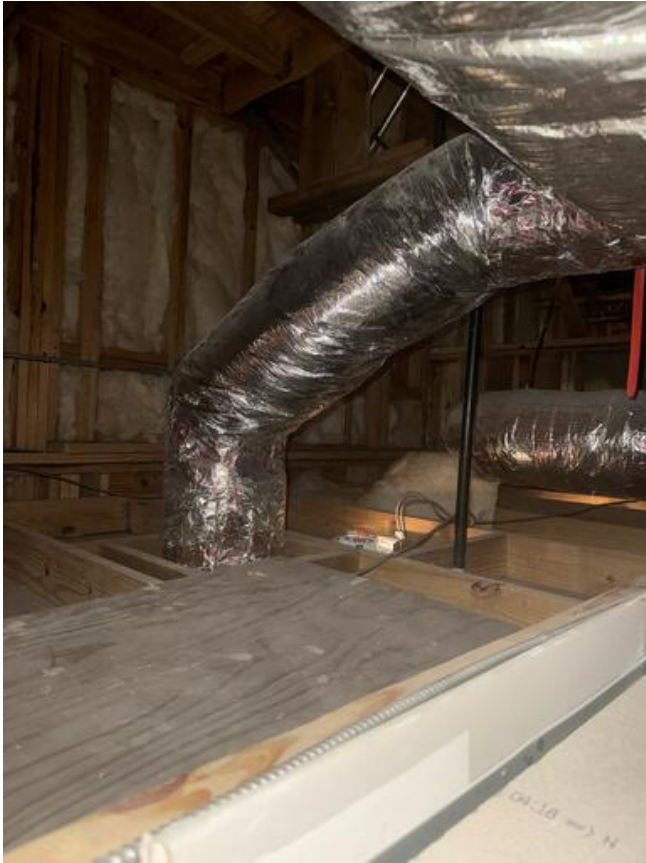
IMG_9163

Rigid 90 degree fitting not installed for SGRD3-4. Airflow to this diffuser is also 66% of design, additionally a scoop may need to be added to reach design flow.

NTi to rebalance during return trip.

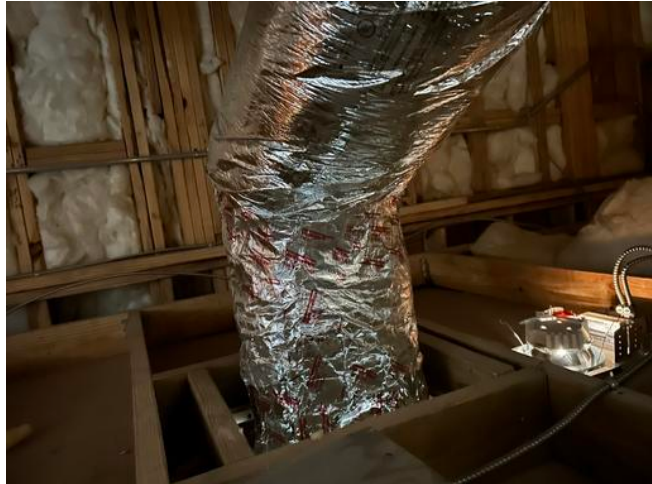
5

Diffuser SGRD3-4. Duct riser with rigid 90 installed

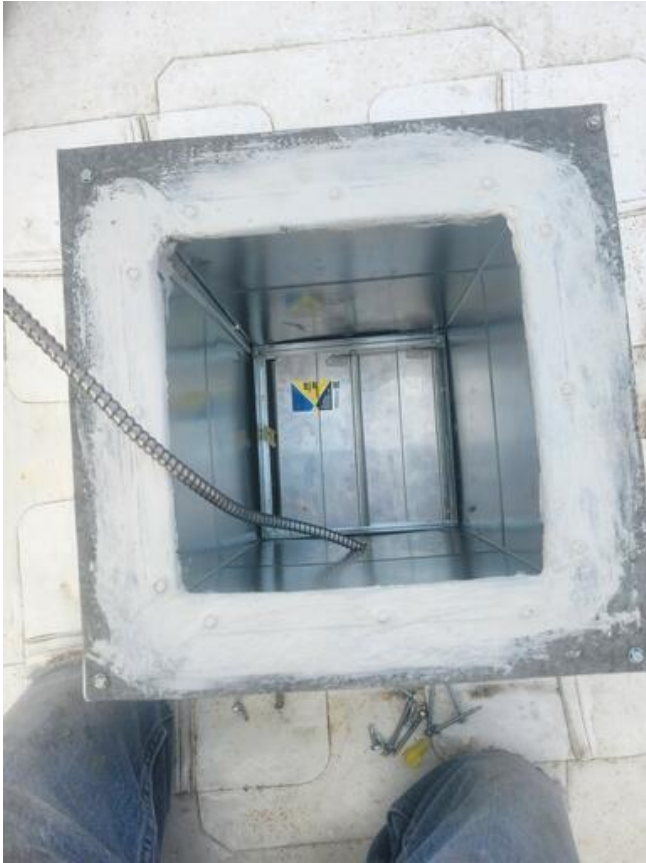
1

EF-3 duct leak corrected

Per Task 242 this duct was reworked. NTi will inspect during return trip.

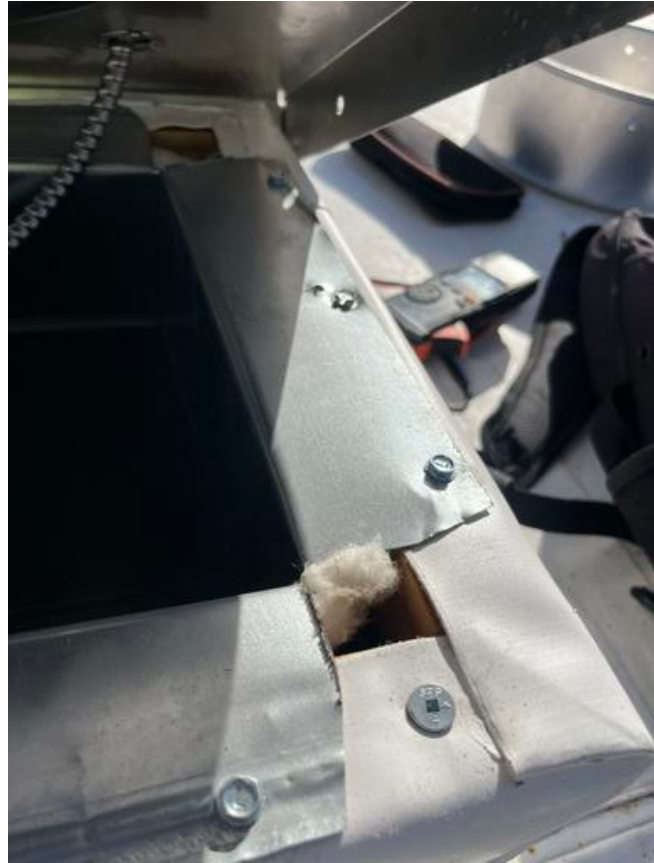
IMG_9137

Description
Restroom exhaust rectangular duct riser not correctly lined per specification. Instead duct is wrapped externally. Recommend installing liner or discussing with EOR to leave as-is.

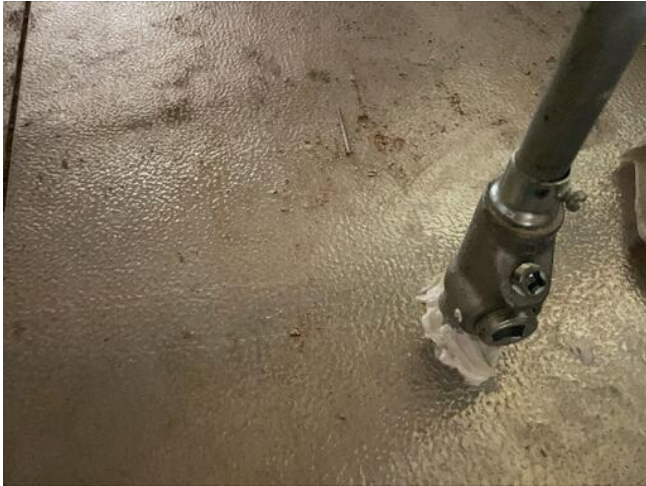
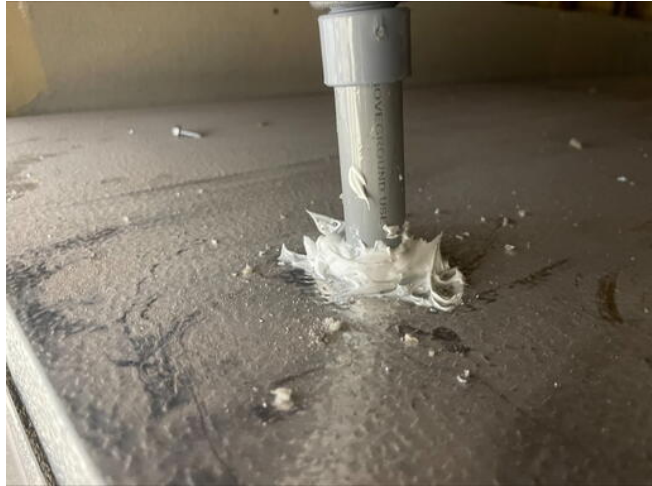
245-2

sealed

Task re-opened. Not sealed per E-501.

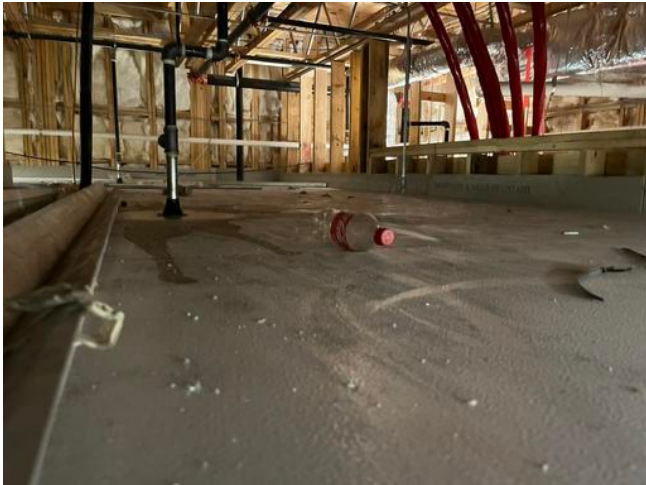
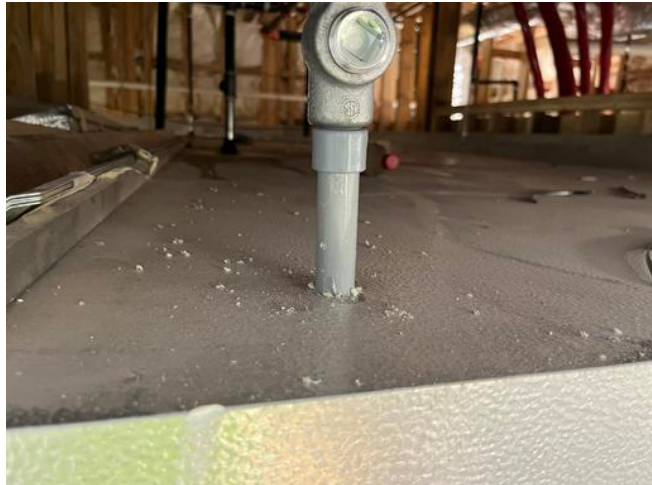
IMG_9142

WIF/WIC penetrations are not sealed inside with silicone and above ceiling panel with 2 layers of 1/4" foam tape 12" above panel at time of inspection.

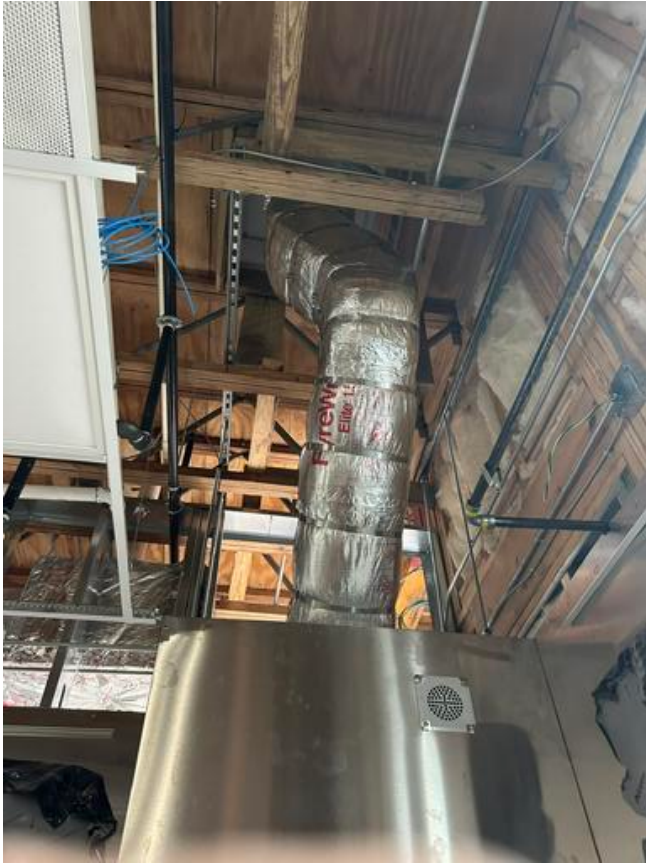
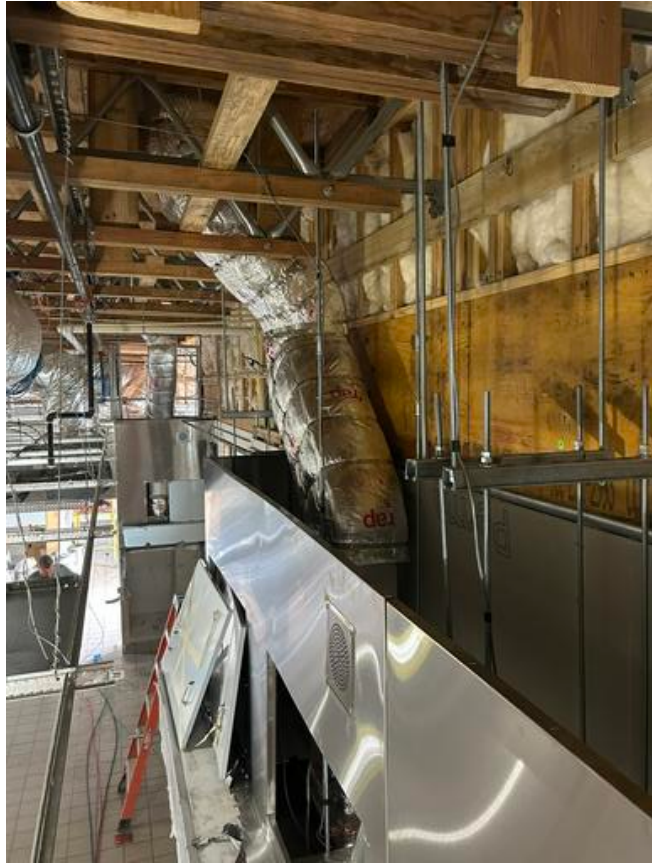
IMG_6345

Below-ceiling grease duct was constructed with extra turns to align the duct with roof risers. Static pressure will be tested during TAB to ensure it is not causing restriction.

Will verify pressures remain acceptable when new motor is installed.
