**Report: TAB REPORT**  
**Function: Test, Adjust, & Balance**  
**Date: 03/30/2023**

**03-27-23 FOOD LION #2856 - LINCOLNTON,  
NC**

TRS-SESCO LLC  
721-A Park Centre Dr  
Kernersville, NC 27284

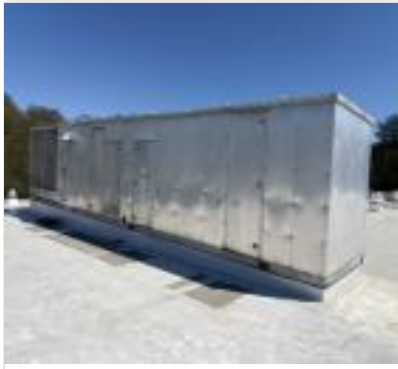
**RTU-1**  
**03/30/2023**

**Issue Name :** EXISTING RTU-1  
**Description :** AIRFLOW MEASURED AT 17348 CFM ACTUAL OUT OF 26975 CFM DESIGN. RECOMMEND A MOTOR SHEAVE CHANGE. ACTUAL AMPS MEASURED AS 33 AVG AND THE MOTOR FLA IS 49.6.  
**Created By :** National TAB                      **Assigned To :** National TAB - Will Turnbough  
**Status :** Open  
**Priority :**    **Asset Tag :**  
**Originated Date :** 03/30/2023 - Zack Epps - National TAB

<b>Issue Name :</b>	EXISTING RTU-1 & RTU-2 - CONDENSATE DRAIN		
<b>Description :</b>	NO CONDENSATE DRAIN INSTALLED. RECOMMEND INSTALLING SO THAT UNIT DRAINS PROPERLY.		
<b>Created By :</b>	National TAB	<b>Assigned To :</b>	National TAB - Will Turnbough
<b>Status :</b>	Open		
<b>Priority :</b>		<b>Asset Tag :</b>	
<b>Originated Date :</b>	03/30/2023 - Zack Epps - National TAB

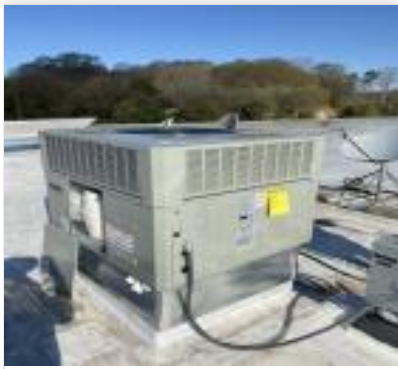
**RTU-3**  
**03/30/2023**

**Issue Name :** NEW RTU-3  
**Description :** AIRFLOW MEASURED AS 586 CFM ACTUAL OUT OF 900 CFM DESIGN. MOTOR IS DIRECT DRIVE. WIRED FOR HIGH SPEED BUT AIRFLOW ONLY INCREASED 36 CFM.

UNIT IS WIRED FOR HIGH SPEED AND IS STILL LOW ON FLOW: 586 CFM ACTUAL / 800 CFM DESIGN

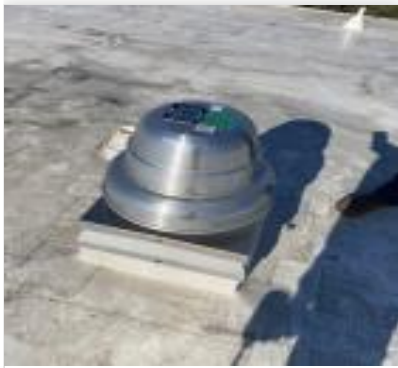
**EF-2**  
**03/30/2023**

**Description :** WHILE MEASURING AMPS ON EF-4, ACCIDENTLY SHORTED THE LEAD OF THE AMP METER AND TRIPPED THE BREAKER FOR EF-4. EF-2 ALSO TURNED OFF. CONTACTED THE ELECTRICIAN AND THEY STATED THAT THEY WERE LIKELY TIED INTO THE SAME EXISTING BREAKER. NEED ASSISTANCE TURNING BREAKER BACK ON SO THAT TESTING CAN BE COMPLETED.

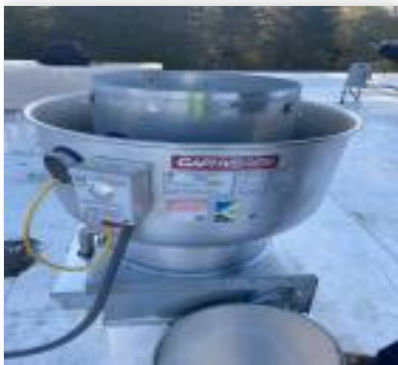
**HEF-1**  
**03/30/2023**

Test Data		
	Design	Actual
CFM	750	657
Fan RPM	1260	DD
Fan Rotation	-	DD
Motor RPM	-	DD
System SetPt	-	MAX
RL Voltage	-	123.2
RL Amperage	-	3.4
Total ESP	0.75"	NA
Fan Inlet SP	-	NA
Fan Discharge SP	-	ATM

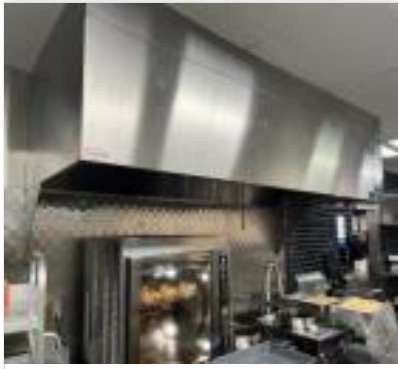
**HD-1**  
**03/30/2023**

Test Data Exhaust		
	Design	Actual
Filter Type	-	BAFFLED
Filter Size 1	-	16X16
Filter Qty 1	-	2
Filter AK factor size 1	-	1.62
Filter Total AK Area	-	3.24
Filter1 FPM	-	214
Filter2 FPM	-	192
Filter Ave FPM(corr)	-	203
CFM	750	657

Notes:  
UNIT AT MAX SETPOINT ON DIAL
