Joseph Airport Hyundai Reno (Vandalla, OH)

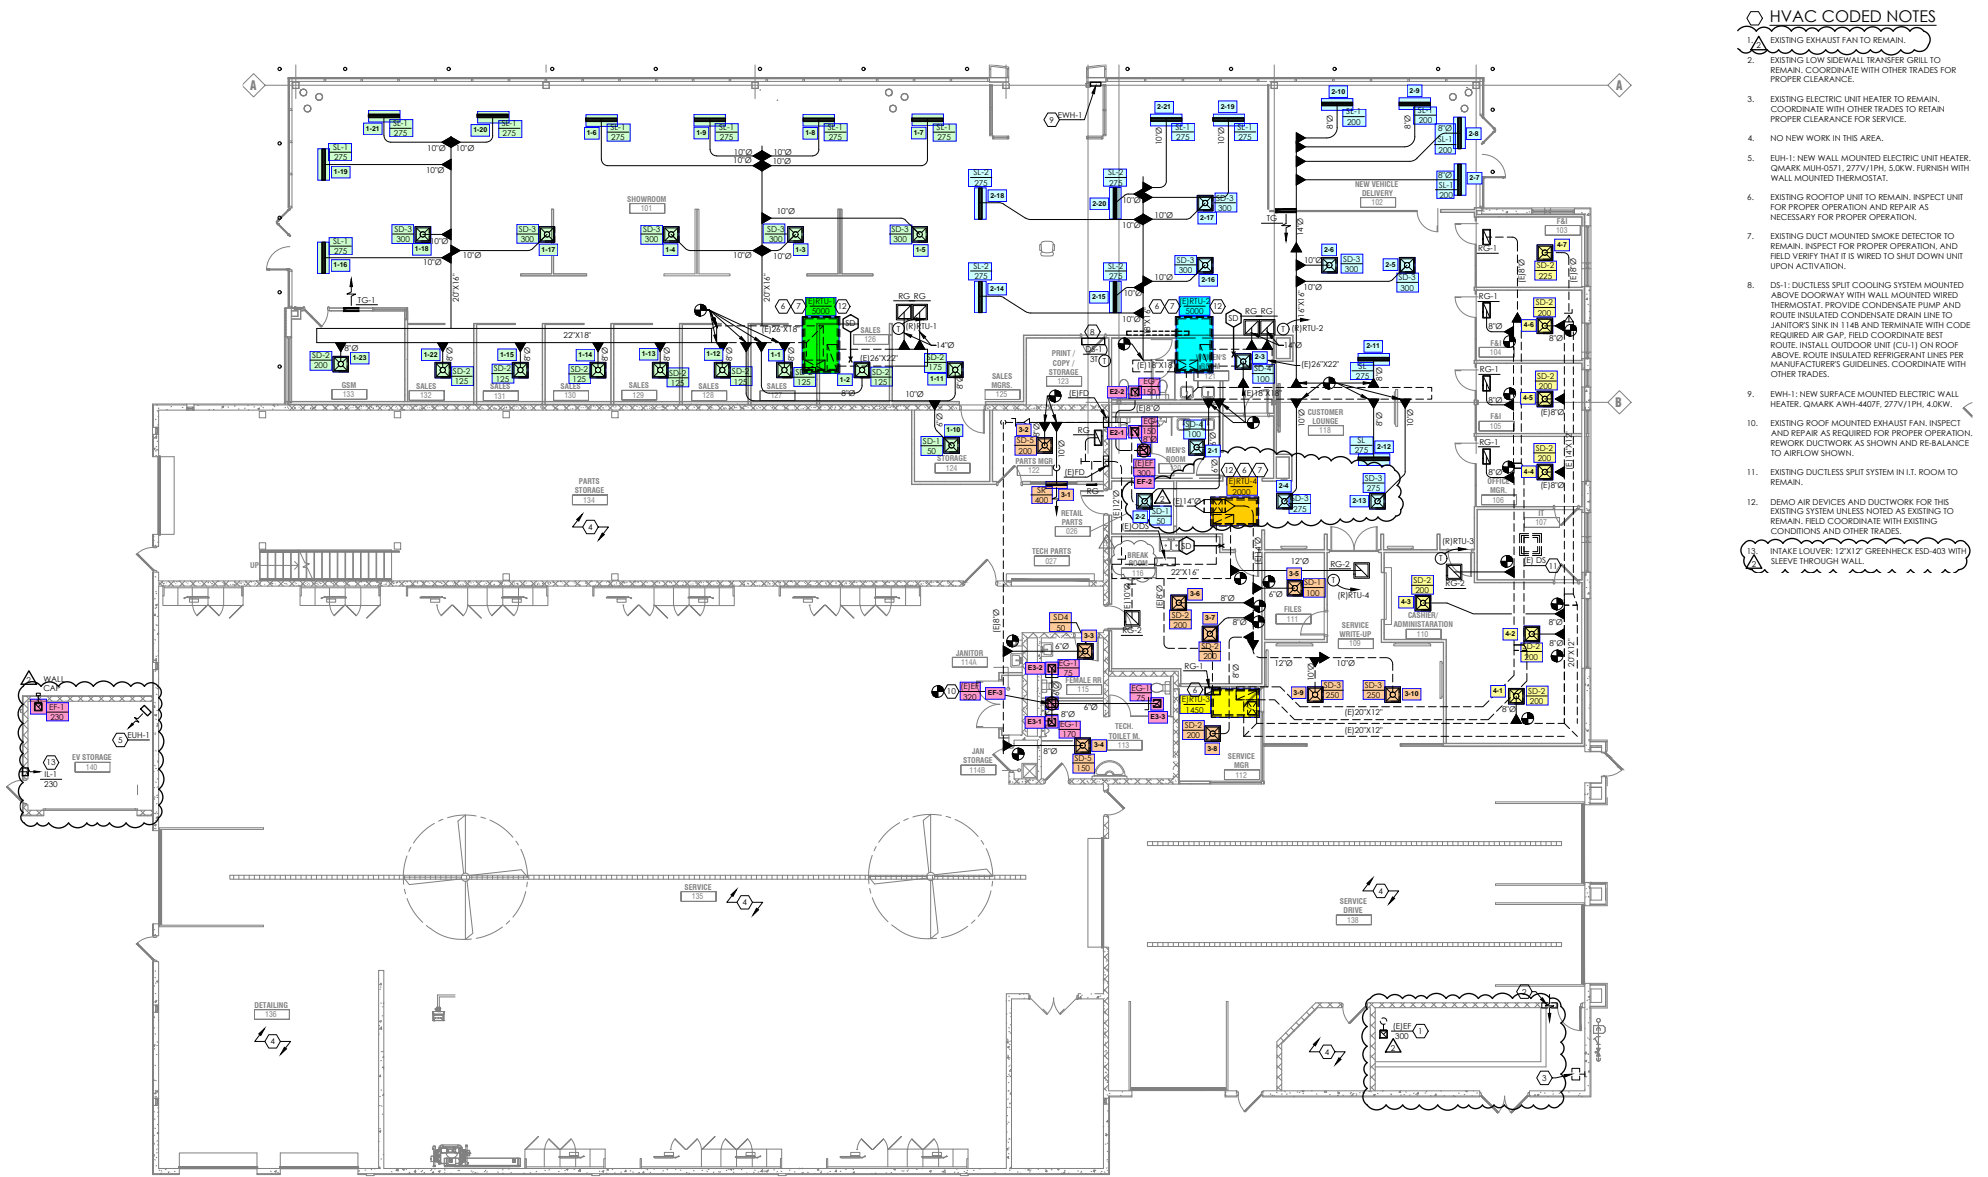
- 1. EXISTING EXHAUST FAN TO REMAIN.
- 2. EXISTING LOW SIDE WALL TRANSFER GRILL TO REMAIN. COORDINATE WITH OTHER TRADES FOR PROPER CLEARANCE.
- 3. EXISTING ELECTRIC UNIT HEATER TO REMAIN. COORDINATE WITH OTHER TRADES TO RETAIN PROPER CLEARANCE FOR SERVICE.

- 4. NO NEW WORK IN THIS AREA.
- 5. EWH-1: NEW WALL MOUNTED ELECTRIC UNIT HEATER. QMARK MWH-571, 277V/1PH, 5.0KW. FURNISH WITH WALL MOUNTED THERMOSTAT.
- 6. EXISTING ROOF TOP UNIT TO REMAIN. INSPECT UNIT FOR PROPER OPERATION AND REPAIR AS NECESSARY FOR PROPER OPERATION.

- 7. EXISTING DUCT MOUNTED SMOKE DETECTOR TO REMAIN. INSPECT FOR PROPER OPERATION, AND FIELD VERIFY THAT IT IS WIRED TO SHUT DOWN UNIT UPON ACTIVATION.

- 8. DS-1: DUCTLESS SPLIT COOLING SYSTEM MOUNTED ABOVE DOORWAY WITH WALL MOUNTED WIRED THERMOSTAT. PROVIDE CONDENSATE PUMP AND ROUTE INSULATED CONDENSATE DRAIN LINE TO JANITORS SINK IN 114B AND TERMINATE WITH CODE REQUIRED AIR GAP. FIELD COORDINATE BEST ROUTE. INSTALL OUTDOOR UNIT (CU-1) ON ROOF ABOVE. ROUTE INSULATED REFRIGERANT LINES PER MANUFACTURER'S GUIDELINES. COORDINATE WITH OTHER TRADES.

- 9. EWH-1: NEW SURFACE MOUNTED ELECTRIC WALL HEATER. QMARK AWH-407F, 277V/1PH, 4.0KW.
- 10. EXISTING ROOF MOUNTED EXHAUST FAN. INSPECT AND REPAIR AS REQUIRED FOR PROPER OPERATION. REWORK DUCTWORK AS SHOWN AND RE-BALANCE TO AIRFLOW SHOWN.

- 11. EXISTING DUCTLESS SPLIT SYSTEM IN 111. ROOM TO REMAIN.
- 12. DEMO AIR DEVICES AND DUCTWORK FOR THIS EXISTING SYSTEM UNLESS NOTED AS EXISTING TO REMAIN. FIELD COORDINATE WITH EXISTING CONDITIONS AND OTHER TRADES.
