Report: TECH

Function: Test, Adjust, & Balance

**12-22-25 Whataburger #1659 - League City,
TX**

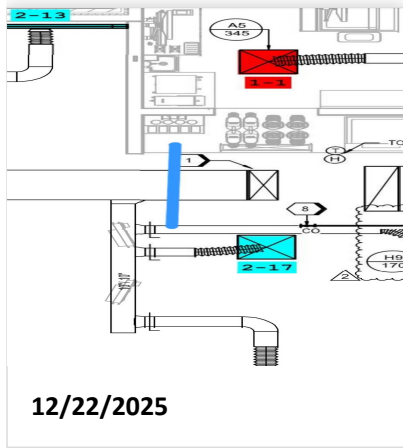
Screenshot of the GRD marked up with supply and return traverse locations for RTU-2 (Add picture here)

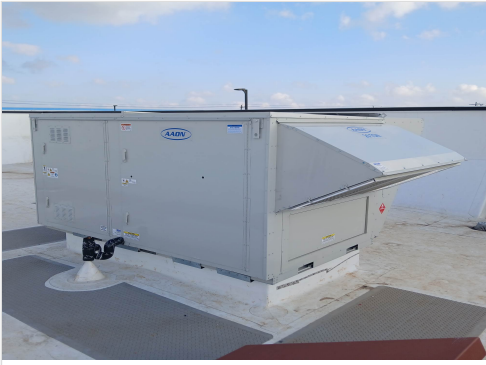
Unit Data - PHOTO LOG

Asset: RTU1

Unit Data	
	Actual
MFG	AAON
Serial Num	202510-BNEP35339
Model Num	RNA-020-C-A-8-FAB04-A04M0
Num OA Filters 1	3
OA Filter Size 1	20x25x1
Num Final Filter 1	6
Final Filter Size 1	20x25x2

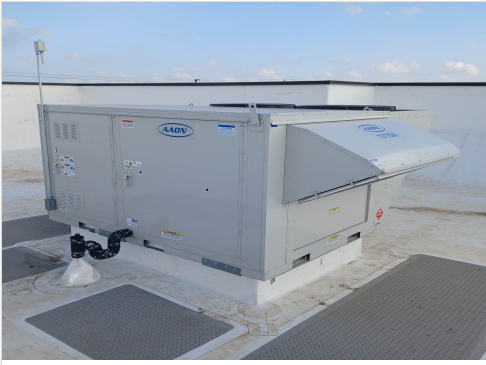
Unit Data - PHOTO LOG

Asset: RTU2

Unit Data	
	Actual
MFG	AAON
Serial Num	202510-ANEK35332
Model Num	RNA-013-B-A-8-FAB04-A04M0
Num OA Filters 1	3
OA Filter Size 1	20x25x1
Num Final Filter 1	4
Final Filter Size 1	20x25x2

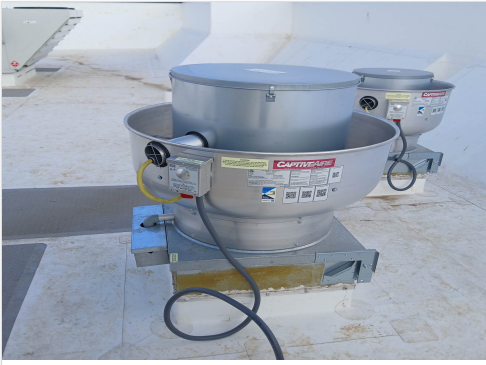
Unit Data - PHOTO LOG

Asset: KEF1

Unit Data		
	Design	Actual
MFG	GREENHECK	CAPTIVE-AIRE
Model Num	CUE-140-VG	DU180HFA
Serial Num	-	7541810
Type	CENTRIFUGAL	CENTRIFUGAL
Configuration	UPBLAST	UPBLAST

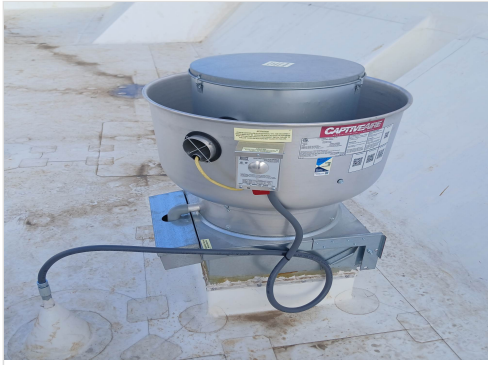
Unit Data - PHOTO LOG

Asset: KEF2

Unit Data		
	Design	Actual
MFG	GREENHECK	CAPTIVE-AIRE
Model Num	CUE-120-VG	DU50HFA
Serial Num	-	7541810
Type	CENTRIFUGAL	CENTRIFUGAL
Configuration	UPBLAST	UPBLAST

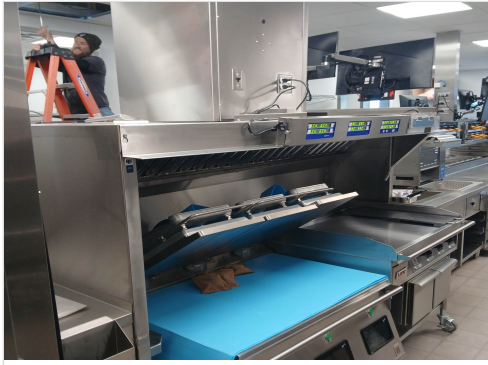
Unit Data - PHOTO LOG

Asset: HD1

Unit Data		
	Design	Actual
MFG	H&K DALLAS INC	H&K DALLAS INC
Model Num	HKD _____	HKD027
Job / Serial Num	-	8175950-001
Type	TYPE I LOW PROXIMITY	TYPE I LOW PROXIMITY
Hood length	-	87"
Hood Width	-	56"

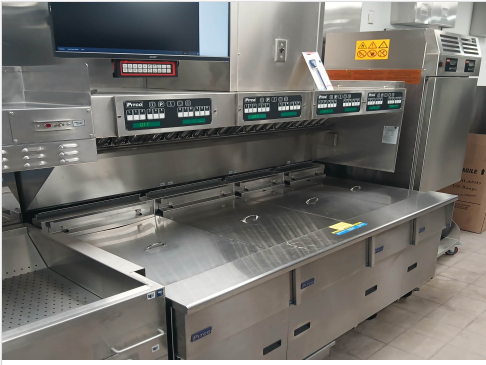
Unit Data - PHOTO LOG

Asset: HD2

Unit Data		
	Design	Actual
MFG	H&K DALLAS INC	H&K DALLAS INC
Model Num	HKD_____	HKD023
Job / Serial Num	-	8175948-001
Type	TYPE I LOW PROXIMITY	TYPE I LOW PROXIMITY
Hood length	-	73"
Hood Width	-	26"
