Report: Notes

Function: Test, Adjust, & Balance

PROJECT
USACE HVAC Reset (Palatka, FL)

Issue Name : Project Notes

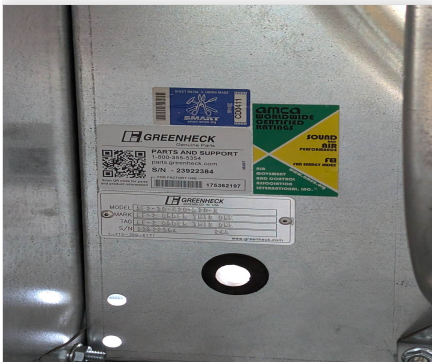
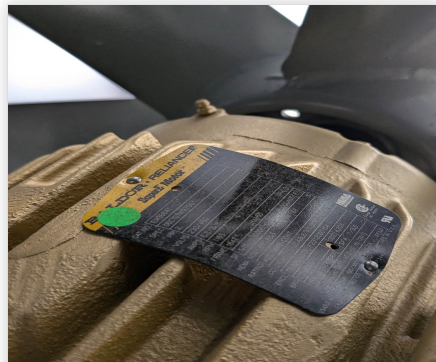
Description : • FCU-8 next steps are just balance diffusers once face accessible dampers are installed. • Women's RR EF (EF-2) - total was roughly set with no diffusers installed. Will rebalance once everything is 100% installed. There was not a 100% seal from the ductwork to the hood due to the lack of diffusers. • PAL02-EF-2 - See attachments. • MAU-2 does no
