**Report: TAB RPT
Function: Test, Adjust, & Balance
Date: 7/15/2022**

**PROJECT
05-16 CULVERS - LOWELL, MI**

Project: 05-16 CULVERS - LOWELL, MI

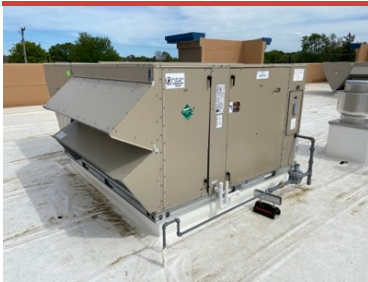
KITCHEN RTU

Notes:DIFFUSERS 1-1 & 1-2 CANNOT BALANCE WITHIN DESIGN. DUCTWORK WAS MODIFIED WHERE THEY HAD TO CONNECT A FLEX IN ORDER TO GET PAST THE WOODEN TRUSSES AND THEN BACK TO HARD DUCT. DAMPERS ARE 100% OPEN

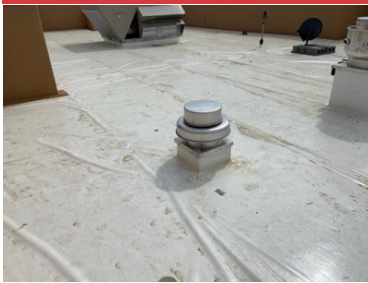
RESTROOM FAN

Notes:[1] FAN IS RUNNING AT MAX SPEED. BACK DRAFT DAMPER IS COMPLETELY OPEN. FACE DAMPERS INSTALLED ARE FULLY OPEN.
