**Report: Prelim Report**  
**Function: Test, Adjust, & Balance**  
**Date: 01/15/2025**  
**Completed By: National TAB**

## 01-13-25 WAWA #6611 FARMVILLE, VA

## Project Summary

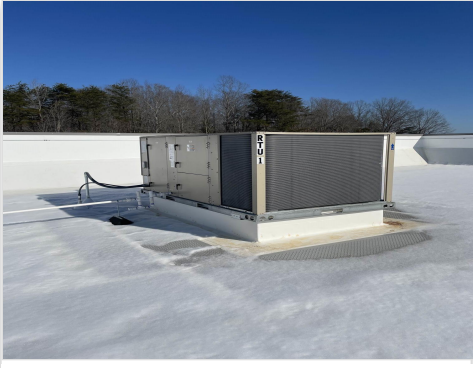
## Unit Data - PHOTO LOG

Asset: RTU1

Unit Data		
	Design	Actual
MFG	LENNOX ENLIGHT	LENNOX ENLIGHT
Serial Num	-	5624D03499
Model Num	LCT092H4E	LCT092H4E
Type	RTU	RTU
Configuration	VERTICAL	VERTICAL
Num OA Filters 1	-	2
OA Filter Size 1	-	24"X15.5"
Num Final Filter 1	-	4
Final Filter Size 1	-	20"X25"X2"

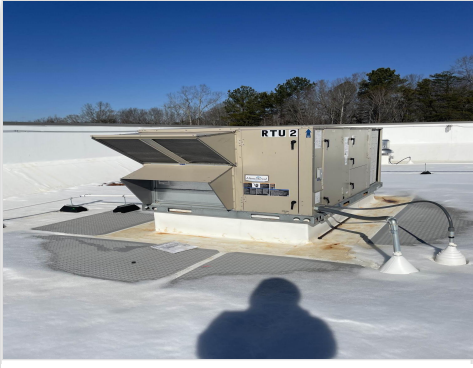
**Unit Data - PHOTO LOG**

Asset: RTU2

Unit Data		
	Design	Actual
MFG	LENNOX ENLIGHT	LENNOX ENLIGHT
Serial Num	-	5624A03690
Model Num	LCT150H4E	LCT150H4E
Type	RTU	RTU
Configuration	VERTICAL	VERTICAL
Num OA Filters 1	-	2
OA Filter Size 1	-	24"X15"5
Num Final Filter 1	-	4
Final Filter Size 1	-	20"X25"X2

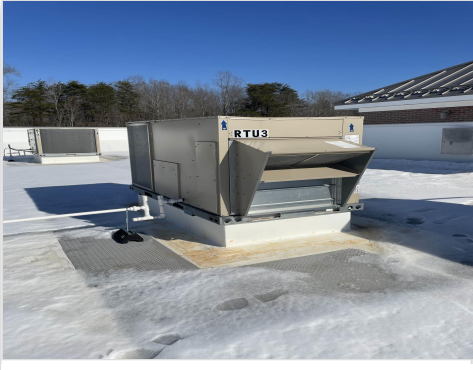
**Unit Data - PHOTO LOG**

Asset: RTU3

Unit Data		
	Design	Actual
MFG	LENNOX ENLIGHT	LENNOX ENLIGHT
Serial Num	-	5624C07753
Model Num	LCT060H4E	LCT060H4E
Type	RTU	RTU
Configuration	VERTICAL	VERTICAL
Num OA Filters 1	-	1
OA Filter Size 1	-	30"X15"
Num Final Filter 1	-	4
Final Filter Size 1	-	20"X20"X2"

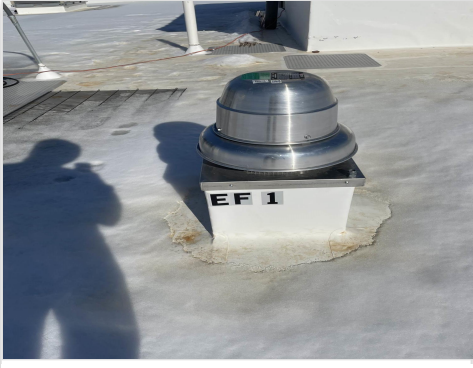
**Unit Data - PHOTO LOG**

Asset: EF1

Unit Data		
	Design	Actual
MFG	PENNBARRY	COOK
Model Num	DX10S	100C10DL
Serial Num	-	224SL3097200/0004101
Type	CENTRIFUGAL	CENTRIFUGAL
Configuration	VERTICAL	VERTICAL

. Set point marked on dial

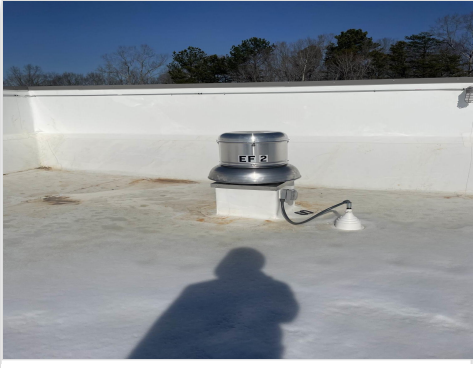
**Unit Data - PHOTO LOG**

Asset: EF2

Unit Data		
	Design	Actual
<b>MFG</b>	PENNBARRY	COOK
<b>Model Num</b>	DX13R	120C15D
<b>Serial Num</b>	-	224LP30972-01/0000701
<b>Type</b>	DOWNBLAST	DOWNBLAST
<b>Configuration</b>	VERTICAL	VERTICAL

. Set point marked on dial
