Report: Punchlist

Function: Test, Adjust, & Balance

Date: 05/30/2025

Seven Hills School (Cincinnati, OH)

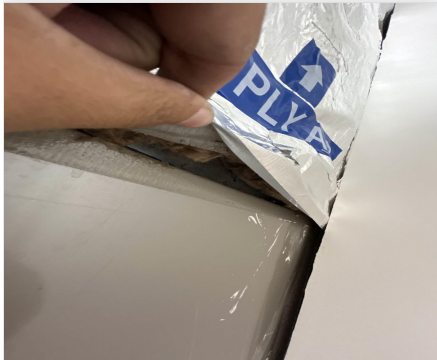
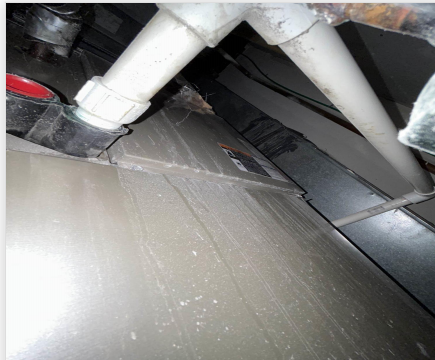
Issue Name : AHU 1 DUCT LEAKAGE
Description : AHU 1 supply duct leaking at evaporator attachment. Recommend sealing attachment areas to ensure proper airflow to space.
Created By : National TAB **Assigned To :** National TAB - Nick Payne
Status : Open
Priority : High **Asset Tag :**
Originated Date : 08/18/2025 - Gabe Merk - National TAB

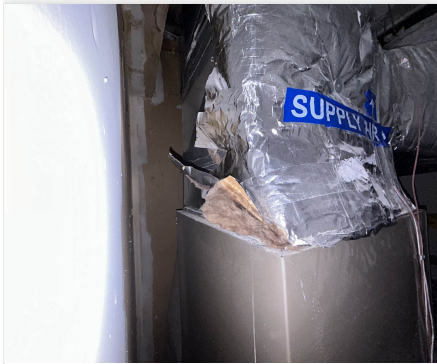
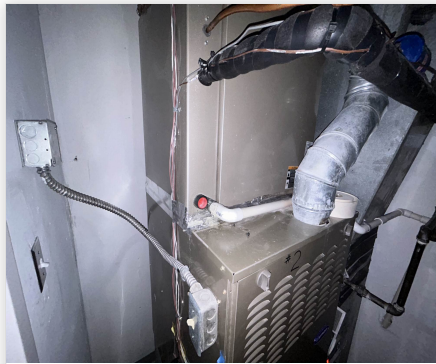
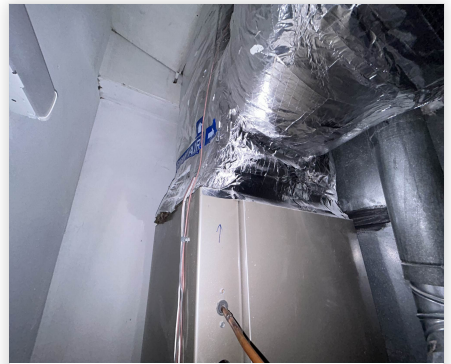
Issue Name : AHU 2 DUCT LEAKAGE
Description : AHU 2 supply duct leaking air into mech closet from connections to evaporator coil section. Recommend sealing duct attachments to unit for better airflow to space.
Created By : National TAB **Assigned To :** National TAB - Nick Payne
Status : Open
Priority : High **Asset Tag :**
Originated Date : 08/18/2025 - Gabe Merk - National TAB

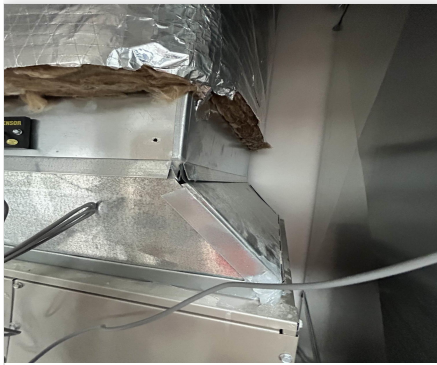
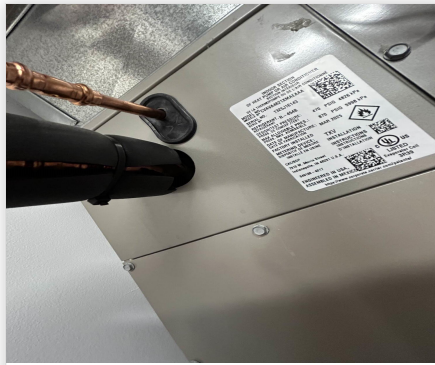
Issue Name : AHU 3 DUCT LEAKAGE
Description : AHU 3 leakage around evaporator connections. Recommend sealing ductwork to allow for additional flow to diffusers.
Created By : National TAB **Assigned To :** National TAB - Nick Payne
Status : Open
Priority : High **Asset Tag :**
Originated Date : 08/18/2025 - Gabe Merk - National TAB
