**Report: TAB Report**  
**Function: Test, Adjust, & Balance**  
**Date: 11/11/2025**  
**Completed By: National TAB**

**PROJECT**  
**11-17-25 QT #1149 GREENVILLE, SC**

Project: 11-17-25 QT #1149 GREENVILLE, SC

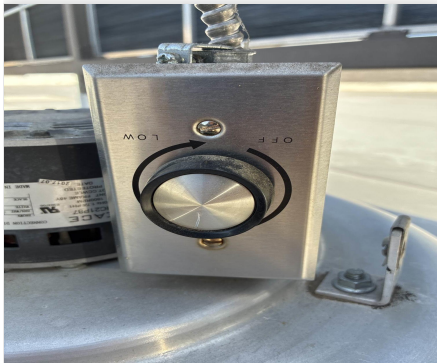
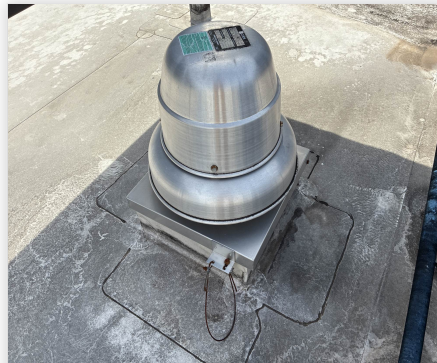
**Issue Name :** EF-1 Excessive Airflow  
**Description :** EF-1 is at the lowest speed setting and is exhausting more air than it needs to.  
**Created By :** National TAB                      **Assigned To :** National TAB - Dan Hertenstein  
**Status :** Open  
**Priority :** InfoOnly                                      **Asset Tag :** EF1  
**Originated Date :** 11/19/2025 - Alex Bauer - National TAB

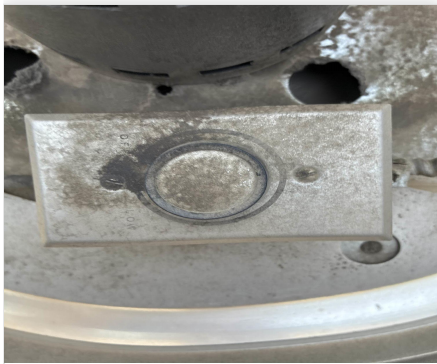
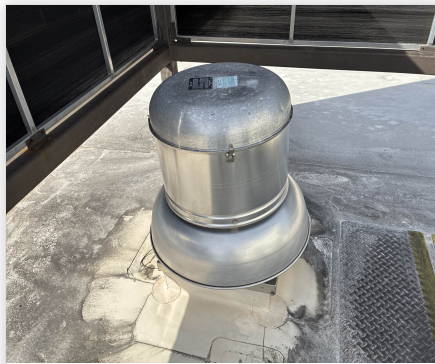
**Issue Name :** EF-2 Low Flow  
**Description :** EF-2 is at the highest speed setting and is not exhausting enough air.  
**Created By :** National TAB                      **Assigned To :** National TAB - Dan Hertenstein  
**Status :** Open  
**Priority :** Low                                      **Asset Tag :** EF2  
**Originated Date :** 11/19/2025 - Alex Bauer - National TAB

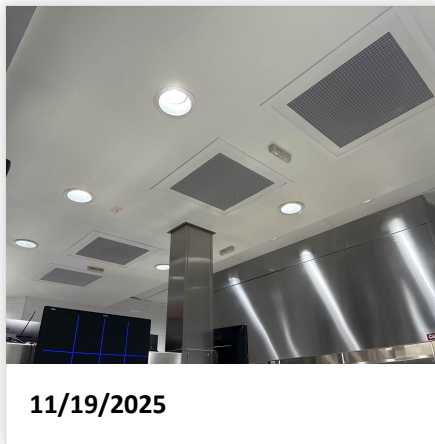
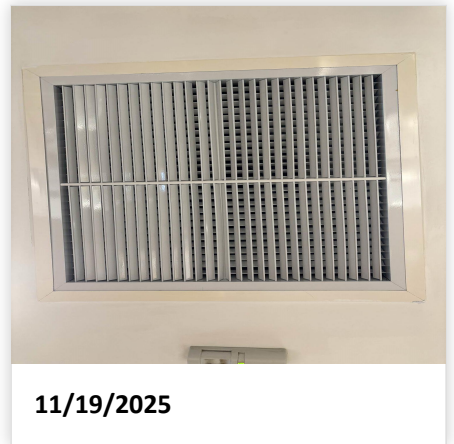
**Issue Name :** Incorrect Kitchen Diffusers  
**Description :** The kitchen diffusers 3-1 through 3-4 are not the Titus S1 diffuser with the controllable damper.  
**Created By :** National TAB                      **Assigned To :** National TAB - Dan Hertenstein  
**Status :** Open  
**Priority :** Low                                      **Asset Tag :** RT-3  
**Originated Date :** 11/19/2025 - Alex Bauer - National TAB

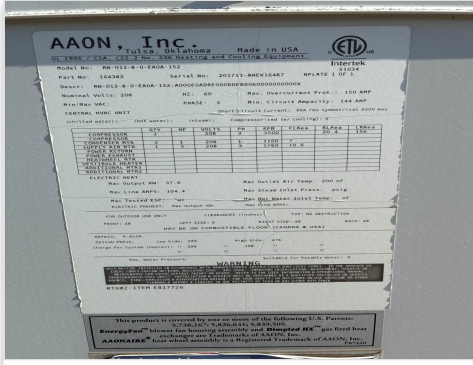
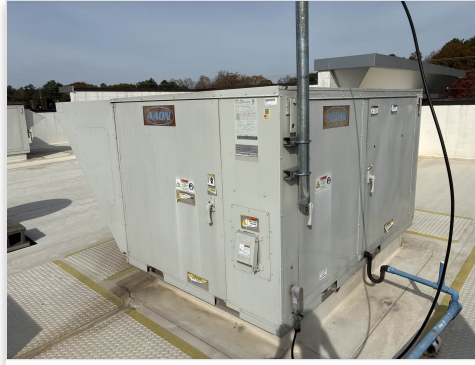
# Unit Data - PHOTO LOG

Notes:  
RTU-1 is actually RTU-2 on the site. Facilibuild is incorrect.

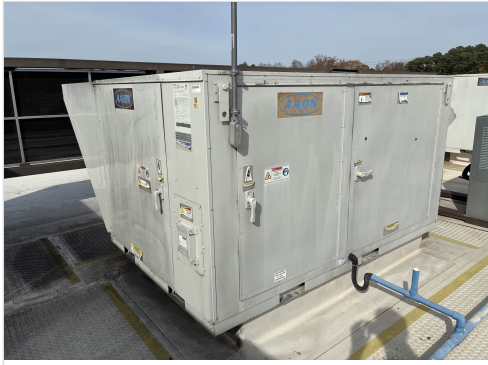
# Unit Data - PHOTO LOG

RTU-3 is actually RTU-1 on the site. Facilibuild is incorrect.

[1] INCORRECT KITCHEN DIFFUSERS

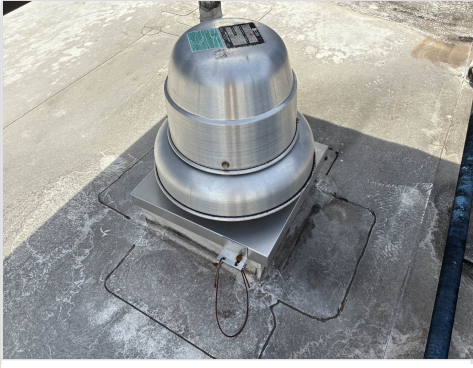
**Unit Data - PHOTO LOG**

Test Data		
	Design	Actual
CFM	225	311
Fan RPM	-	DD
Fan Rotation	-	CCW
Motor RPM	-	DD
System SetPt	-	LOW
RL Voltage	-	NA
RL Amperage	-	NA
Total ESP	-	0.36"
Fan Inlet SP	-	-0.36"
Fan Discharge SP	-	ATMO

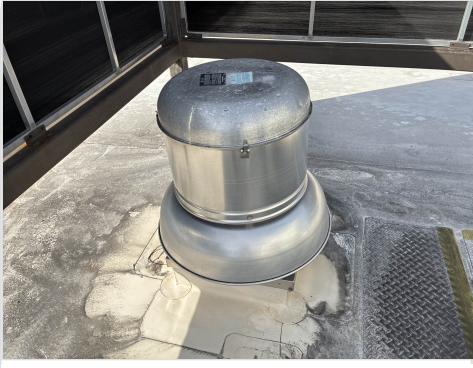
**Unit Data - PHOTO LOG**

Test Data		
	Design	Actual
CFM	525	203
Fan RPM	-	DD
Fan Rotation	-	CCW
Motor RPM	-	DD
System SetPt	-	MAX
RL Voltage	-	NA
RL Amperage	-	NA
Total ESP	-	0.19"
Fan Inlet SP	-	-0.19"
Fan Discharge SP	-	ATMO

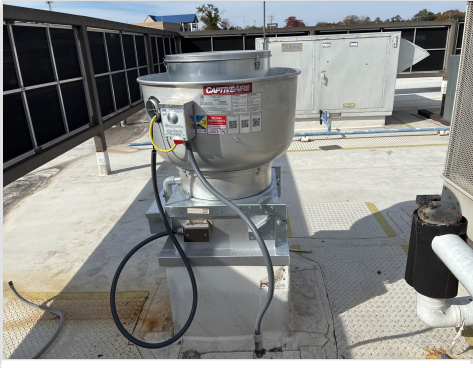
## Unit Data - PHOTO LOG

Test Data		
	Design	Actual
CFM	1350	1310
Fan RPM	-	DD
Fan Rotation	-	CCW
Motor RPM	-	DD
System SetPt	-	54.8 Hz
RL Voltage	-	NA
RL Amperage	-	NA
Total ESP	-	0.73"
Fan Inlet SP	-	-0.73"
Fan Discharge SP	-	ATMO
