# PlanGrid Task Report - Feb 18, 2025

**01041 South Parkway FSU // Huntsville, AL ...**

11820 Memorial Parkway Southwest, Huntsville, Alabama

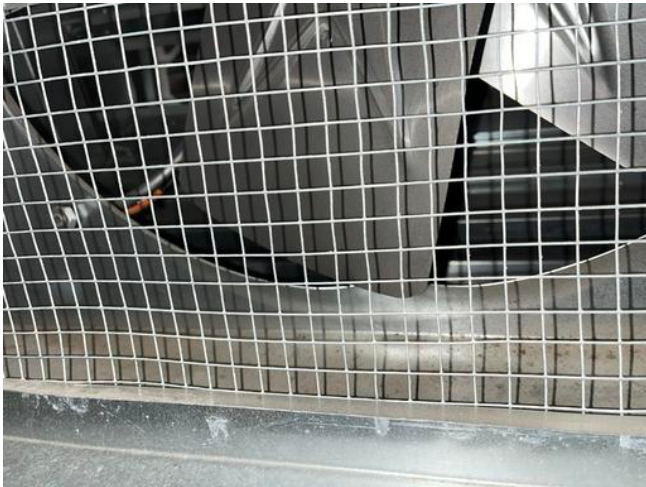
IMG\_7086

## #353 [UNIT 520] [NEW] Equipment option(s) not operational.

AC1 has one power exhaust fan that is not operational and appears fan blades are bound up against the fan housing.

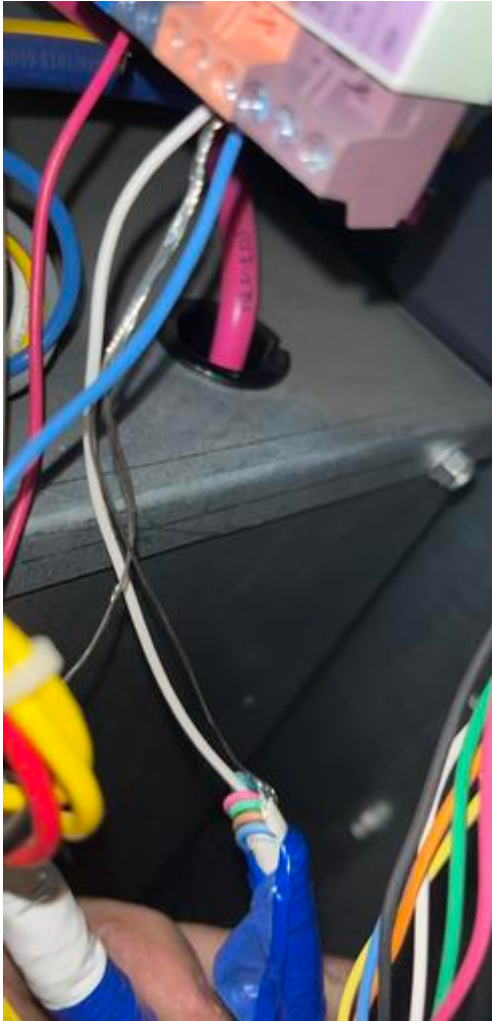
IMG\_7083

## #351 [CNTL 012] [NEW] CRITICAL (BAS) – Wiring specification.

AC1, AC2, AC3, AC4  
humidity sensor wiring used  
is incorrect per plans:  
SHIELDED CABLE BY MC.  
NETWORK THERMOSTAT  
CONNECT-AIR  
W1812C-2148,  
HONEYWELL GENESIS  
TWP-18/12 (47690112) OR  
EQUAL . 18AWG, 1-PAIR,  
TWISTED,  
SHIELDED, WITH DRAIN.  
PLENUM RATED. NO  
SUBSTITUTIONS.

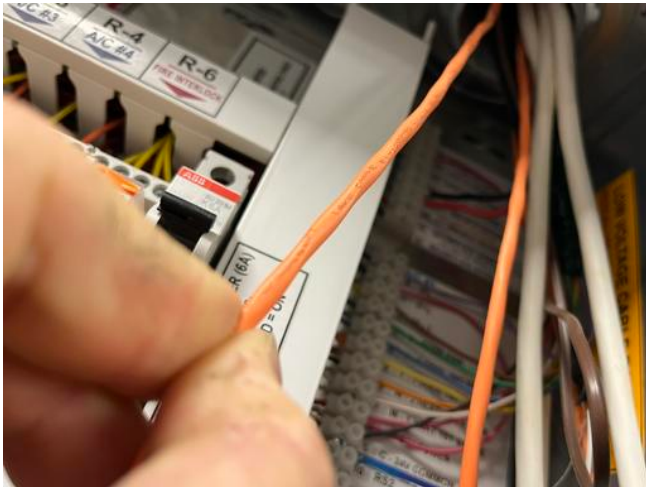
IMG\_7046

## #350 [CNTL 012] [NEW] CRITICAL (BAS) – Wiring specification.

AC1, AC2, AC3, AC4 temp.  
sensor wiring installed is  
Lake Cable brand. Plans call  
for specifically  
W221P-2003NT.

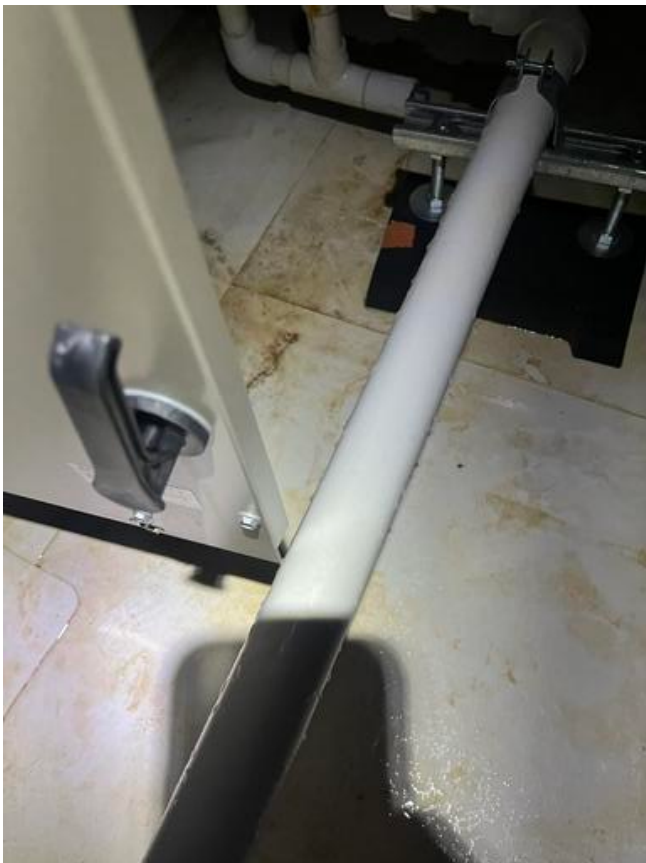
IMG\_7035

## #349 [UNIT 999] [NEW] (MISC) [AC2 Condensate line obstruction]

AC2 condensate line obstructs / makes contact with unit filter door.

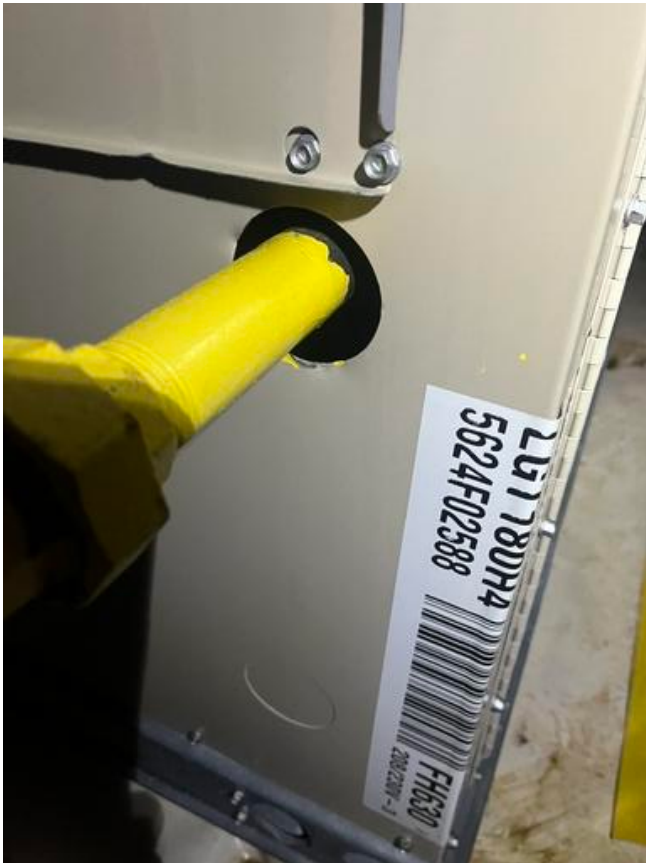
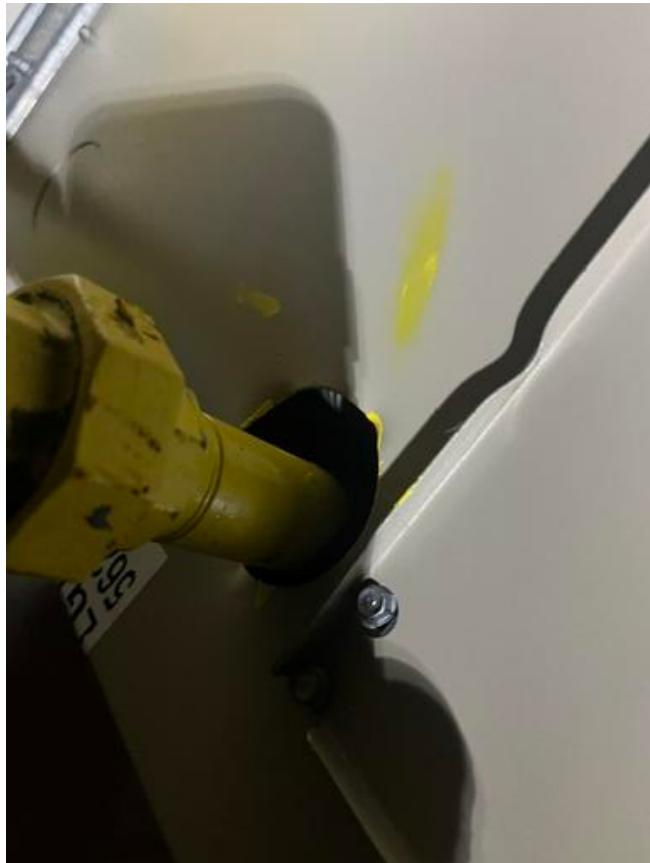
IMG\_7031

## #348 [UNIT 514] [NEW] Equipment gas piping.

AC2 & AC3 gas pipe  
grommets are not installed

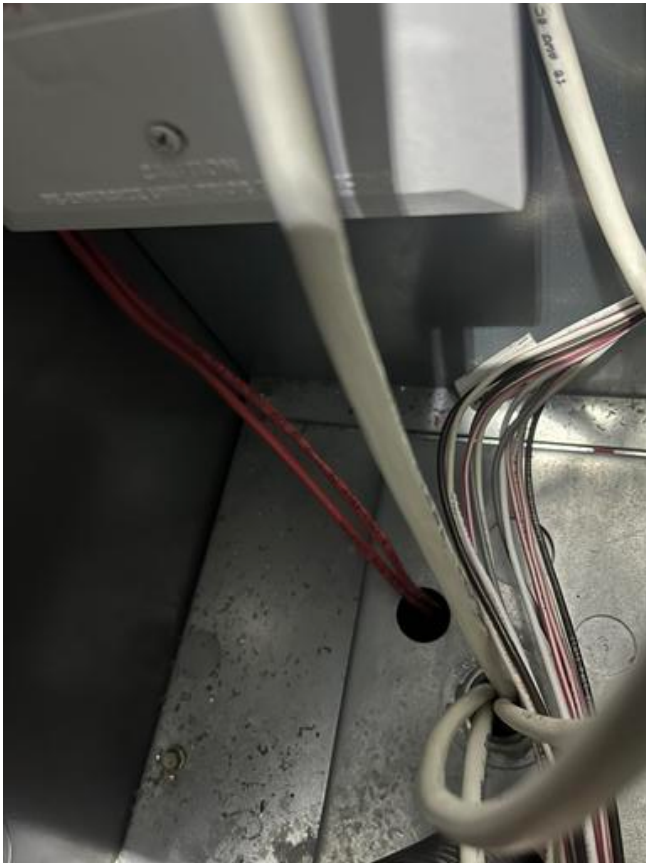
IMG\_7034

## #347 [UNIT 505] [NEW] Equipment wiring portals.

AC1, AC2, AC3, AC4  
grommets are not installed  
around the wiring portal for  
the smoke detectors wiring.

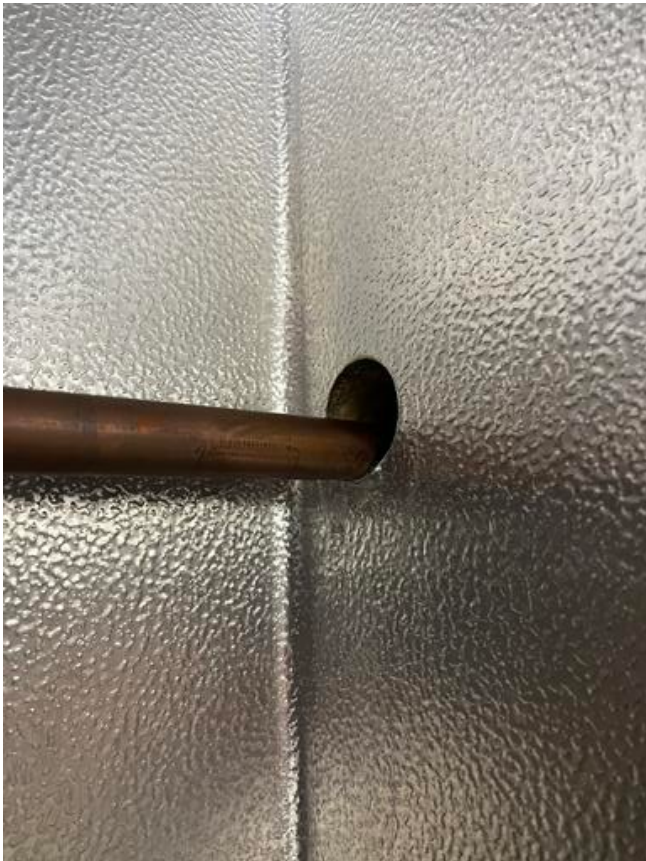
IMG\_7055

## #346 [REFG 508] [NEW] WIC/WIF panel penetrations.

WIC drain line cut out inside  
the wic box needs to be  
sealed.

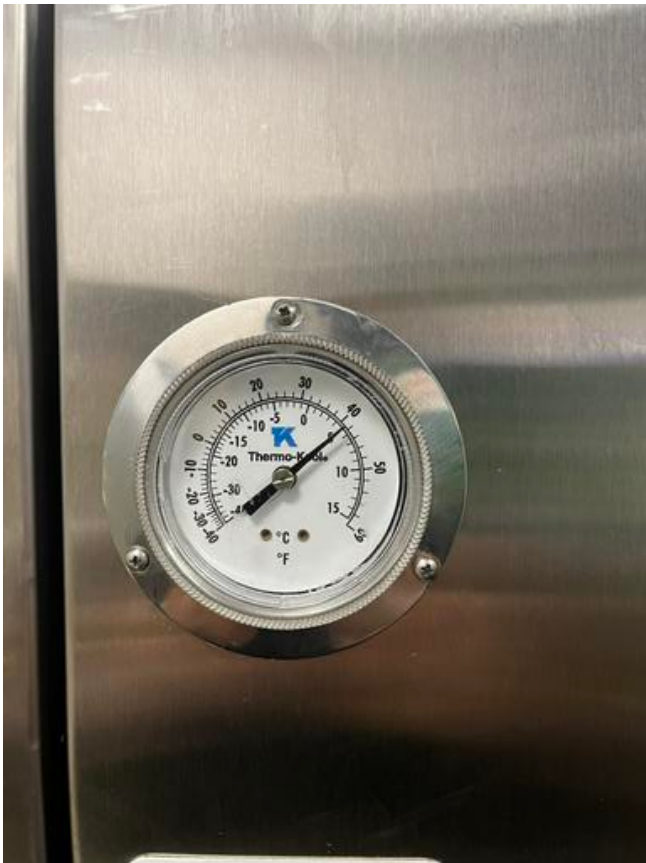
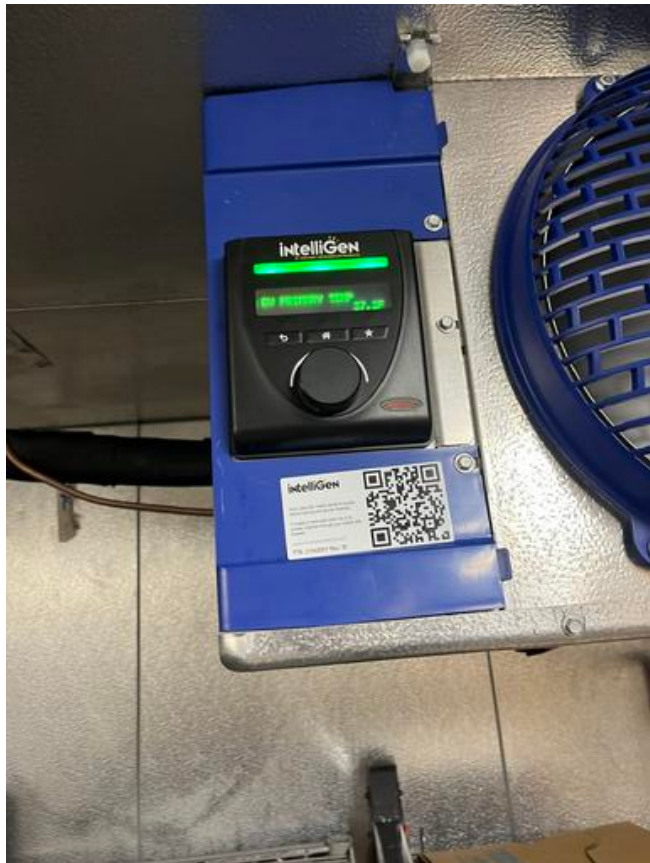
IMG\_7056

### #345 [REFG 500] [NEW] WIC/WIF temperatures.

WIC temp. inside the box is 37F & dial reads over 40F. WIC should be holding temp. at 35F. and dial should be calibrated to match actual temp. inside WIC.

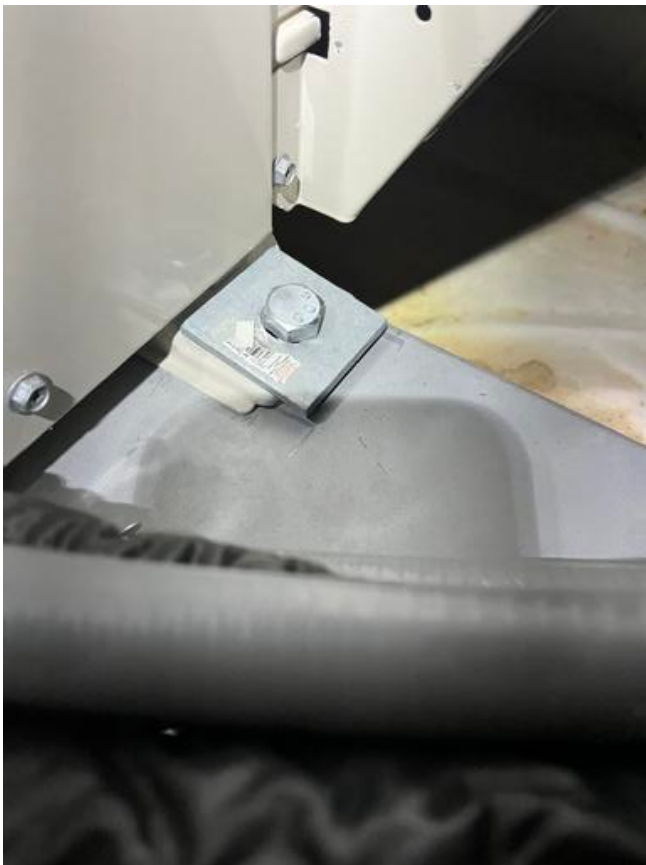
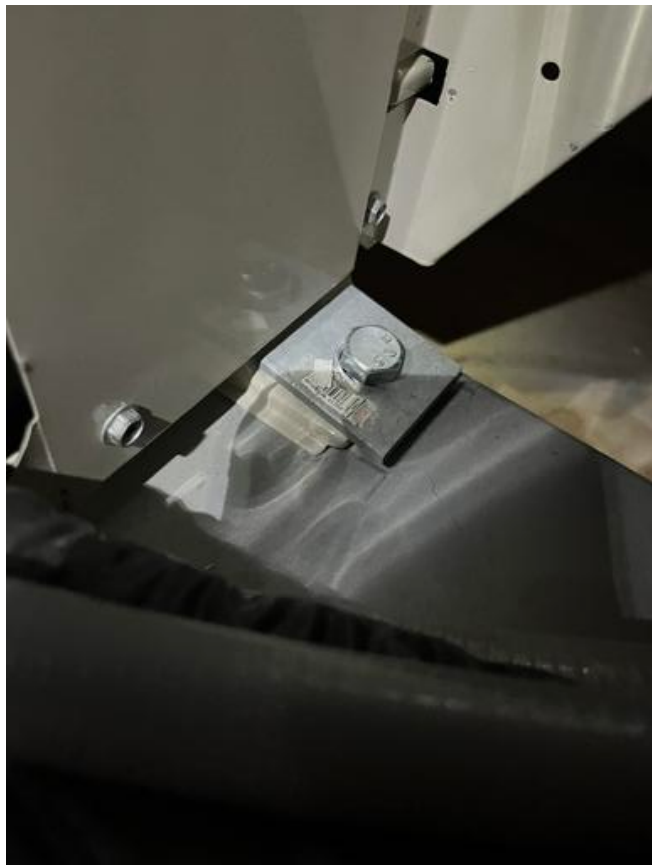
IMG\_7044  
Dale Wheeler  
Feb 17, 2025 7:09 PM

### #344 [UNIT 999] [NEW] (MISC) [MINI SPLIT]

Mini split does not have vibration pads installed between the condensing unit and the rack structure.

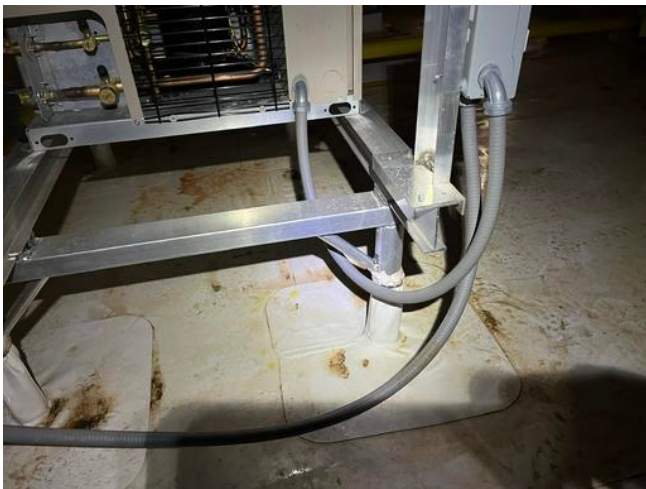
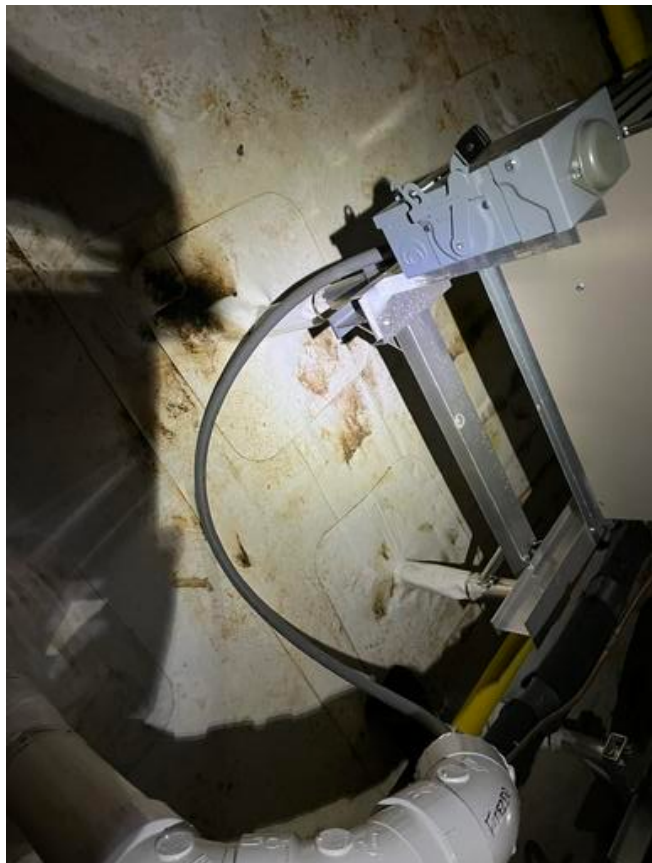
IMG\_7040

## #343 [REFG 999] [NEW] (MISC) [WIC & WIF ELECRTICAL]

WIF & WIC electrical lines are not secured / anchored to condenser stands.

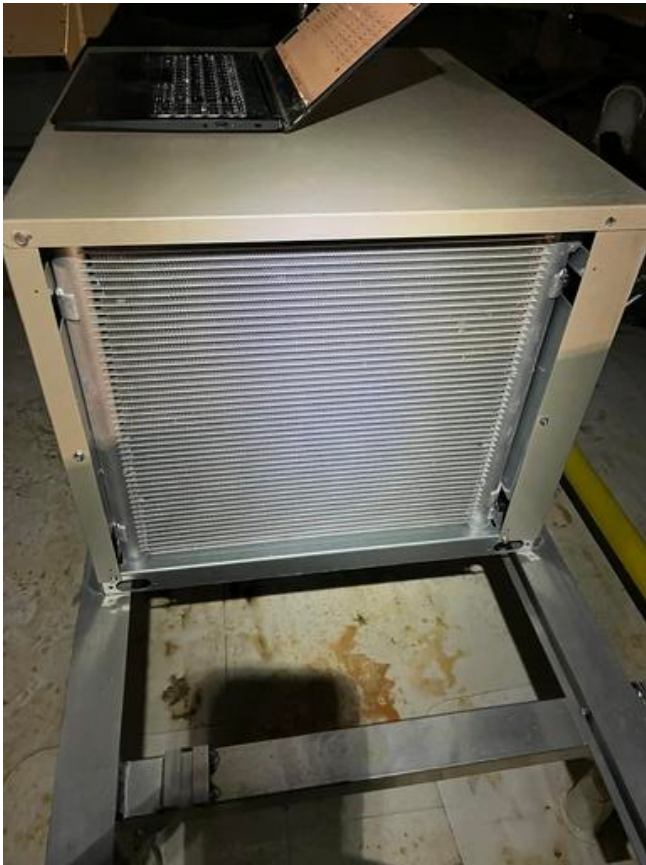
IMG\_7041

## #342 [REFG 517] [NEW] Hail guards.

WIC condenser hail guard is not installed.

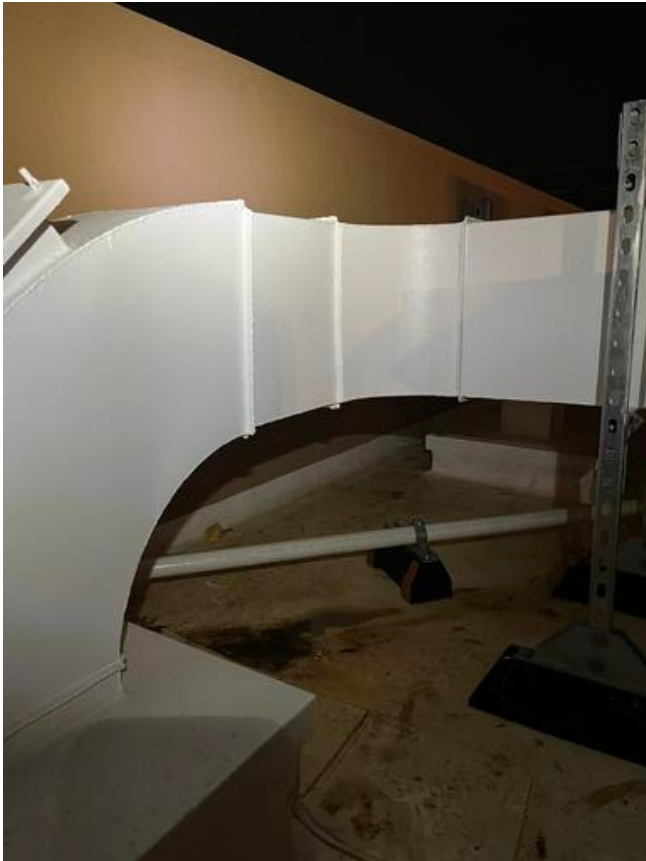
IMG\_7037

## #341 [EXHA 510] [NEW] Grease exhaust duct stands.

EF1 is missing grease duct support stands at duct drops / turn down through the roof. Grease duct should be supported at all duct drops.

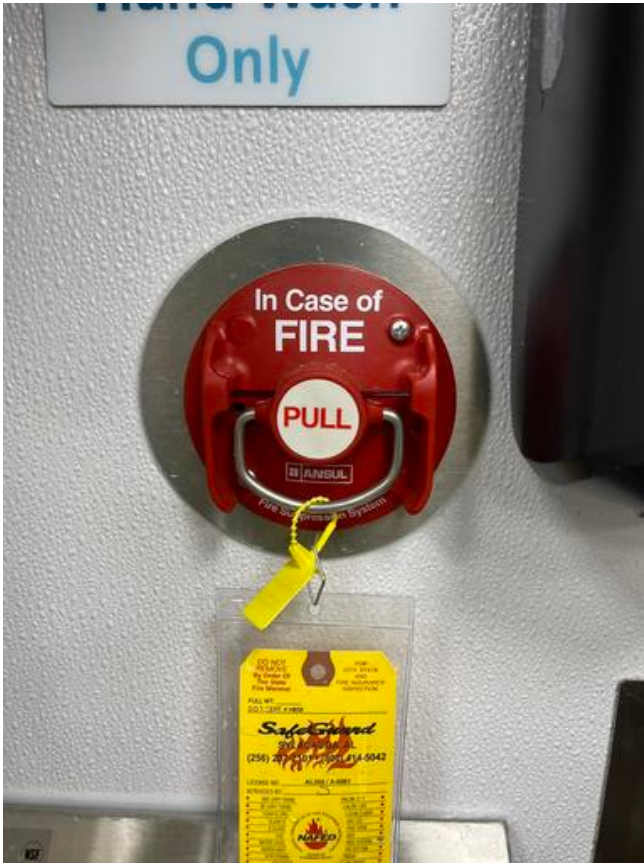
IMG\_7051

## #340 [CNTL 509] [NEW] Ansul pull labeling.

Label all Ansul pull stations  
for which hoods they serve.
