Report: TAB Report
Function: Test, Adjust, & Balance
Date: 03/02/2026
Completed By: National TAB

11-03-25 QT #0830 BUFORD, GA

QUIKTRIP
4705 SOUTH 129TH EAST AVENUE
TULSA, OK 74134

Section	Page #
Summary	3
Balance Schedule	4
Checklist	5
RTU-1	11
RTU-2	13
RTU-3	15
EF-1 - Exhaust	18
Combi-Oven Grille	20
EF-3 - Hood Exhaust	21
Kitchen Hood Type I	23
GRD Layout	25

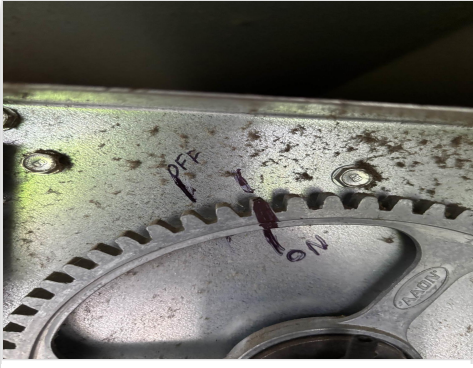
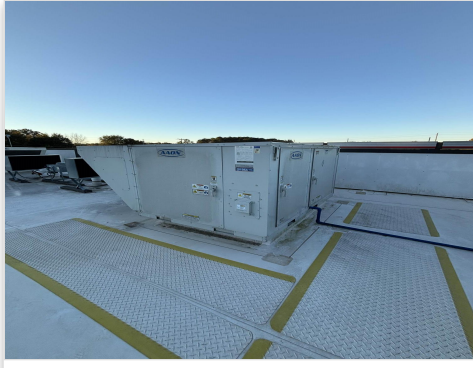
Asset: RT-1

Test Data		
	Design	Actual
SF CFM	4200	4149
SF RPM	-	1496
OA CFM (Hoods On)	800	832
OA CFM (Hoods Off)	350	378
RL Voltage	-	189 VFD
RL Amperage	-	8.62 VFD
VFD Max SetPt	-	51 HZ
VFD Min SetPt	-	24 HZ
OA Damper Position (Hoods On)	-	46%
OA Damper Position (Hoods Off)	-	26%

General	
	Actual
Fan Rotation Correct	YES
Unit Filters Clean	YES
Condensate Drain Installed	YES

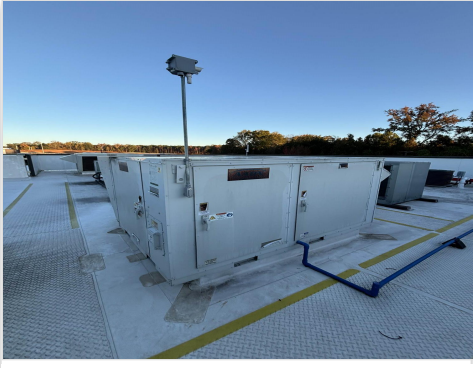
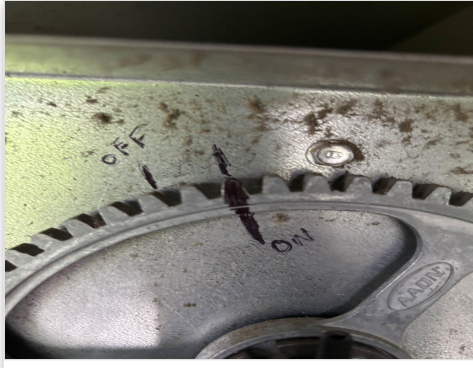
Asset: RT-2

Test Data		
	Design	Actual
SF CFM	4200	4332
SF RPM	-	1408
OA CFM (Hoods On)	800	853
OA CFM (Hoods Off)	350	344
RL Voltage	-	170 VFD
RL Amperage	-	8.31 VFD
VFD Max SetPt	-	48 HZ
VFD Min SetPt	-	24 HZ
OA Damper Position (Hoods On)	-	46%
OA Damper Position (Hoods Off)	-	26%

General	
	Actual
Fan Rotation Correct	YES
Unit Filters Clean	YES
Condensate Drain Installed	YES

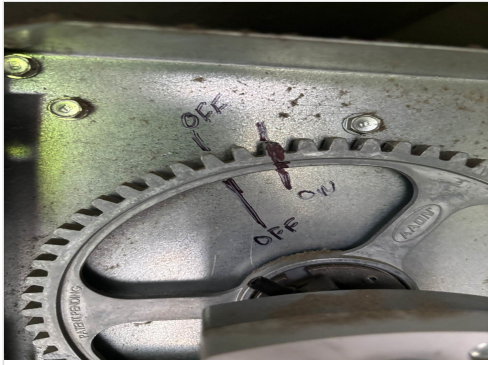
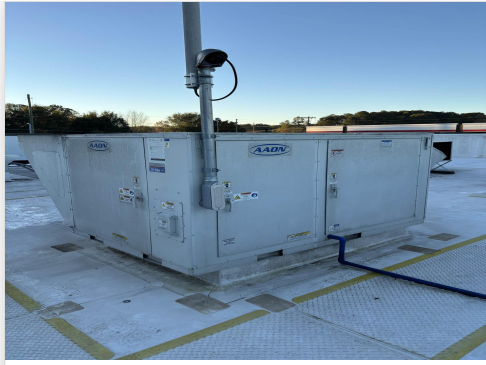
Asset: RT-3

Test Data		
	Design	Actual
SF CFM	4200	3874
SF RPM	-	1496
OA CFM (Hoods On)	800	798
OA CFM (Hoods Off)	350	351
RL Voltage	-	190 VFD
RL Amperage	-	9.16 VFD
VFD Max SetPt	-	51 HZ
VFD Min SetPt	-	24 HZ
OA Damper Position (Hoods On)	-	46%
OA Damper Position (Hoods Off)	-	26%

General	
	Actual
Fan Rotation Correct	YES
Unit Filters Clean	YES
Condensate Drain Installed	YES

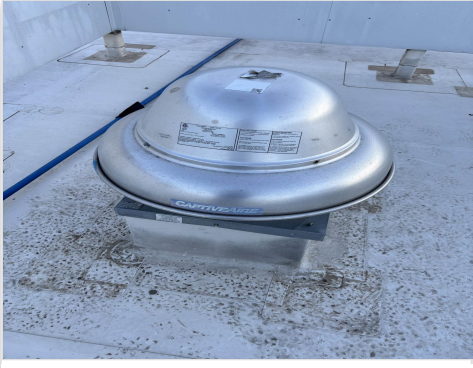
Asset: EF1

Test Data		
	Design	Actual
CFM	850	832
Fan Rotation	-	CCW
System SetPt	-	LOW
RL Voltage	-	[1]
RL Amperage	-	[1]
Total ESP	0.50"	0.34"
Fan Inlet SP	-	-0.34"
Fan Discharge SP	-	1 ATM

[1] UNABLE TO READ VOLTS AND AMPS SAFELY

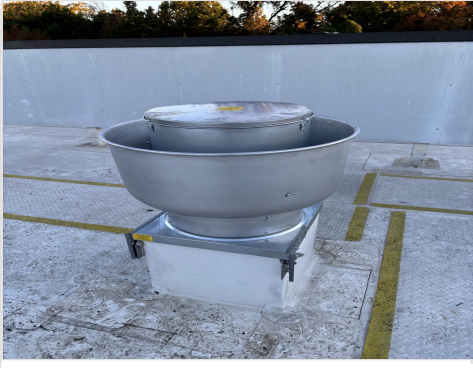
Asset: EF3

Test Data		
	Design	Actual
CFM	1350	1323
Fan RPM	-	1174
Fan Rotation	-	CCW
Motor RPM	-	1174
System SetPt	-	51.8 HZ
RL Voltage	-	211
RL Amperage	-	1.6
Total ESP	0.750"	0.33"
Fan Inlet SP	-	-0.33"
Fan Discharge SP	-	1 ATM

Notes:
64% ON MSC

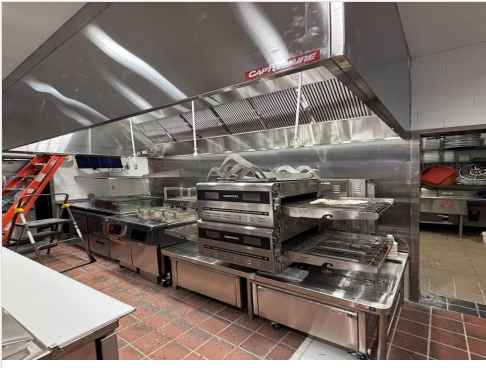
Asset: HD1

Design	Actual
Filter Type	CAPTRATE SOLO FILTER	CAPTRATE SOLO FILTER
Filter Size 1	20X16	20X16
Filter Qty 1	6	6
Filter AK factor size 1	2.08	2.08
Filter Total AK Area	12.48	12.48
Filter1 FPM	-	107
Filter2 FPM	-	106
Filter3 FPM	-	116
Filter4 FPM	-	107
Filter5 FPM	-	108
Filter6 FPM	-	96
Filter Ave FPM(corr)	-	106
CFM	1350	1323
