TAB Punch List CFA 01920 Fairlawn OH

Prepared by Cody Collett

Sep 22, 2025

01920 Montrose // Fairlawn, OH // 2025

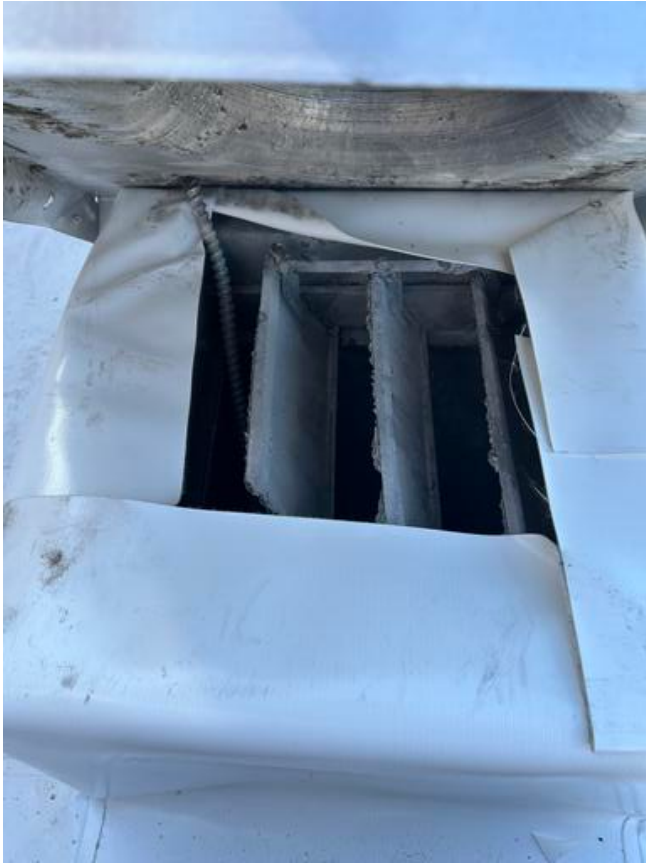
IMG_1127

#246 [EXHA 005] [EXIST] CRITICAL – Restroom fan damper.

Restroom fan backdraft damper is not installed properly or does not move freely. Unable to accurately balance system until corrected.

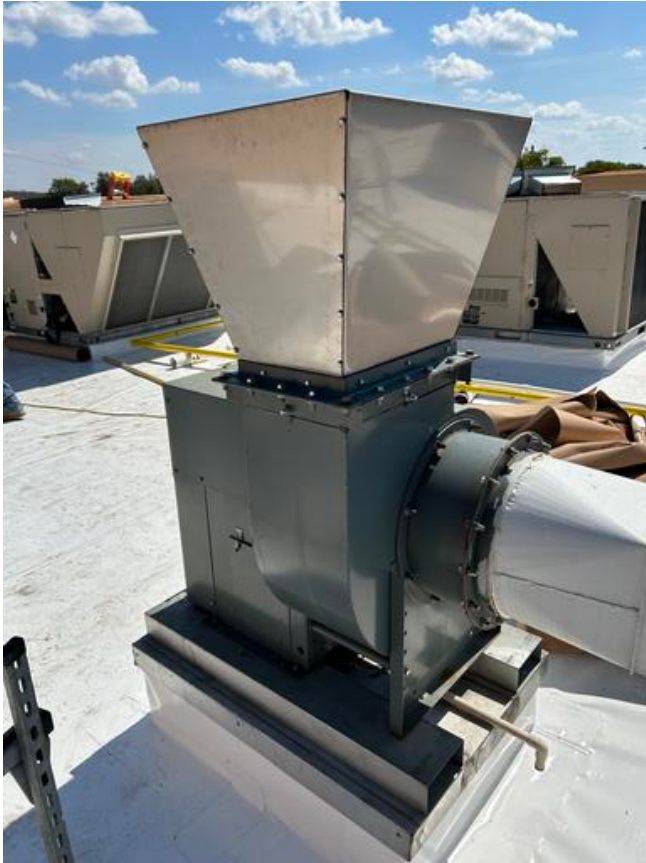
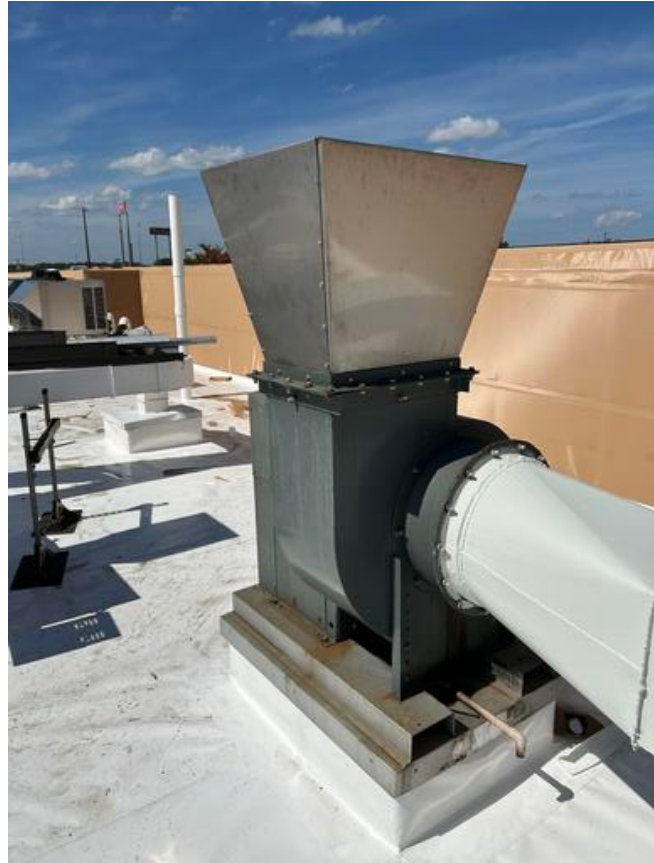
#240 [EXHA 508] [EXIST] Exhaust fan G2 Drip Guard.

Exhaust fan G2 Drip Guard
is not installed correctly or is
missing.

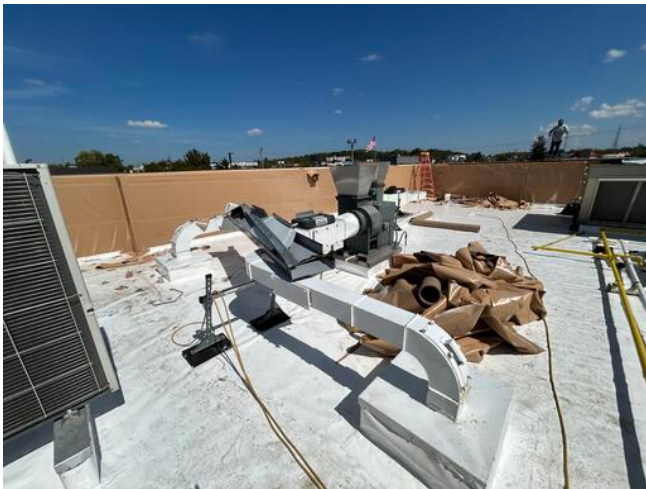
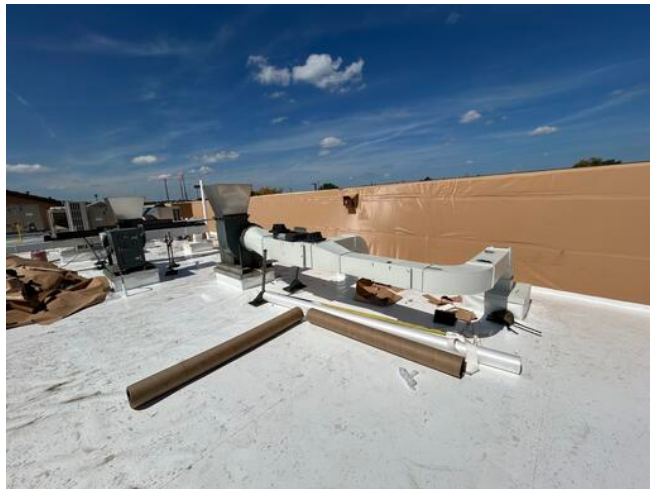
#239 [EXHA 510] [EXIST] Grease exhaust duct is not supported.

Exhaust duct is to be supported per kitchen hood exhaust fan detail on 6'0" centers.

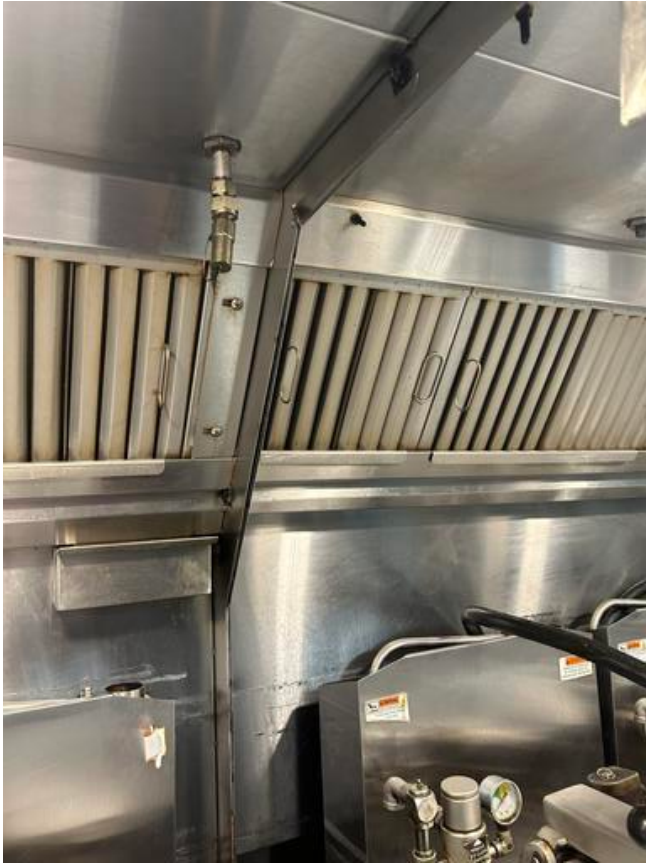
IMG_1136

#237 [HOOD 511] [EXIST] Hood 1L/1R hardware.

Hoods 1L/1R are missing bolting hardware and / or the splice brackets that are to be installed at their midpoint connection seams. (Missing screws for multiple access panels, HD1R-HD1L splice bracket is broken and half is missing.)

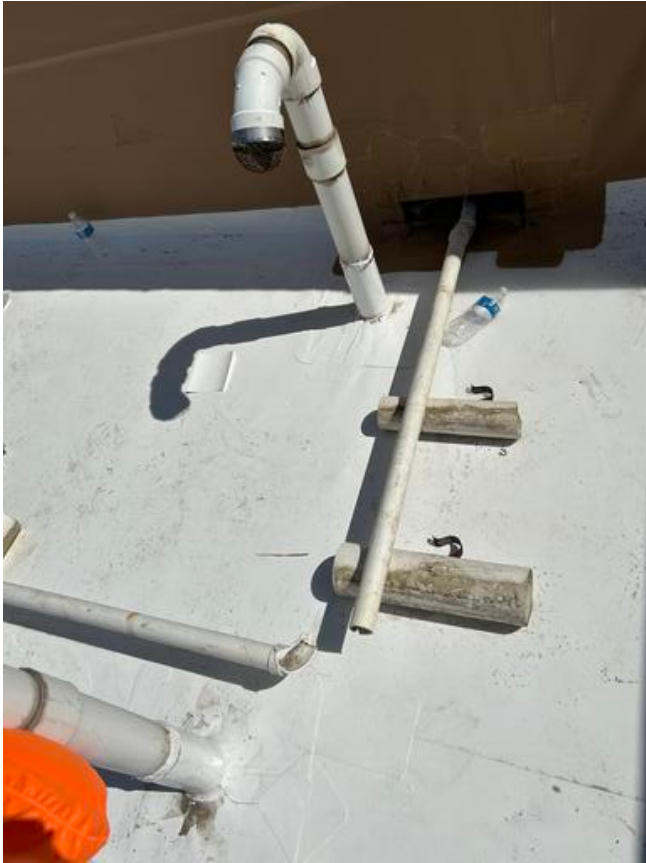
IMG_1159

#235 [UNIT 517] [EXIST] Condensate piping construction.

Equipment condensate piping or p-trap is not constructed per normal CFA specifications.
