Issue List

NCANG Repair Bldg 51 (Charlotte, NC)

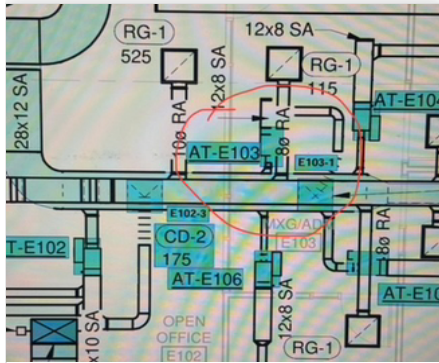
Issue Name : VAV AT-E103 Wrong Location
Description : VAV AT-E103 is installed in the wrong location per the drawings. It should have been installed in MXG/ADM E103 but instead was installed in room OPEN OFFICE E102. A diffuser is installed in room E103, but it is connected to VAV AT-E101, which is incorrect.

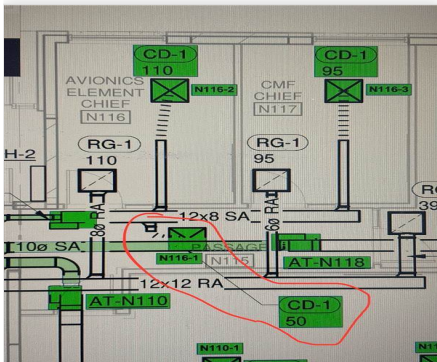
Issue Name : VAV AT-N116 Missing Diffuser
Description : Diffuser missing in Passage N115 (N116-1).
Created By : National TAB **Assigned To :** National TAB - Antonio Flores-De La Cruz
Status : Closed
Priority : Urgent **Asset Tag :**
Originated Date : 11/11/2025 - Antonio Flores-De La Cruz - National TAB

- **02/09/2026** National TAB - Antonio Flores-De La Cruz
 - done
