Issue List

NCANG Repair Bldg 51 (Charlotte, NC)

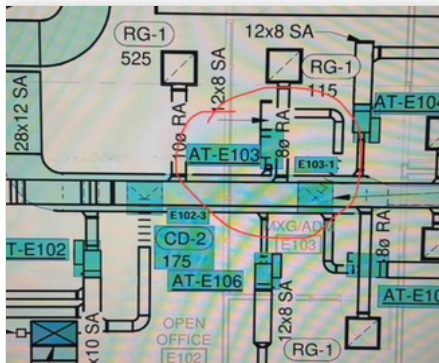
Issue Name : VAV AT-E103 Wrong Location
Description : VAV AT-E103 is installed in the wrong location per the drawings. It should have been installed in MXG/ADM E103 but instead was installed in room OPEN OFFICE E102. A diffuser is installed in room E103, but it is connected to VAV AT-E101, which is incorrect.

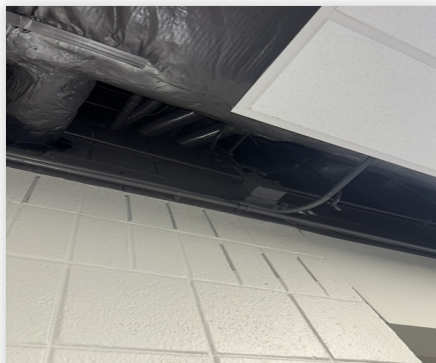
Issue Name : VAV AT-E117 Missing Grille
Description : Diffuser E117-1 in CORRIDOR E115 is missing. Upon inspection, it appears that the duct is attached to the VAV but it stops at the brick wall of room BREAK E117 and doesn't penetrate to the other side.
Created By : National TAB **Assigned To :** National TAB - Antonio Flores-De La Cruz
Status : Open
Priority : **Asset Tag :**
Originated Date : 01/21/2026 - Antonio Flores-De La Cruz - National TAB

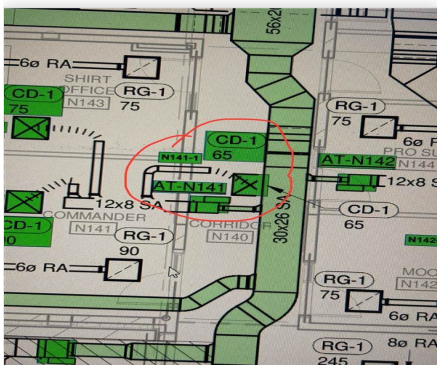
Issue Name : VAV AT-N141 Missing Diffuser
Description : Diffuser in Corridor N140 (N141-1) is missing.
Created By : National TAB **Assigned To :** National TAB - Antonio Flores-De La Cruz
Status : Open
Priority : **Urgent** **Asset Tag :**
Originated Date : 11/11/2025 - Antonio Flores-De La Cruz - National TAB

- **01/21/2026 National TAB - Antonio Flores-De La Cruz**
 - SAW MECHANICAL CONTRACTOR FIXING ISSUE, WILL CHECK
- **11/12/2025 National TAB - Antonio Flores-De La Cruz**
 - Diffuser was installed, but after attempting to balance, the supply grille in Shirt Office N143 (N141-2) is swapped with the grille for the return. It must be swapped.
