**Report: TAB Report**  
**Function: Test, Adjust, & Balance**  
**Date: 04/21/2025**  
**Completed By: National TAB**

## 04-14-25 CHIPOTLE #5397 MORGANTON, NC

Project: 04-14-25 CHIPOTLE #5397 MORGANTON, NC

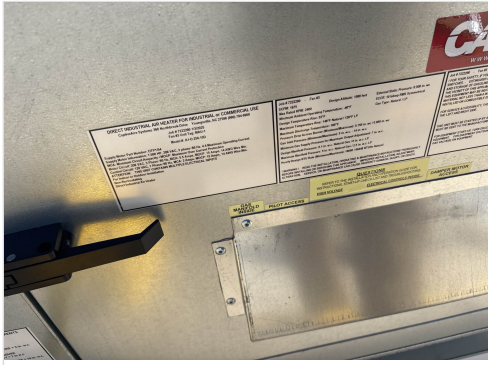
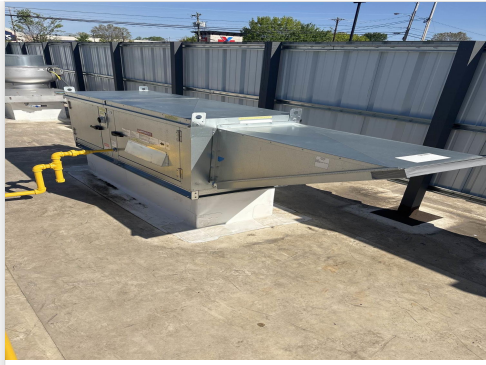
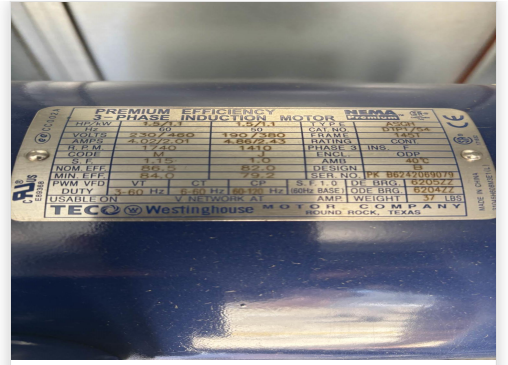
# Unit Data - PHOTO LOG

intake is 1823, discharge is 948. no dampers on connection to hood or from the run. all runs come off the top of the MAU. see issues.
