**Report: Final TAB Report  
Function: Test, Adjust, & Balance  
Date: 8/24/2022**

**PROJECT  
08-08 PENN STATION - SPRINGFIELD, OH**

Project: 08-08 PENN STATION - SPRINGFIELD, OH

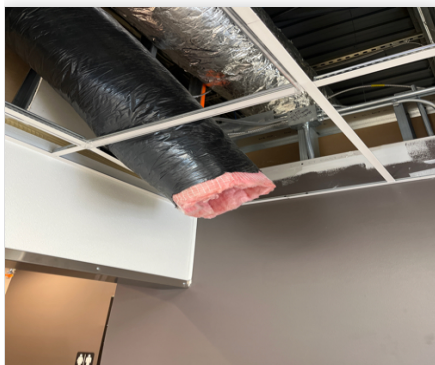
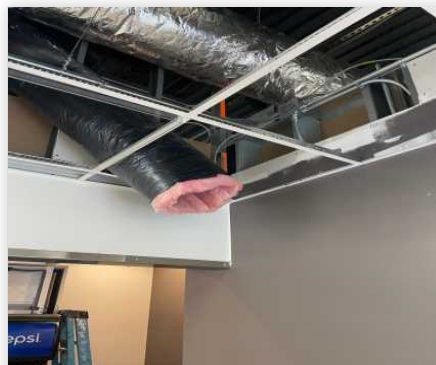
MISSING\_DIFFUSER.jpg

**Issue Name :** Diffuser missing

**Description :** One air duct is missing a diffuser in the kitchen. (diffuser 1-8)

| All diffusers and grilles are installed and match design? | NO - ISSUES MADE (DIFFUSER 1-8 MISSING AS WELL AS BATHROOM EXHAUST FAN) |

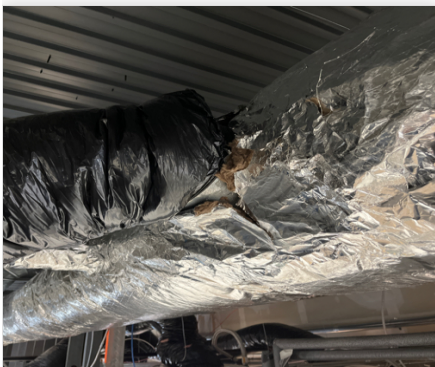
**Issue Name :** No damper  
**Description :** No damper on diffuser 2-4  
**Created By :** National TAB                      **Assigned To :** National TAB - Joe Hertenstein  
**Status :** Open  
**Originated Date :** 08/10/2022 - Jack Bain - National TAB

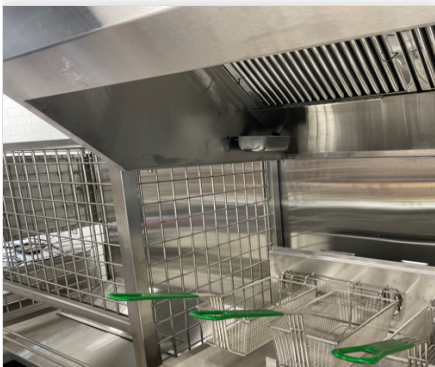
**Issue Name :** No end panel on hood 3

**Description :** No end panel on hood 3
