Issue List

03-02-26 QT #0739 TUCKER, GA

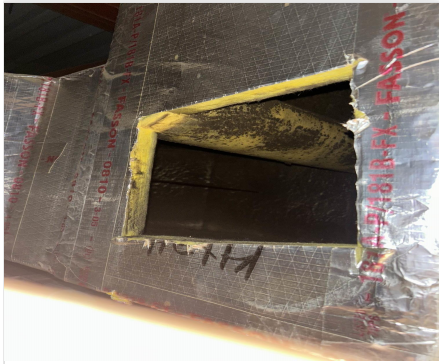
Issue Name : RTU-1 Duct Leakage
Description : At the supply drop of RTU-1 there is a duct leakage causing the unit to be unable to be balanced.
Created By : National TAB **Assigned To :** National TAB - Dan Hertenstein
Status : Open
Priority : Urgent **Asset Tag :**
Originated Date : 03/04/2026 - Anthony Taylor - National TAB
