Report: TAB Report
Function: Test, Adjust, & Balance
Date: 03/04/2026
Completed By: National TAB

03-02-26 QT #0758 DOUGLASVILLE, GA

2786 CHAPEL HILL RD

QUIKTRIP
4705 SOUTH 129TH EAST AVENUE
TULSA, OK 74134

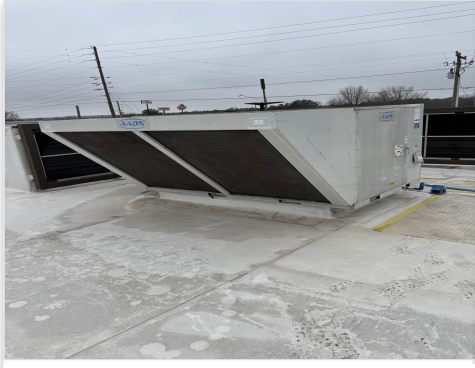
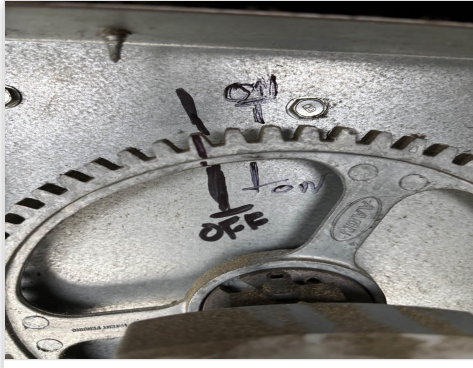
Unit Data - PHOTO LOG

Asset: RT-1

Unit Data	
	Actual
MFG	AAON
Serial Num	201906-ANEK19102
Model Num	RN-013-8-0-EA09-152
Num OA Filters 1	1
OA Filter Size 1	22X45
Num Final Filter 1	4
Final Filter Size 1	20X25X2

Test Data		
	Design	Actual
SF CFM	4200	4513
SF RPM	-	1179
OA CFM (Hoods On)	800	812
OA CFM (Hoods Off)	350	344
RL Voltage	-	125 VFD
RL Amperage	-	8.44 VFD
VFD Max SetPt	-	40.2 Hz
VFD Min SetPt	-	24 Hz
OA Damper Position (Hoods On)	-	46%
OA Damper Position (Hoods Off)	-	26%

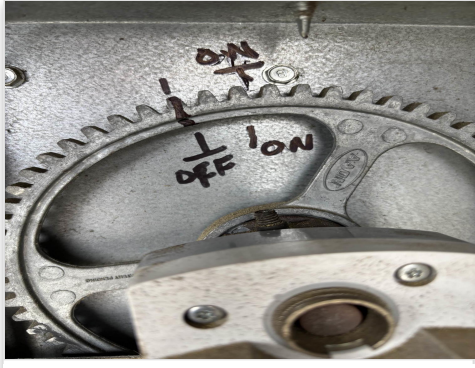
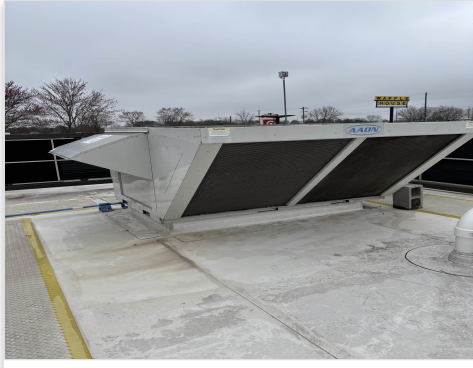
Unit Data - PHOTO LOG

Asset: RT-2

Unit Data	
	Actual
MFG	AAON
Serial Num	201906-ANEK19101
Model Num	RN-013-8-0-EA09-152
Num OA Filters 1	1
OA Filter Size 1	22X45
Num Final Filter 1	4
Final Filter Size 1	20X25X2

Test Data		
	Design	Actual
SF CFM	4200	4373
SF RPM	-	1197
OA CFM (Hoods On)	800	784
OA CFM (Hoods Off)	350	358
RL Voltage	-	128 VFD
RL Amperage	-	8.13 VFD
VFD Max SetPt	-	40.8 Hz
VFD Min SetPt	-	24 Hz
OA Damper Position (Hoods On)	-	46%
OA Damper Position (Hoods Off)	-	27%

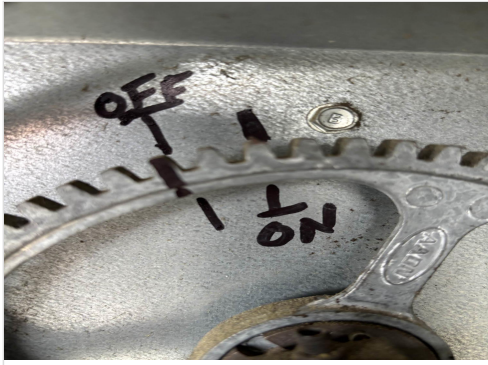
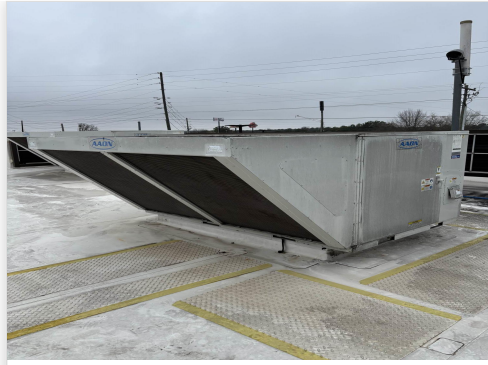
Unit Data - PHOTO LOG

Asset: RT-3

Unit Data	
	Actual
MFG	AAON
Serial Num	201906-ANEK19100
Model Num	RN-013-8-0-EA09-152
Num OA Filters 1	1
OA Filter Size 1	22X45
Num Final Filter 1	4
Final Filter Size 1	20X25X2

Test Data		
	Design	Actual
SF CFM	4200	4024
SF RPM	-	1179
OA CFM (Hoods On)	800	805
OA CFM (Hoods Off)	350	351
RL Voltage	-	125 VFD
RL Amperage	-	8.64 VFD
VFD Max SetPt	-	40.2 Hz
VFD Min SetPt	-	24 Hz
OA Damper Position (Hoods On)	-	46%
OA Damper Position (Hoods Off)	-	26%

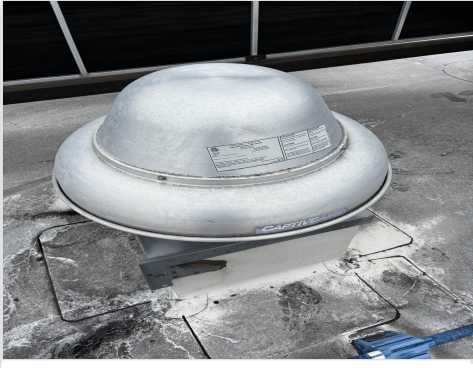
Unit Data - PHOTO LOG

Asset: EF-1

Unit Data	
	Actual
MFG	CAPTIVEAIRE
Model Num	DR50HFA
Serial Num	3882330
Type	DOWNBLAST
Configuration	VERTICAL

Test Data		
	Design	Actual
CFM	750	744
Fan Rotation	-	CCW
System SetPt	-	MEDIUM LOW
RL Voltage	-	[1]
RL Amperage	-	[1]
Total ESP	-	0.64"
Fan Inlet SP	-	-0.64"
Fan Discharge SP	-	ATM

Notes:
[1] UNABLE TO READ VOLTS AND AMPS SAFELY

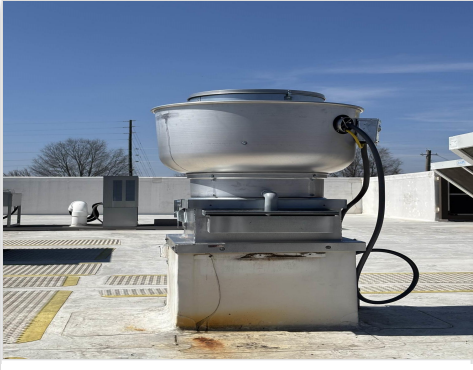
Unit Data - PHOTO LOG

Asset: EF-3

Unit Data		
	Design	Actual
MFG	NA	CAPTIVEAIRE
Model Num	NA	DU50HFA
Serial Num	-	8385033
Type	UPBLAST	UPBLAST
Configuration	VERTICAL	VERTICAL

Test Data		
	Design	Actual
CFM	1350	1373
Fan RPM	-	1172
Fan Rotation	-	CCW
Motor RPM	-	1172
System SetPt	-	52.6 Hz (65% on MSC)
RL Voltage	-	213
RL Amperage	-	1.9
Total ESP	0.75"	0.38"
Fan Inlet SP	-	-0.38"
Fan Discharge SP	-	ATM

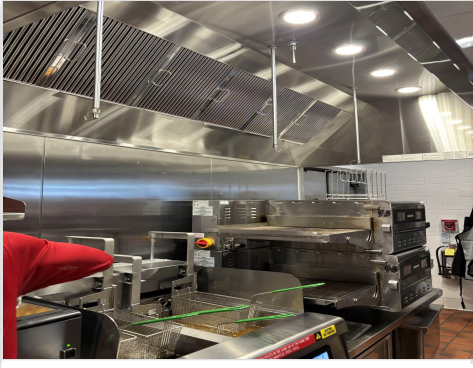
Unit Data - PHOTO LOG

Asset: HD-1

Unit Data		
	Design	Actual
MFG	CAPTIVEAIRE	CAPTIVEAIRE
Model Num	6030ND-2-F	6030ND-2-F
Job / Serial Num	-	8385033
Type	TYPE I CANOPY	TYPE I CANOPY
Hood length	108"	108"
Hood Width	60"	60"

Test Data Exhaust		
	Design	Actual
Filter Type	CAPTRATE SOLO FILTER	CAPTRATE SOLO FILTER
Filter Size 1	20X16	20X16
Filter Qty 1	6	6
Filter AK factor size 1	2.08	2.08
Filter Total AK Area	12.48	12.48
Filter1 FPM	-	101
Filter2 FPM	-	107
Filter3 FPM	-	113
Filter4 FPM	-	123
Filter5 FPM	-	116
Filter6 FPM	-	104
Filter Ave FPM(corr)	-	110
CFM	1350	1373
