Report: TAB REPORT
Function: Test, Adjust, & Balance
Date: 11/12/2024
Completed By: National TAB

PROJECT
Warby Parker (Liberty Twp, OH)

Project: Warby Parker (Liberty Twp, OH)

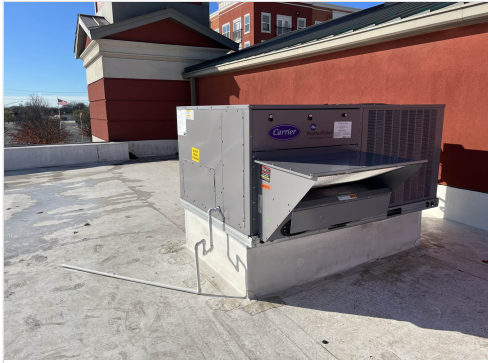
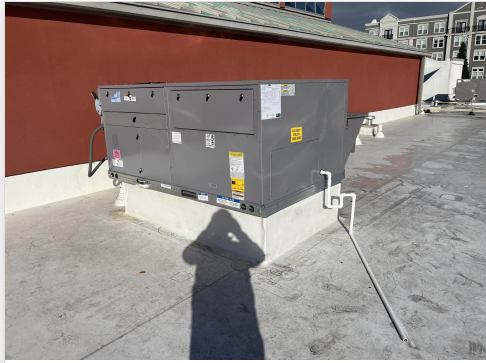
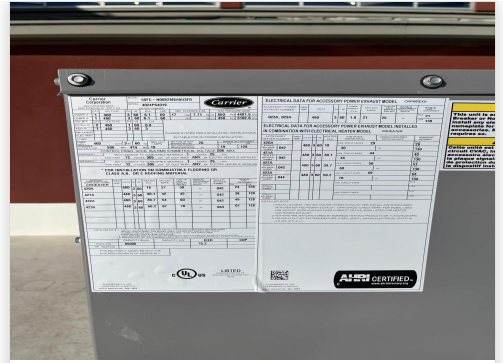
Unit Data - PHOTO LOG

Notes:
 Final BP -0.03"
 BP with equipment off -0.04
 Building is not a stand alone building and there are multiple KEF's serving other spaces.

Unit total flows are in design; diffusers were opened or closed as much as they would allow to bring each one as close to design as possible.

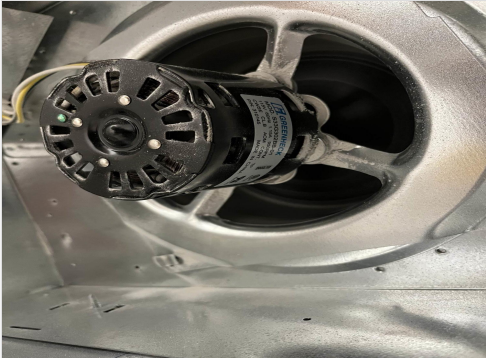
Motor Data - PHOTO LOG

Notes:
Single speed fan; unable to reduce CFM.

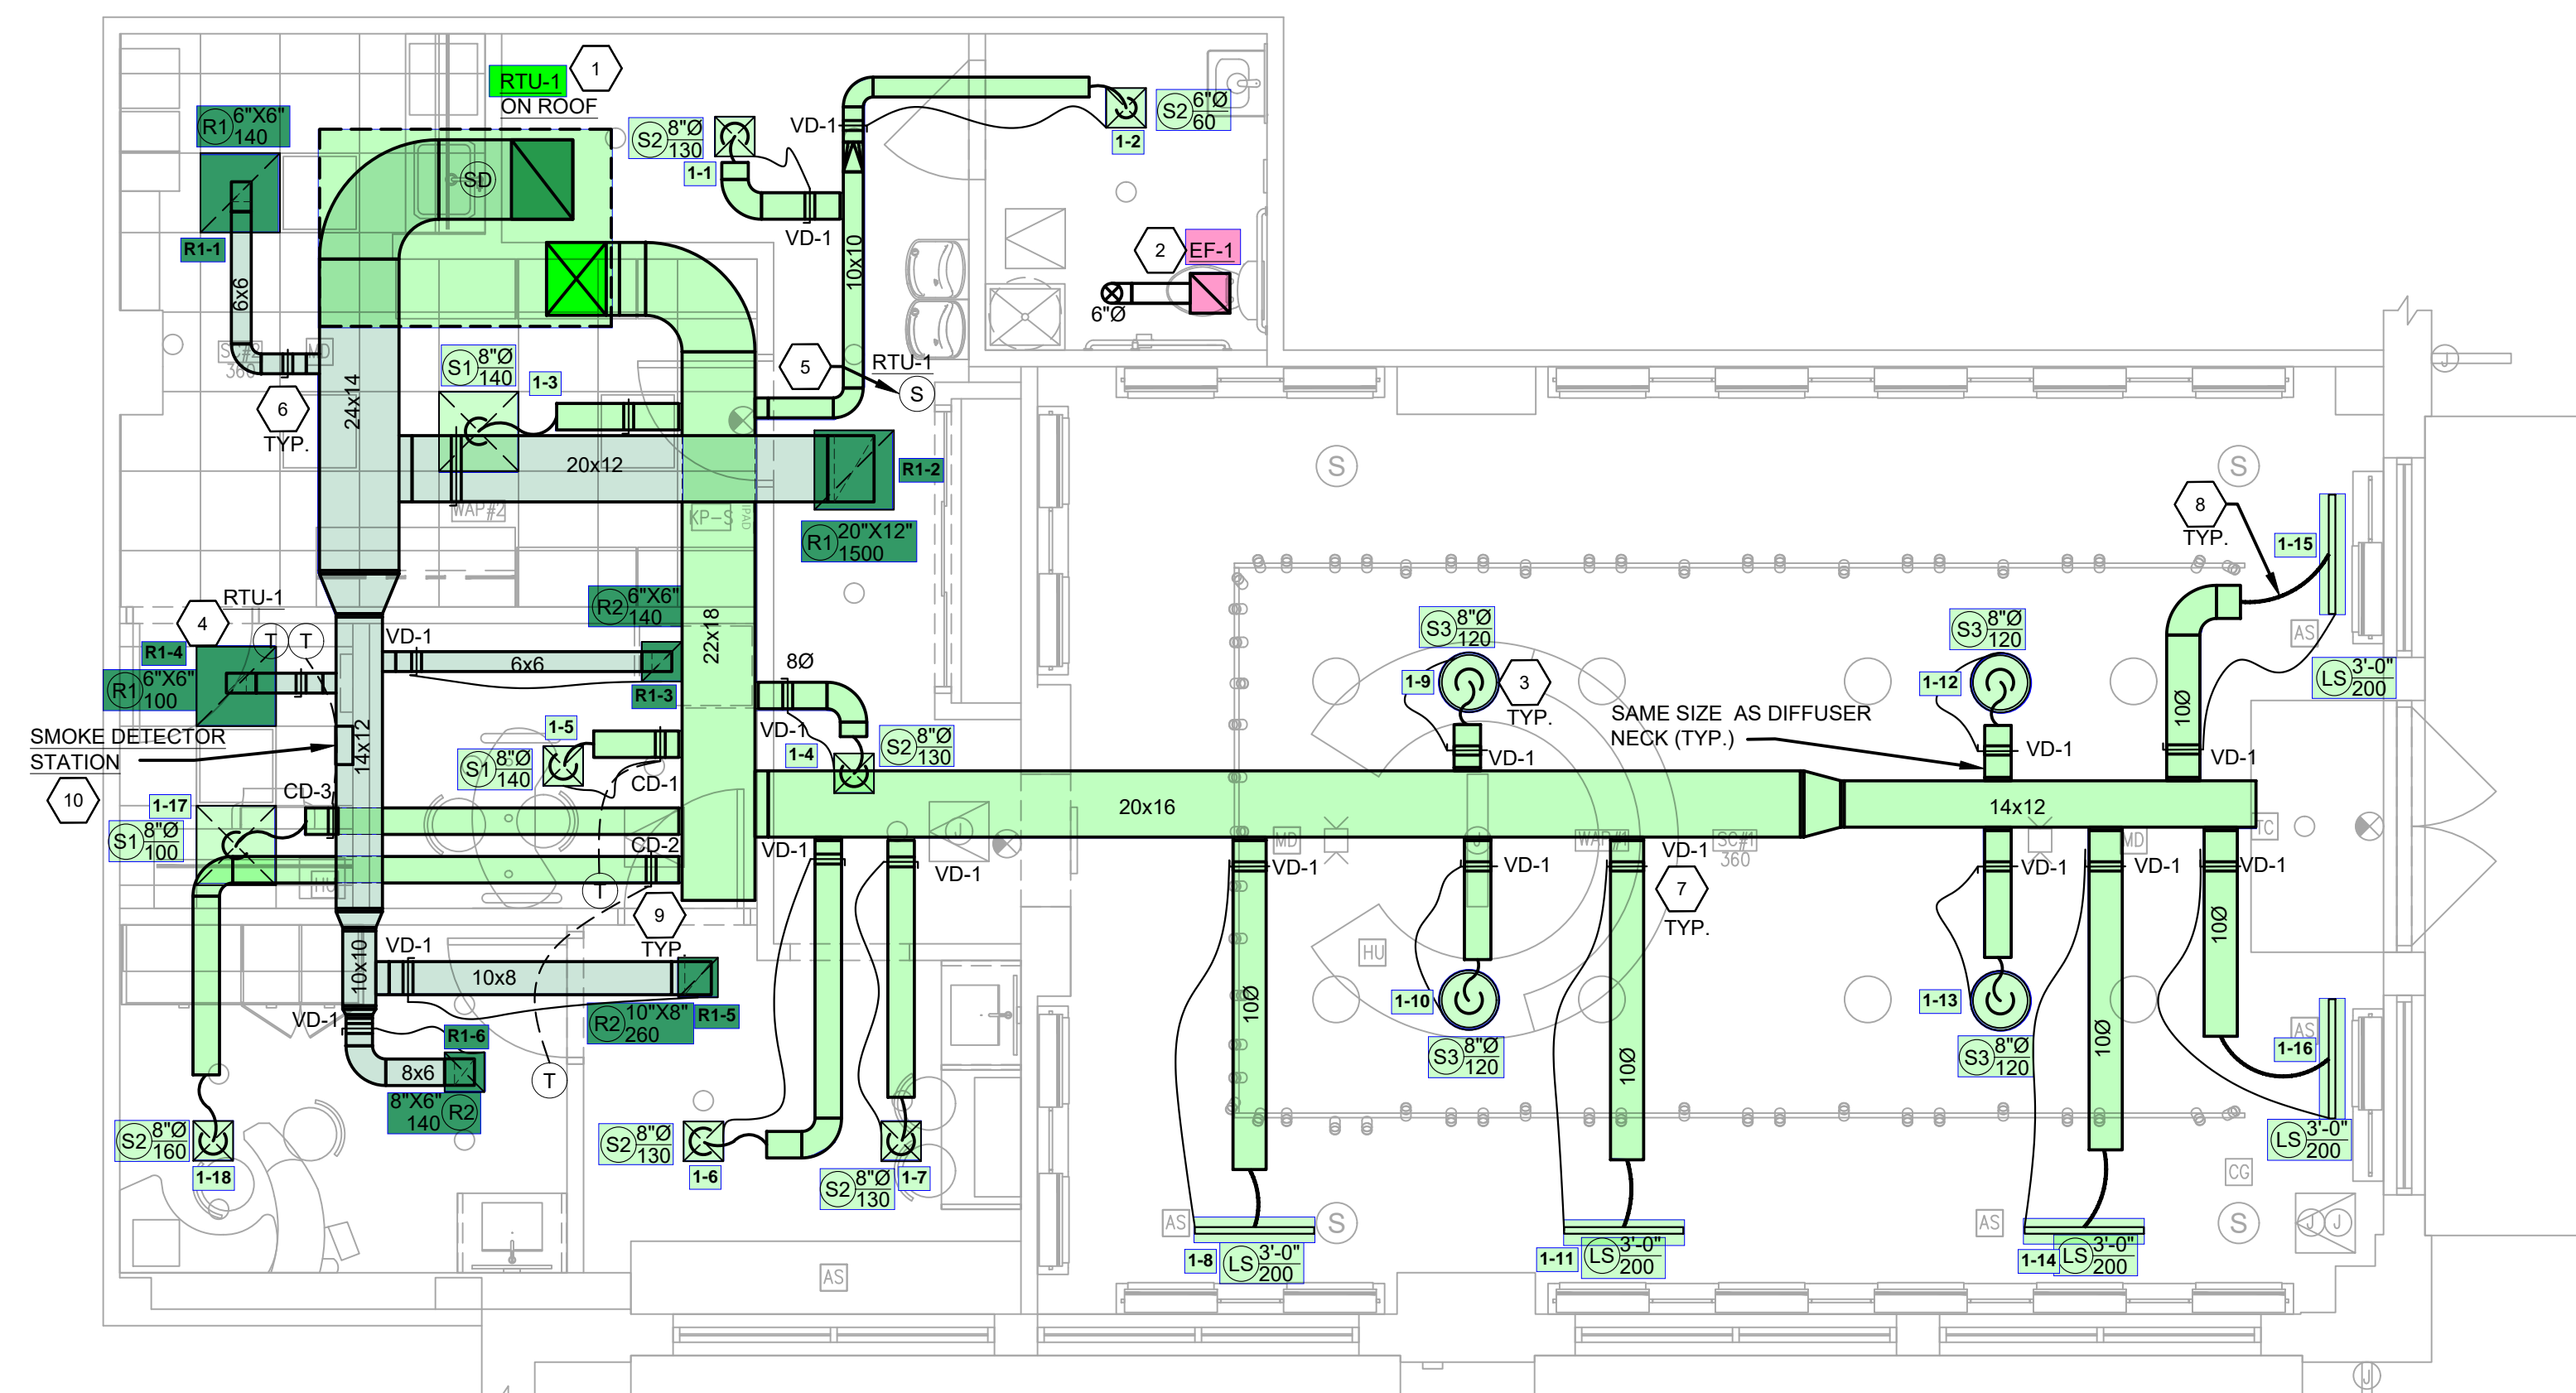
1 MECHANICAL PLAN
SCALE: 1/4" = 1'-0"

- 1. INSTALL NEW RTU PER MANUFACTURER'S IOM AND MAINTAIN CLEARANCES. TRANSITION DUCT TO FULL SIZE CONNECTION AT UNIT AS REQUIRED. REFER TO DETAIL 9/M-103.

- 2. PROVIDE NEW TOILET EXHAUST FAN PER SCHEDULE ON M-101. INTERLOCK FAN WITH LIGHT SWITCH. NEW 6" EXHAUST DUCT UP TO ROOF AND TERMINATE INTO A ROOF CAP, EQUIVALENT TO GREENHECK MODEL GRSR SIZE 8. PROVIDE WITH INTEGRAL BIRDSCREEN, PREFABRICATED ROOF CURB AND GRAVITY BACKDRAFT DAMPER. FIELD VERIFY LOCATION AND DISTANCE IN FIELD TO MAINTAIN A MINIMUM DISTANCE OF 10" FROM AIR INTAKE.

- 3. 1-SLOT ROUND DIFFUSER. COORDINATE DIFFUSER LOCATION WITH TRACK LIGHTS, SPEAKERS AND EXISTING STRUCTURE. TRACK LIGHTS AND SPEAKER LOCATIONS SHALL NOT HAVE TO BE RELOCATED WITHOUT PRIOR APPROVAL FROM ARCHITECT AND/OR WARBY PARKER PM. MECHANICAL CONTRACTOR SHALL COORDINATE DIFFUSER LAYOUTS WITH ALL SUB-CRONTACTORS AND TRADES. PRIOR TO ANY FABRICATION OF DUCTWORK.

- 6. PROVIDE MANUAL VOLUME DAMPER WITH LOCKING QUADRANT IN EASILY ACCESSIBLE LOCATION WHEN POSSIBLE. PROVIDE DIFFUSER MOUNTED DAMPERS WHERE DUCT MOUNTED DAMPER WOULD BE INACCESSIBLE. TYPICAL OF BACK OF HOUSE.
