Report: TAB Report
Function: Test, Adjust, & Balance
Date: 01/21/2026
Completed By: Wesley John

PROJECT
01-19-26 CHIPOTLE #5470 Edinburg, TX

Project: 01-19-26 CHIPOTLE #5470 Edinburg, TX

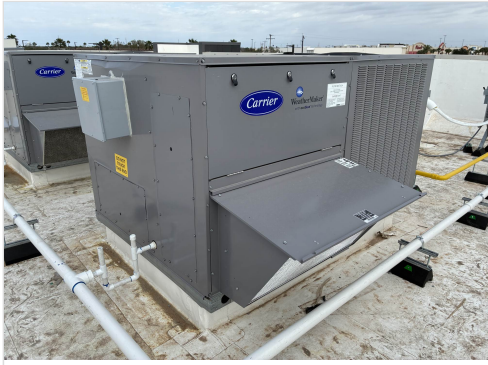
Unit Data - PHOTO LOG

Asset: RTU1

| Unit Data | | |
|---|---|---|
| Model Num | 48FCFN12 | 48FCFN12D3M5A6W4F0 |

| Performance Data | | |
|---|---|---|
| Total ESP | 1.00" | 1.25" |

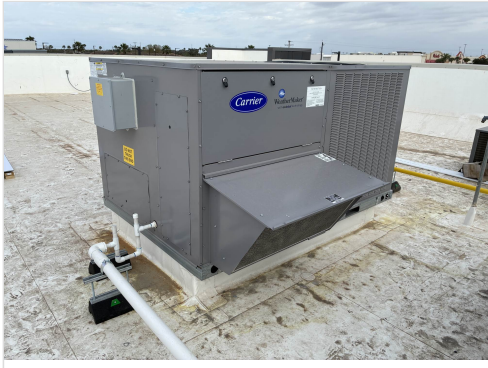
Unit Data - PHOTO LOG

Asset: RTU2

| Unit Data | | |
|---|---|---|
| Model Num | 48FCFN12 | 48FCFN12D3M5A6W4F0 |

| Performance Data | | |
|---|---|---|
| Total ESP | 1.00" | 1.03" |

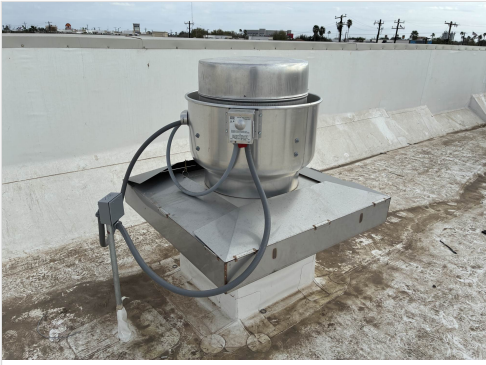
Unit Data - PHOTO LOG

Asset: EF1

| Unit Data | | |
|---|---|---|
| Model Num | XCUE-160-VG | XCUE-160-20-VG-1-26-G |

| Test Data | | |
|---|---|---|
| Total ESP | 1.2" | 1.08" |

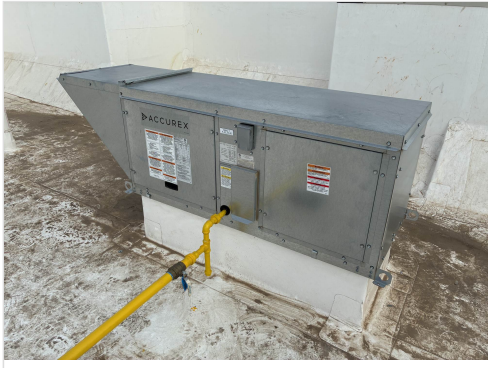
Unit Data - PHOTO LOG

GAS PIPING INSTALLED BUT GAS VALVE IN OFF POSITION. MAU GAS HEAT NOT TESTED.

Asset: MAU1

| Unit Data | | |
|---|---|---|
| Model Num | XDGX-P115-H05-VG | XDGX-P115-H05-VG |

[1] GAS TO MAU WAS TURNED OFF. GAS HEAT NOT TESTED.
