Report: TAB Punchlist
Function: Test, Adjust, & Balance
Date: 01/06/2025
Completed By: National TAB

12-30-24 CAVA BRUNSWICK, NJ (MIDSTATE MALL)

Project: 12-30-24 CAVA BRUNSWICK, NJ (MIDSTATE MALL)

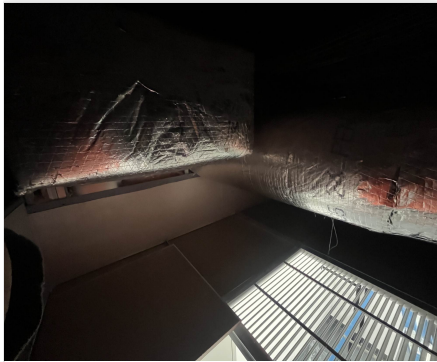
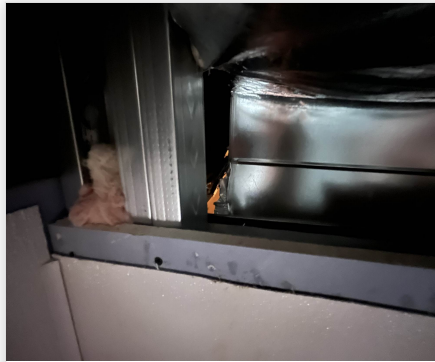
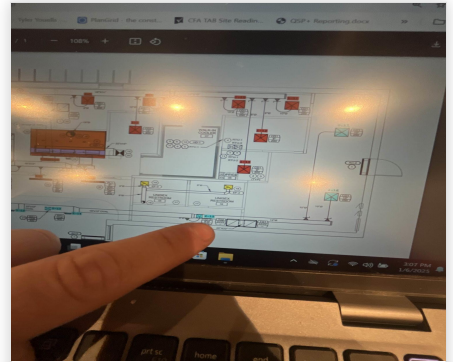
Issue Name : Dining-BOH Transfer Grille
Description : Transfer grille is not connected from dining corridor to the BOH storage room. Duct connection at the one grille is not well sealed.
Created By : National TAB **Assigned To :** National TAB - Tyler Youells
Status : Open
Priority : Low **Asset Tag :**
Originated Date : 01/06/2025 - Tyler Youells - National TAB

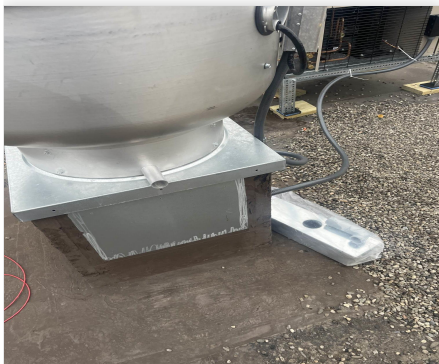
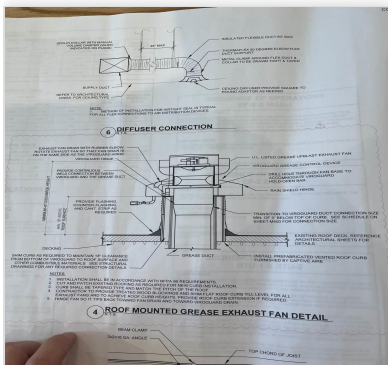
Issue Name : KEF-1 Grease cup
Description : KEF-1 Grease cup is not yet installed. Grease will drip onto roof when cooking starts
Created By : National TAB **Assigned To :** National TAB - Tyler Youells
Status : Open
Priority : Low **Asset Tag :**
Originated Date : 01/06/2025 - Tyler Youells - National TAB

- **01/06/2025 National TAB - Tyler Youells**
 - PER Revision KEF-1 is supposed to have a Viroguard Grease trough installed and not a grease cup.

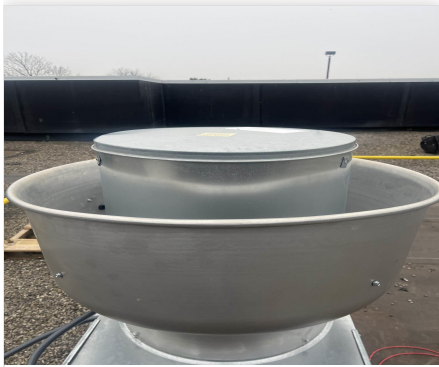
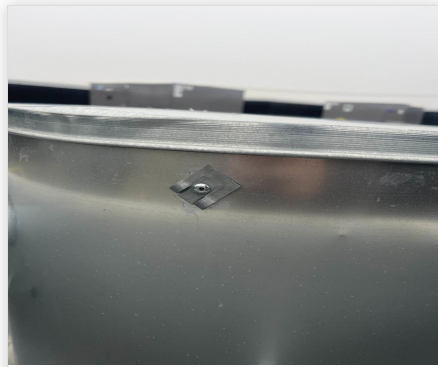
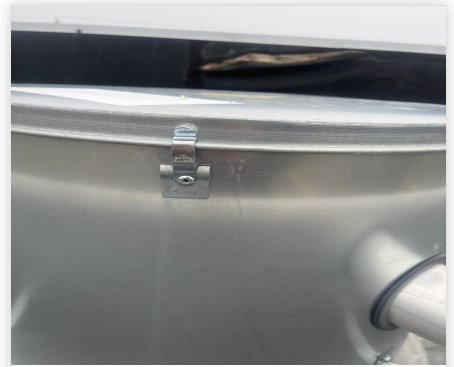
Issue Name : KEF-1 Lid latches
Description : The kid on KEF-1 is missing two of the three latches.
Created By : National TAB **Assigned To :** National TAB - Tyler Youells
Status : Open
Priority : Low **Asset Tag :**
Originated Date : 01/06/2025 - Tyler Youells - National TAB

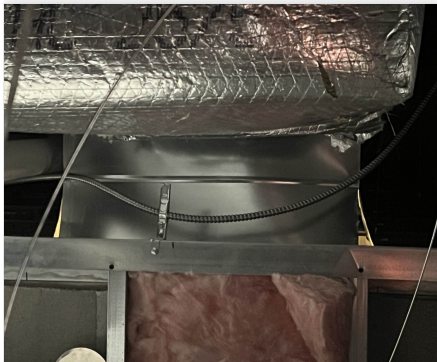
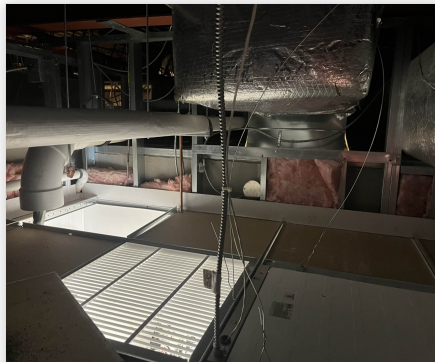
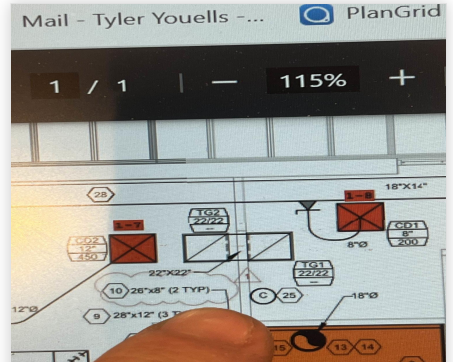
Issue Name : Kitchen Transfer Grille
Description : Kitchen Transfer grille is not connected to the BOH side. Kitchen side is also not sealed to the grille.
Created By : National TAB **Assigned To :** National TAB - Tyler Youells
Status : Open
Priority : Low **Asset Tag :**
Originated Date : 01/06/2025 - Tyler Youells - National TAB
