Report: TAB Report
Function: Test, Adjust, & Balance
Date: 6/10/2022

PROJECT
05-30 CULVERS - WILDWOOD, FL

Project: 05-30 CULVERS - WILDWOOD, FL

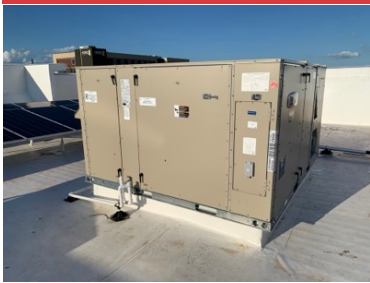
RTU 1

Asset: RTU1

Test Data		
	Design	Actual
SF CFM	5200	5243
SF RPM	-	646
RA CFM	4300	4376
OA CFM	900	867
RL Voltage	-	209/210/212
RL Amperage	-	4.9/4.8/5.3
SF Rotation	-	CCW
RA Damper Position	-	100%
Min OA Damper Position	-	47%
Min OA Damper Type	-	ECONOMIZER
Brake Horse Power	-	1.75

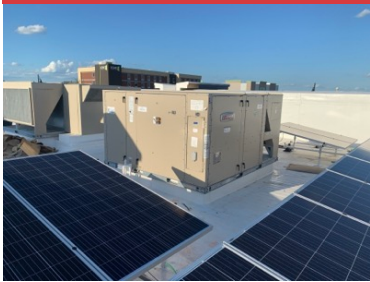
RTU 2

Asset: RTU2

Test Data		
	Design	Actual
SF CFM	5000	4741
SF RPM	-	631
RA CFM	4050	3800
OA CFM	950	941
RL Voltage	-	209/210/208
RL Amperage	-	4.6/4.2/4.9
SF Rotation	-	CCW
RA Damper Position	-	100%
Min OA Damper Position	-	50%
Min OA Damper Type	-	OBD
Brake Horse Power	-	1.60

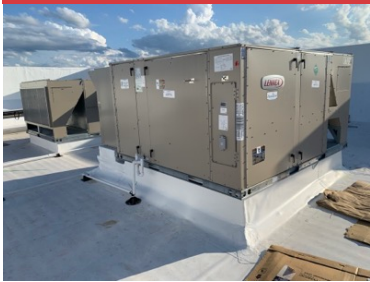
RTU OA

Asset: RTU-OA3

Test Data		
	Design	Actual
SF CFM	3250	3279
SF RPM	-	578
RA CFM	1250	1259
OA CFM	2000	2020
RL Voltage	-	209/211/209
RL Amperage	-	4.5/4.6/4.8
SF Rotation	-	CCW
RA Damper Position	-	3/4
Min OA Damper Position	-	100%
Min OA Damper Type	-	OBD
Brake Horse Power	-	1.63

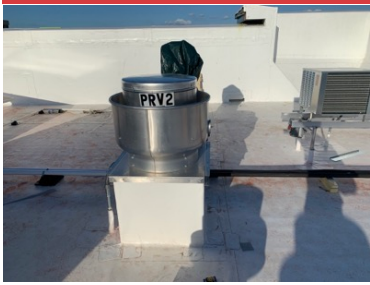
PRV 2

Asset: PRV2

Test Data		
	Design	Actual
CFM	1500	1395
Fan RPM	2411	2412
Fan Rotation	-	CW
Motor RPM	-	1769
RL Voltage	-	208/209/209
RL Amperage	-	3.3/3.3/3.5
Suction ESP	-	-0.77"
Discharge ESP	-	ATM
Total ESP	2.337"	0.77"

Notes:[1] SEVERE FAN BLADE INTERERENCE. MC AWARE AND WORKING ON FAN. // RESOLVED.

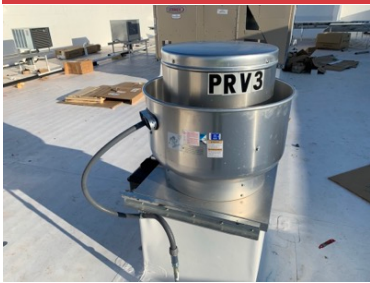
PRV 3

Asset: PRV3

Test Data		
	Design	Actual
CFM	1500	1545
Fan RPM	1377	1260
Fan Rotation	-	CW
Motor RPM	-	1777
RL Voltage	-	209/210/211
RL Amperage	-	1.6/1.7/1.6
Suction ESP	-	-0.86"
Discharge ESP	-	ATM
Total ESP	1.0"	0.86"

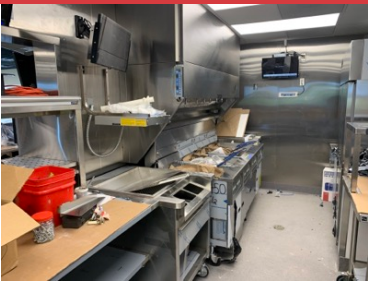
HOOD 1

Asset: HD1

Performance Data		
	Design	Actual
Smoke Generation Type	-	SMOKE EMITTER
Hood Capture %	-	100%
End Panels Installed (Y/N)	-	YES

Test Data Exhaust		
	Design	Actual
Filter Type	XTRACTOR	XTRACTOR
Filter Size 1	16X16	16X16
Filter Qty 1	5	5
Filter AK factor size 1	1.53	1.53
Filter Total AK Area	7.65	7.65
Filter1 FPM	-	213
Filter2 FPM	-	198
Filter3 FPM	-	192
Filter4 FPM	-	191
Filter5 FPM	-	218
Filter Ave FPM(corr)	-	202
CFM	-	1545
