Report: Issue Report
Function: Test, Adjust, & Balance
Date: 12/09/2024
Completed By: National TAB

PROJECT
12-09-24 CULVERS PRINCETON, MN

Issue List

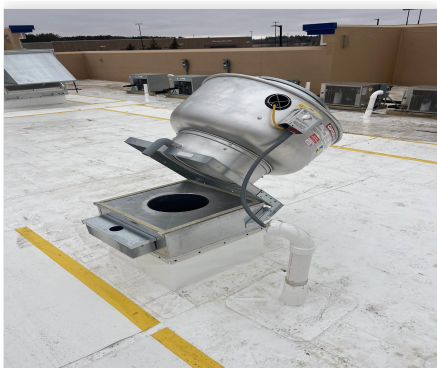
Issue Name : PRV-2: Electrical Conduit Length
Description : When fan is leaned back, electrical conduit is completely tight and prevents fan from fully Leaning back. This will likely lead to damage when fans are cleaned. Recommend conduit is lengthened.
Created By : National TAB **Assigned To :** National TAB - Dan Hertenstein
Status : Open
Priority : Medium **Asset Tag :**
Originated Date : 12/09/2024 - Michael McDonnell - National TAB

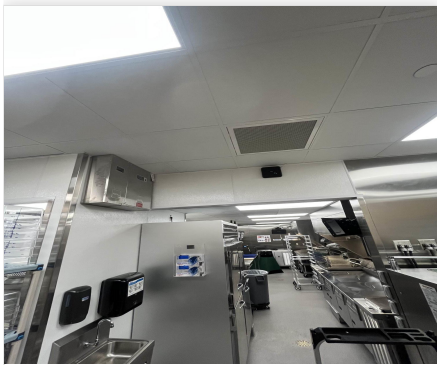
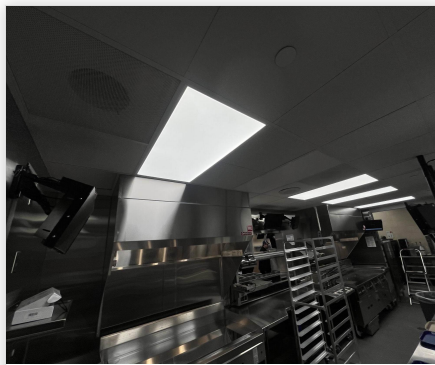
Issue Name : RTU-2: Diffuser / Return Locations
Description : Cookline Diffuser 1-7 is not in correct position per plans. It's important cookline diffusers are installed per plan for hood capture. Additionally, a return is out of location and positioned immediately to right of hood. Recommend diffusers and grilles are installed per plan.
