**National TAB
1329 E. KEMPER ROAD
SUITE 4210
CINCINNATI, OH 45246**

**Report: DEFICIENCY REPORT
Function: Test, Adjust, & Balance
Date: 11/14/2022**

**PROJECT
11-14 CHICK-FIL-A #02053 - WAYCROSS, GA
(WAYCROSS FSU) REINVEST**

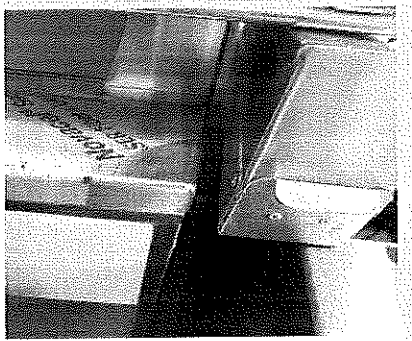
FuseITe739b2d4a8c4491...

Issue Name : Hood 2 Side Bracket Not Installed

Description : The side bracket is not installed on hood 2.

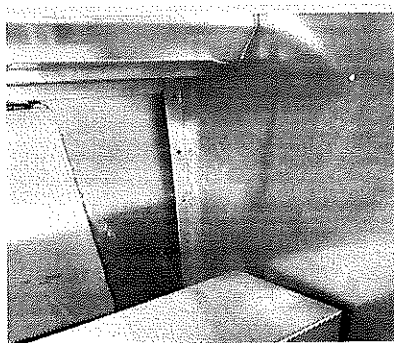
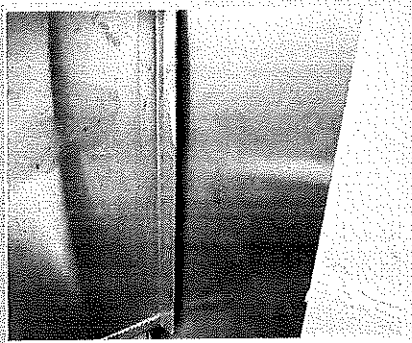
Issue Name : Hoods 2 & 3 Not Secured At Pre Punched Locations

Description : Hood 2 does not have screws installed in all pre punched holes on the hood, due to this it is not sitting flush with the wall. Hood 3 does not have any pre punched holes, however, it is also not flush with the wall. Installing screws may close the gap. Any gaps left unresolved will collect grease over time.

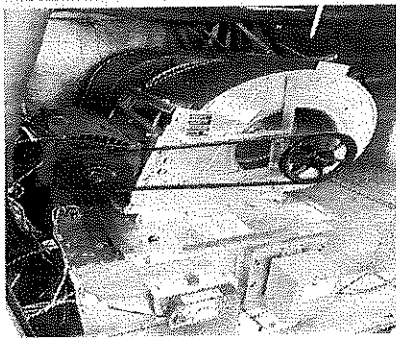
FuseIT8da9d0fec90411...

Issue Name : New RTU #1 No Belt Tensioner
Description : There is no belt tensioner installed on RTU #1.
Created By : National TAB **Assigned To :** National TAB - Stephen Tassinaro
Status : Open
Originated Date : 11/14/2022 - Stephen Tassinaro - National TAB

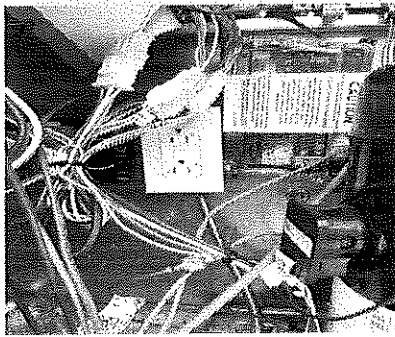
FuseIT9e65feddda8d471...

Issue Name : New RTU #5 GFI Not Functional
Description : GFI inside RTU #5 is not functional.
Created By : National TAB **Assigned To :** National TAB - Stephen Tassinaro
Status : Open
Originated Date : 11/14/2022 - Stephen Tassinaro - National TAB

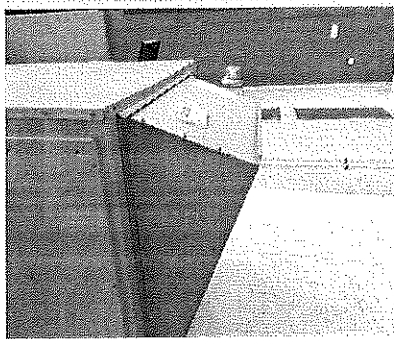
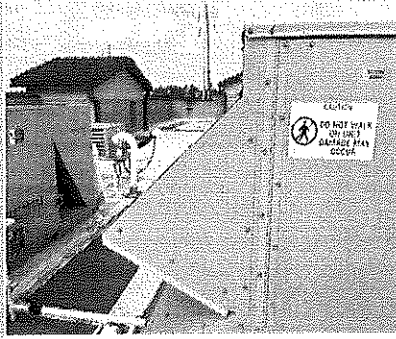
Issue Name : New RTUs Missing Caulking

Description : New RTUs #1 and #5 do not have caulking installed at the corners of the OA hood.

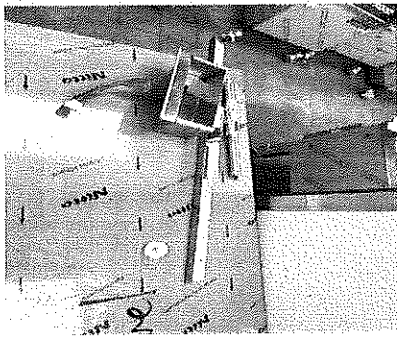
FuselT2a91f1fa2572454...

Issue Name : Parts In Grease Trough

Description : See picture for the parts found in the Hood 1 grease trough.
