# Test and Balance Punch List - Mar 25, 2024

**L05068\_Spring Station FSU (KY)**

962 Breckenridge Lane, Louisville, Kentucky

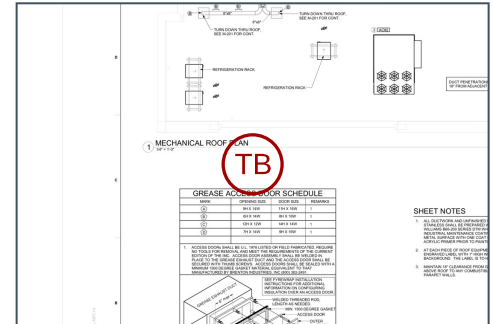
M-250

Cleanout doors do not meet size specifications listed in cleanout door schedule on M-250.

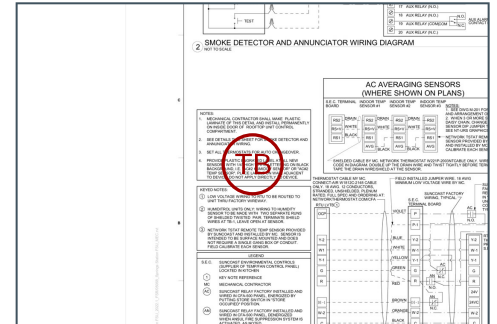
M-501

See M-501, Detail 1, Note 4:  
1/4" High white  
Lettering on black  
background. Label on wall  
ADJACENT TO DEVICE.  
Sensors improperly  
Labeled.
