**Report: Final Report
Function: Test, Adjust, & Balance
Date: 8/24/2022**

**PROJECT
08-15 FIVE GUYS - SAVANNAH, GA**

Project: 08-15 FIVE GUYS - SAVANNAH, GA

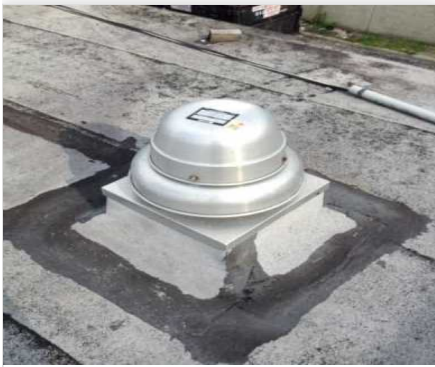
SAV4.JPG

Issue Name : EF2

Description : EF2 RR FAN IS NOT RUNNING MOTOR IS SEIZED, UNABLE TO BALANCE FAN.

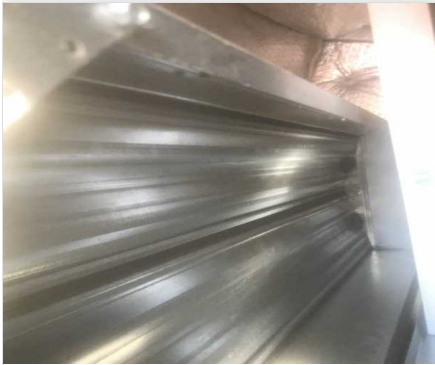
SAV3.jpg

Issue Name : RTU-E4 ECON

Description : ECON IS NOT FUNCTIONING CORRECTLY. OUTSIDE AIR HAD TO BE SET MANUALLY

Notes: [1] UNIT GRILLS DO NOT MATCH WHAT IS SHOWN ON GRD. [2] OA HAD TO BE SET MANUALLY DUE TO ECON NOT WORKING. UNIT TEMP. DISCHARGE IS 66F AT DIFFUSER

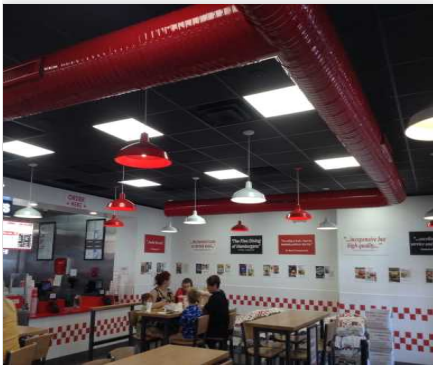
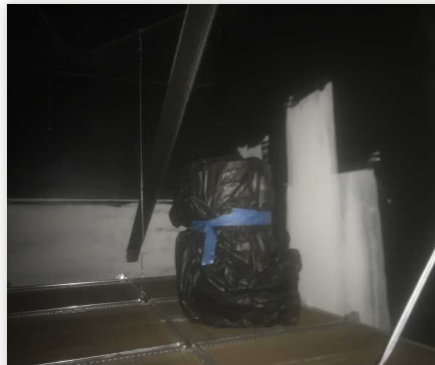
SAV2.JPG

Issue Name : SPIRAL DINING ROOM DUCT INSTALLED

Description : SPIRAL DINING ROOM DUCT INSTALLED IS CAPPED OFF AND DOES NOT CONNECT TO ANY RTU. FOUR WAY DIFFUSERS WERE INSTALLED IN THE DROP CEILING. THIS IS DIFFERENT THEN WHAT IS SHOWN ON THE GRD.

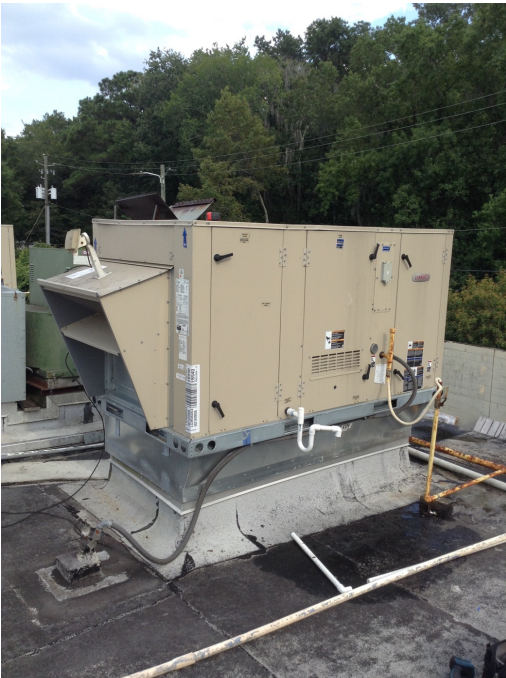
RTU-E3

Notes: [1] UNIT GRILLS TO NOT MATCH WHAT IS SHOWN ON GRD. [2] UNIT DOES NOT HAVE AN OA CANOPY/ INTAKE INSTALLED RECOMMEND ONE BE INSTALLED ON UNIT.
