Report: INSPECTION TAB REPORT

Function: Test, Adjust, & Balance

Date: 03/25/2025

03-24-25 CHIPOTLE #5326 GREENFIELD, WI

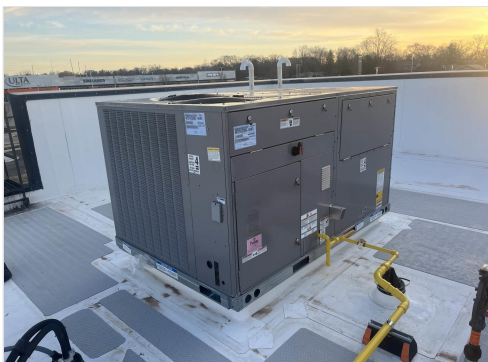
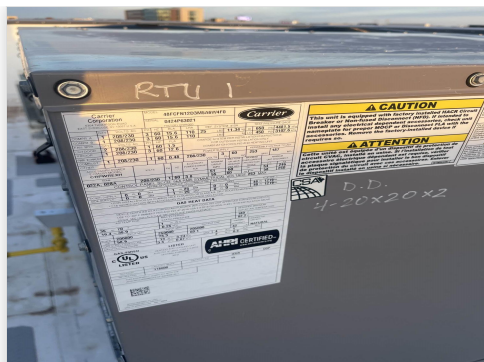
Asset: RTU1

General	
	Actual
Fan Rotation Correct	YES
Unit Filters Clean	CONSTRUCTION FILTERS INSTALLED
Condensate Drain Installed	YES

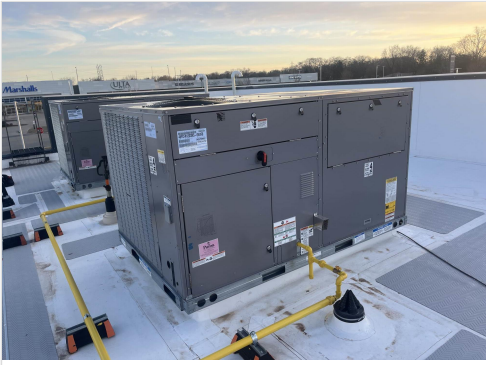
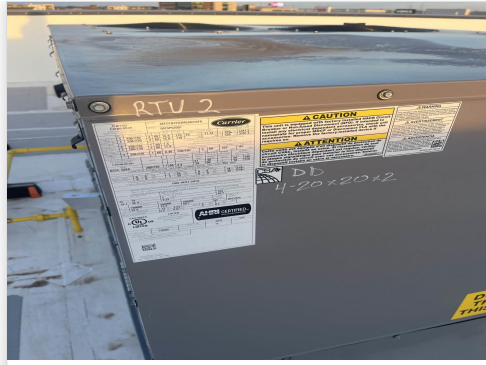
Asset: RTU2

[1] NOT FULLY ALIGNED ON CURB. SOME LEAKAGE ON ROOF.

[2] TURBO DIFFUSERS 2-3 THRU 2-7 NOT INSTALLED. UNABLE TO BALANCE INDIVIDUAL DIFFUSERS AS A RESULT. NOT ANTICIPATED TO CAUSE ISSUE AS UNIT SERVES OPEN AREA.

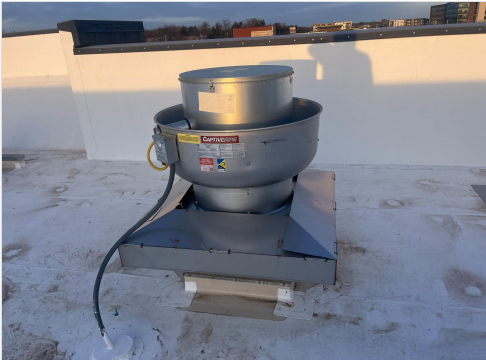
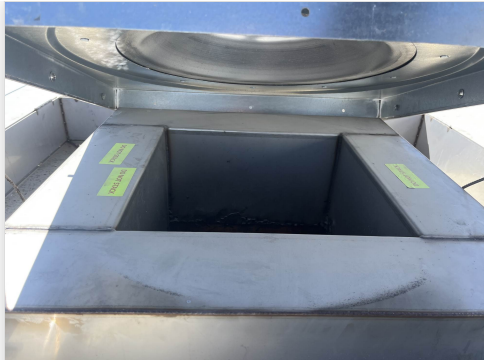
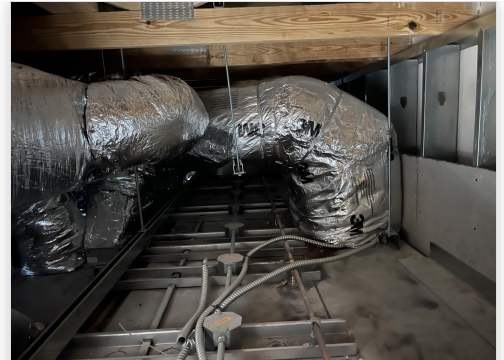
Asset: EF1

Test Data		
	Design	Actual
CFM	2550	2639
Fan RPM	-	998
Fan Rotation	-	CCW, CORRECT
Motor RPM	-	998
System SetPt	-	51.2 HZ
RL Voltage	-	100 @VFD
RL Amperage	-	5.3 @VFD
Total ESP	1.2"	1.13"
Fan Inlet SP	-	-1.13"
Fan Discharge SP	-

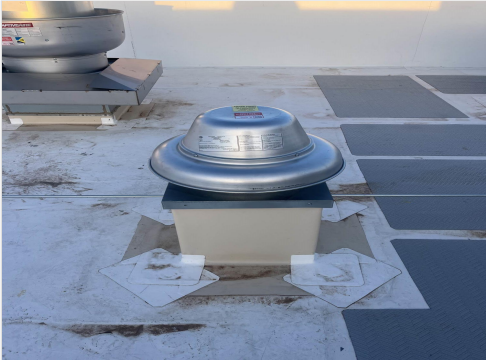
Asset: EF2

Test Data		
	Design	Actual
CFM	150	150
Fan RPM	-	1057
Fan Rotation	-	CCW, CORRECT
Motor RPM	-	1057
System SetPt	-	56%
RL Voltage	-	121
RL Amperage	-	0.6
Total ESP	.6"	0.31"
Fan Inlet SP	-	-0.31"
Fan Discharge SP	-	ATM

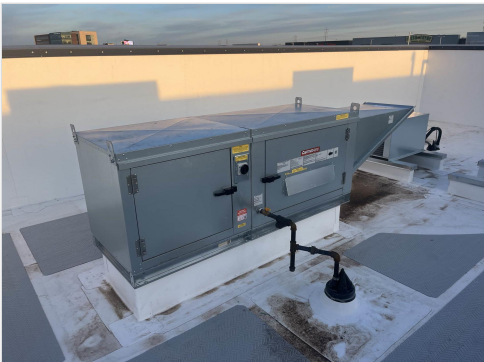
Asset: MAU1

Gas Heat		
	Design	Actual
Heater Operates (y/n)	-	YES
Flame Status (pass/fail)	-	PASS
Inlet Air Temp SetPt	-	55
Discharge Air Temp SetPt	-	60
Air Flow Switch SP Actual	-	0.321"

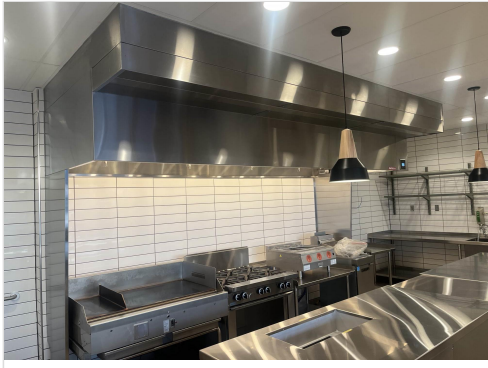
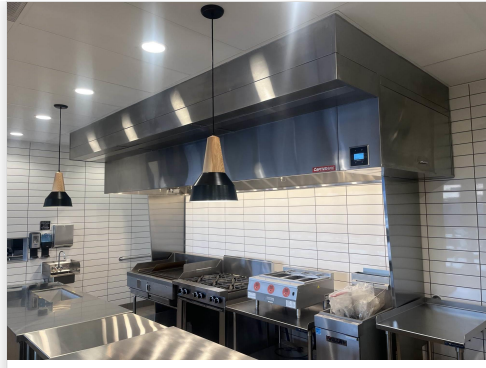
Asset: HD1

Test Data Exhaust		
	Design	Actual
Filter Type	CAPTRATE SOLO	CAPTRATE SOLO
Filter Size 1	16x16	16X16
Filter Qty 1	9	9
Filter AK factor size 1	1.62	1.62
Filter Total AK Area	14.58	14.58
Filter1 FPM	-	167
Filter2 FPM	-	165
Filter3 FPM	-	181
Filter4 FPM	-	200
Filter5 FPM	-	202
Filter6 FPM	-	199
Filter7 FPM	-	183
Filter8 FPM	-	177
Filter9 FPM	-	160
Filter Ave FPM(corr)	-	181
CFM	2550	2639
