### AIR BALANCE SCHEDULE

## 07-11 CULVERS - ELLISVILLE, MO

**Issue Name :** asset note RTU1 [1]  
**Description :** OA filters and hood have not arrived yet. GC helped make a makeshift hood to read OA measuring 14.75x76  
**Created By :** National TAB **Assigned To :** National TAB - Will Turnbough  
**Status :** Pending  
**Originated Date :** 07/13/2022 - Jacob Davidson - National TAB

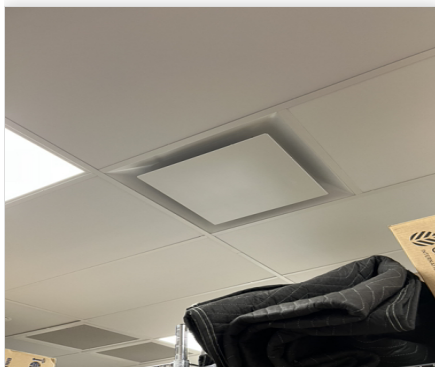
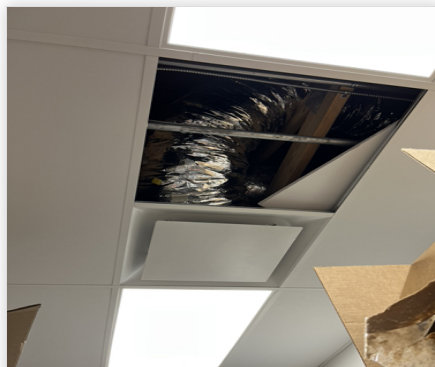
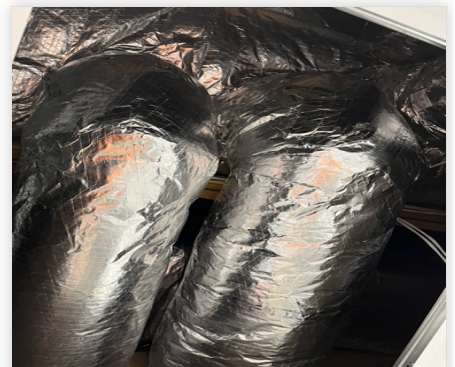
**Issue Name :** RTU2 diffusers for dry goods have no dampers

**Description :** Diffusers for dry goods do not have dampers. The 200 cfm diffuser is high and the 600 cfm diffuser is very low due to excess flex and ceiling restrictions. Since it is in an open area, I do not foresee it causing comfort issues.

- **07/14/2022**    **National TAB - Dan Hertenstein**
  - Low Priority due to overall space comfort

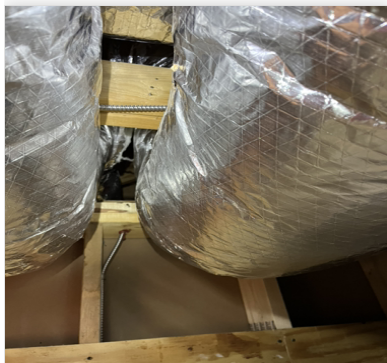
- **07/13/2022**    **National TAB - Jacob Davidson**
  - Current airflow for each is 260/200 and 344/600. Pic is another angle looking for damper

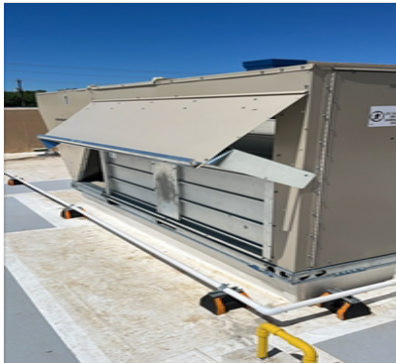
Makeshifhood.jpeg

NO // 7-12-22 Economizer is installed, however full assembly for hood and OA filters has not arrived. OA read in open area as shown.
