Report: Prelim Field TAB Report
Function: Test, Adjust, & Balance
Date: 7/14/2022

PROJECT
07-11 CULVERS - ELLISVILLE, MO

Project: 07-11 CULVERS - ELLISVILLE, MO

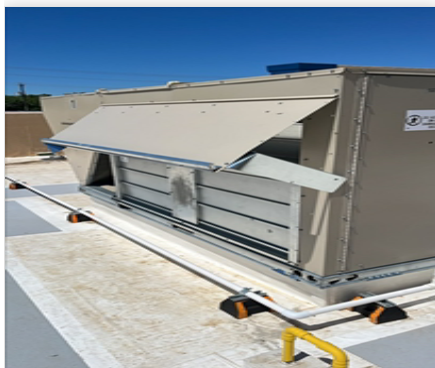
Makeshifthood.jpeg

Issue Name : asset note RTU1 [1]
Description : OA filters and hood have not arrived yet. GC helped make a makeshift hood to read OA measuring 14.75x76
Created By : National TAB **Assigned To :** National TAB - Will Turnbough
Status : Pending
Originated Date : 07/13/2022 - Jacob Davidson - National TAB

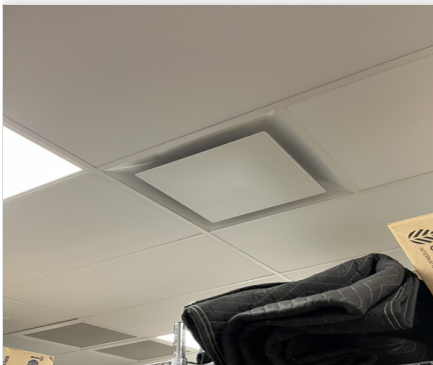
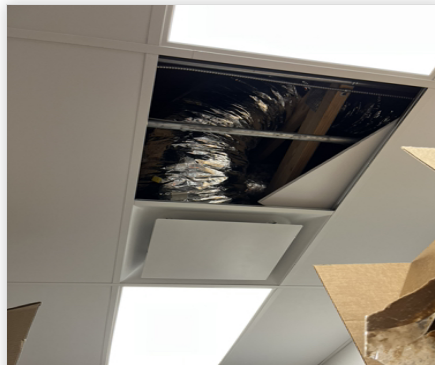
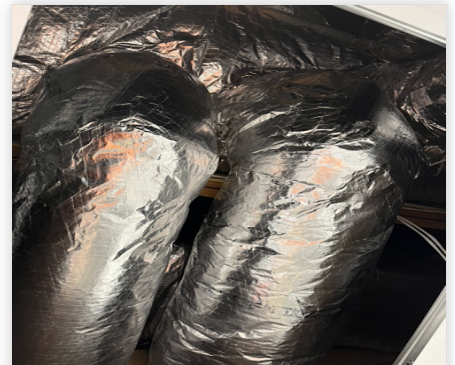
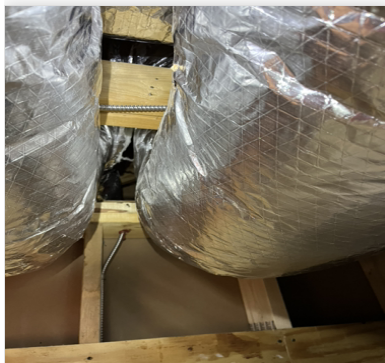
Issue Name : RTU2 diffusers for dry goods have no dampers

Description : Diffusers for dry goods do not have dampers. The 200 cfm diffuser is high and the 600 cfm diffuser is very low due to excess flex and ceiling restrictions. Since it is in an open area, I do not foresee it causing comfort issues.

- **07/13/2022** **National TAB - Jacob Davidson**
 - Current airflow for each is 260/200 and 344/600. Pic is another angle looking for damper

- **07/14/2022** **National TAB - Dan Hertenstein**
 - Low Priority due to overall space comfort

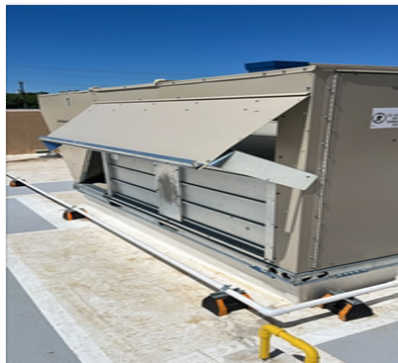
Makeshifthood.jpeg

NO // 7-12-22 Economizer is installed, however full assembly for hood and OA filters has not arrived. OA read in open area as shown.

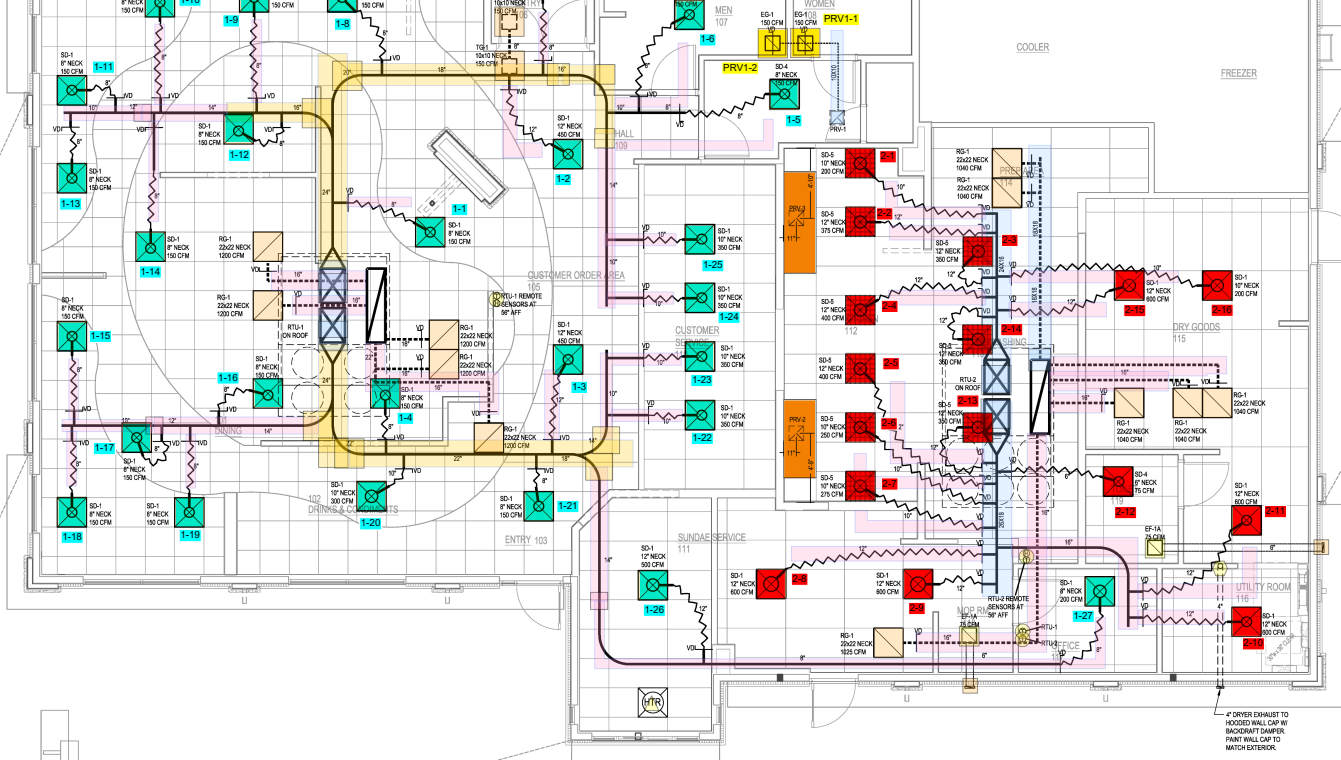
E5 HVAC PLAN
SCALE: 1/4" = 1'-0"

NOTE: ALL DUCTWORK TO BE LOCATED IN TRUSS SPACE WHERE POSSIBLE. SEE FRAMING PLAN.
HVAC SETPOINTS RECOMMENDED BY CORPORATE OPERATIONAL GUIDELINES:
1. DINING: HEATING 70 DEGF, COOLING 72 DEGF.
2. KITCHEN: HEATING 68 DEGF, COOLING 74 DEGF.
