Report: Brightview-DOAS1 Analysis

Function: Test, Adjust, & Balance

Date: 09/22/2025

BVE - Brightview Senior Living (Eatontown, NJ)

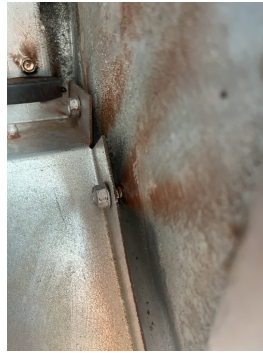
Per DJW DOAS filters have been replaced and Heat wheel cleaned and serviced by Facility staff. Fresh filters were found inside the unit at time of testing. All doors have had additional foam to seal gaps and to prevent leakage. No air supply/exhaust can be felt around any access doors showing the unit is well sealed. The only spot where there could be some short cycling is a bracket piece on the inside of the unit. Pictured:

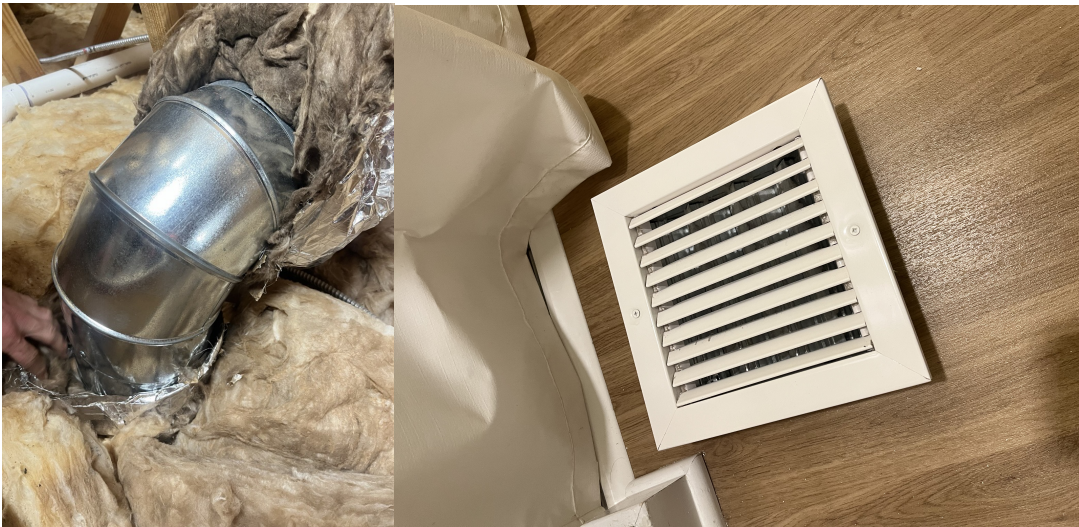
It was not possible to obtain a traverse of any part of the trunkline for the supply side of DOAS-1 due to the location of the duct above hard ceiling in the hallway and clearance needed to insert the pitot tube. Flow hood readings were taken on the supply side with three hood configurations types and it was found that there is no consistency and ability to triangulate hood readings or traverses. The hood readings on the supply side we deem as inaccurate. The reason for the discrepancy/inconsistency in readings is from the 1. Supply grille type, and 2. how the supply grille is connected to ductwork with an elbow directly on top of the plenum box. the configuration is creating turbulence across the flow hood grid where the flow hood requires laminar flow in order to read supply air accurately as you would see with a typical 4 way throw diffuser.

A total traverse of the DOAS supply was not possible so for further testing it would be recommended to read the total intake on the roof via alternative methods.

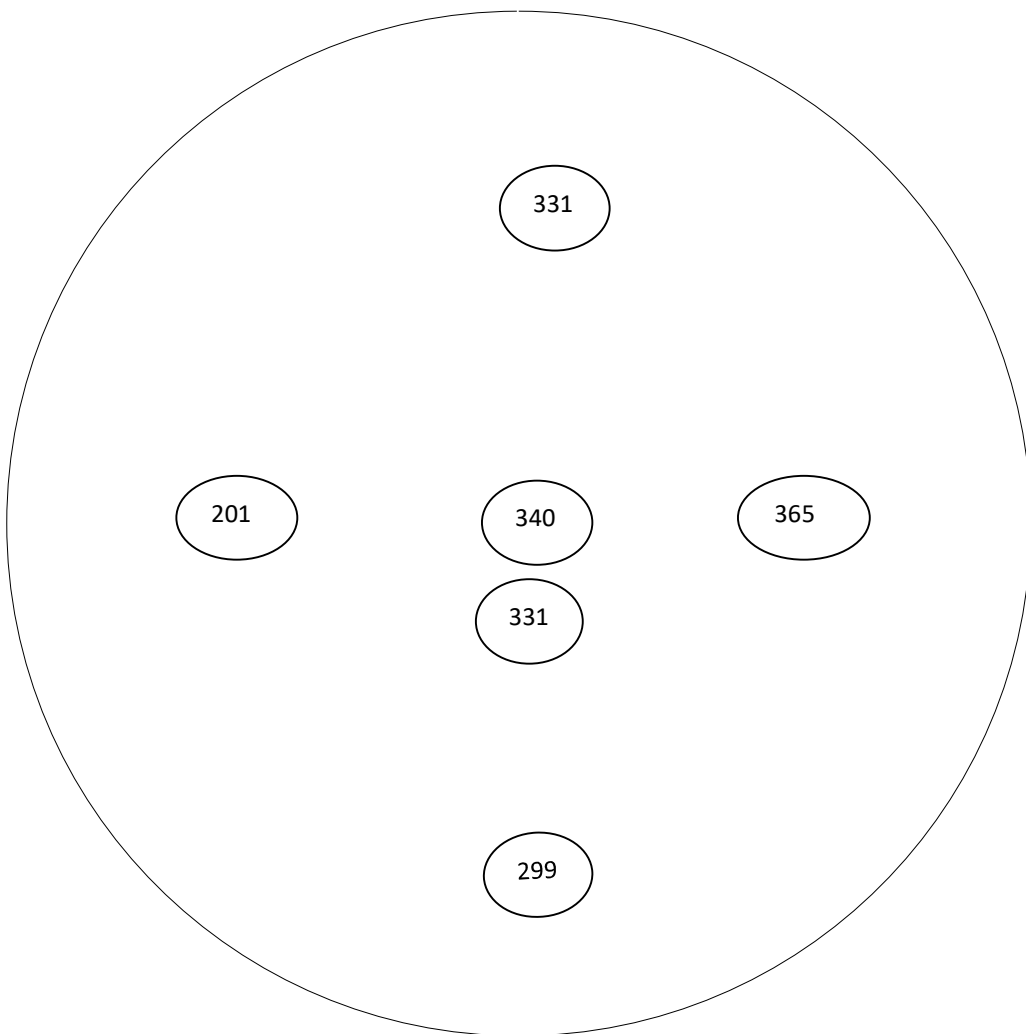
ROUND DUCT TRAVERSE FORM

PROJECT:	Brightview Senior Living	SYSTEM:	DOAS 1
LOCATION - ZONE:	Attic	SERVICE:	Supply Register 10
ALTITUDE:		DENSITY:	
		FACTOR:

DUCT	REQUIRED	ACTUAL
S.P.: 0.14"	SCFM:	SCFM:
SIZE: 6"	FPM: 326	FPM: 311
AREA: 0.35Ft^2	CFM: 65	CFM: 61
TEMP:

REMARKS:
[1] Accessed in attic space
