Report: PUNCHLIST
Function: Test, Adjust, & Balance
Date: 03/10/2026
Completed By: National TAB

PROJECT
03-09-26 QT #0588 OMAHA, NE

QUIKTRIP
4705 SOUTH 129TH EAST AVENUE
TULSA, OK 74134

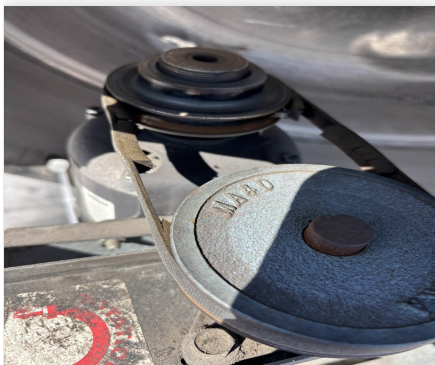
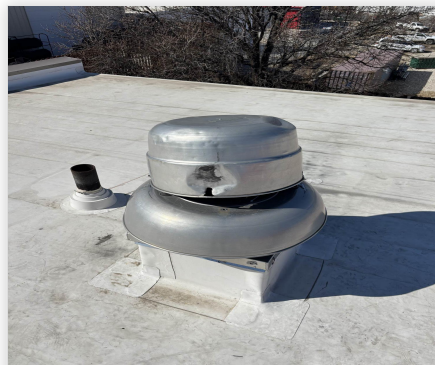
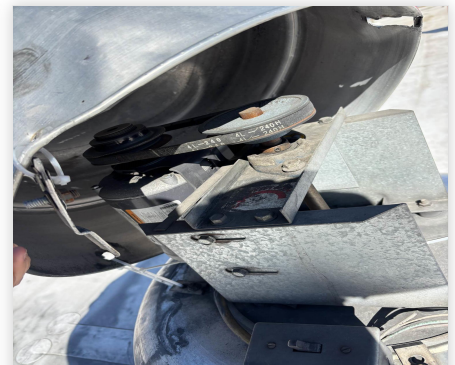
Issue Name : EF-1: Damage
Description : EF-1 was found off upon arrival. Drive belt is cracked and missing chunks out of it. The cover is also heavily damaged and being held on with zip ties. Recommend replacing drive belt and cover. Unit left turned off.
Created By : National TAB **Assigned To :** National TAB - Dan Hertenstein
Status : Open
Priority : Urgent **Asset Tag :** EF1
Originated Date : 03/10/2026 - Kalen Kemp - National TAB

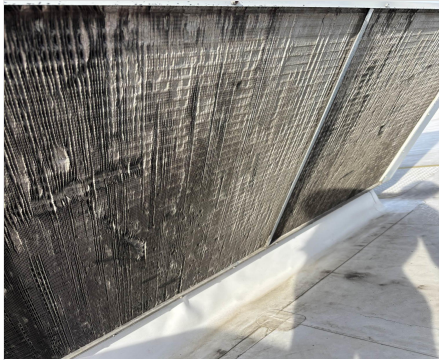
Issue Name : RT-2: Condenser Coil
Description : The condenser coil for RT-2 is damaged. Recommend service.
Created By : National TAB **Assigned To :** National TAB - Dan Hertenstein
Status : Open
Priority : Medium **Asset Tag :**
Originated Date : 03/11/2026 - Kalen Kemp - National TAB
