Report: TAB REPORT
Function: Test, Adjust, & Balance
Date: 12/06/2023

PROJECT
12-04-23 FIREBIRDS - PLANO, TX

Project: 12-04-23 FIREBIRDS - PLANO, TX

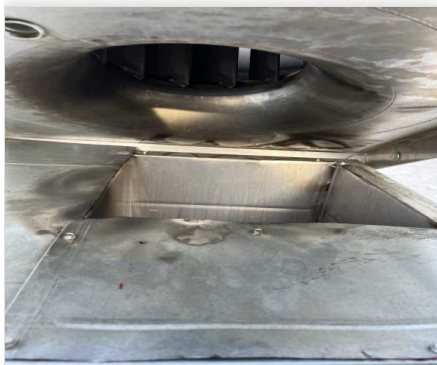
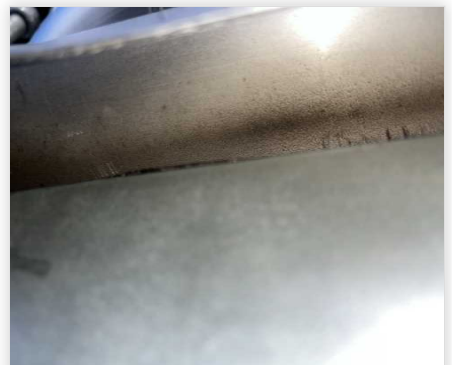
EF_DISH_ISSUE_1
12/08/2023

Issue Name : EF-DISH Fan Seal
Description : EF-DISH does not sit all the way down on the curb for the fan. There is about a 1/2" to 3/4" gap all the way around. There is also not a rubber seal on the bottom of the fan or on the curb to help seal off the duct. The duct itself that comes up through the curb does not align with the intake of the exhaust fan. Pictures attached provide insight.
Created By : National TAB **Assigned To :** National TAB - Will Turnbough
Status : Open
Priority : InfoOnly **Asset Tag :**
Originated Date : 12/08/2023 - Bayley Morvant - National TAB
